R-030A

S 2ND ST
New Bedford

Inspection Status: Remote Inspection
Inspection Level: Level 2

Project: | New Bedford 3D Regulator Inspections

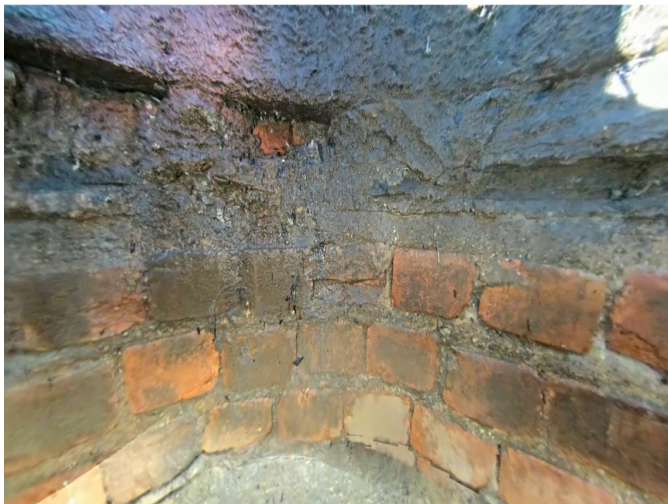
Code: **SRI**
Description: **Surface Damage Roughness Increased**

Distance: **0ft**
Structural Grade: **1**
O&M Grade: **0**
Clock Start/From: **12**
Clock To: **12**
1st Value:
2nd Value:
Value Percent:
Continuous Index:
Within Eight" of Joint: **False**
Remarks:

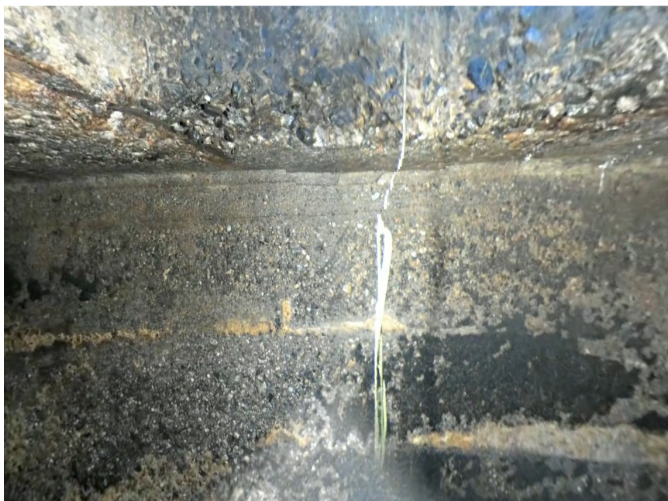
Code: **SAV**
Description: **Surface Damage Aggregate Visible**

Distance: **2ft**
Structural Grade: **2**
O&M Grade: **0**
Clock Start/From: **12**
Clock To: **12**
1st Value:
2nd Value:
Value Percent:
Continuous Index: **S01**
Within Eight" of Joint: **False**
Remarks:

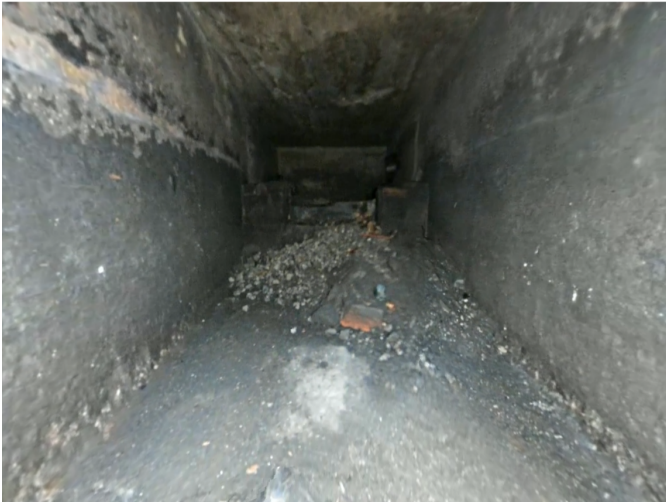
Code: **DSGV**
Description: **Deposits Settled Gravel**

Distance: **4ft**
Structural Grade: **0**
O&M Grade: **2**
Clock Start/From: **12**
Clock To:
1st Value:
2nd Value:
Value Percent: **50**
Continuous Index:
Within Eight" of Joint: **False**
Remarks:

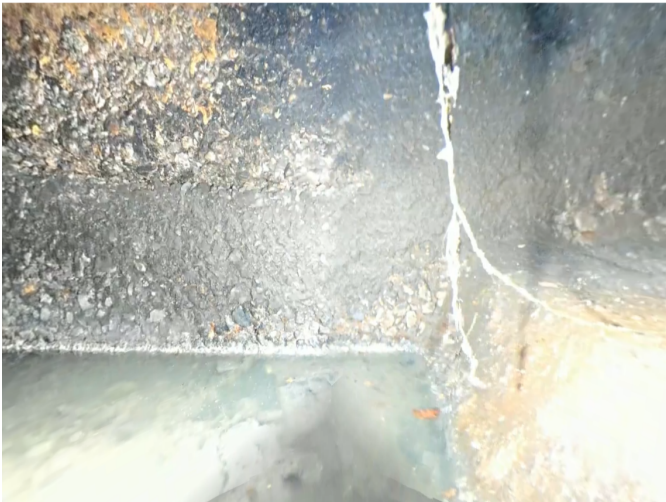
Code: **SAV**
Description: **Surface Damage Aggregate Visible**

Distance: **5ft**
Structural Grade: **2**
O&M Grade: **0**
Clock Start/From: **12**
Clock To: **12**
1st Value:
2nd Value:
Value Percent:
Continuous Index: **F01**
Within Eight" of Joint: **False**
Remarks:
