R-030B

S 2ND ST
New Bedford

Project: | New Bedford 3D Regulator Inspections

Condition Report

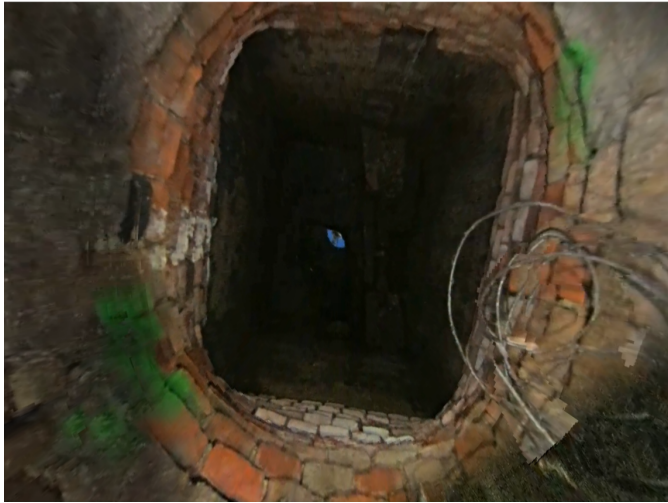
Code: **MGO**
Description: **Miscellaneous General Observation**

Distance: **0ft**
Structural Grade: **0**
O&M Grade: **0**
Clock Start/From:
Clock To:
1st Value:
2nd Value:
Value Percent:
Continuous Index:
Within Eight" of Joint: **False**
Remarks: **Start inspection**

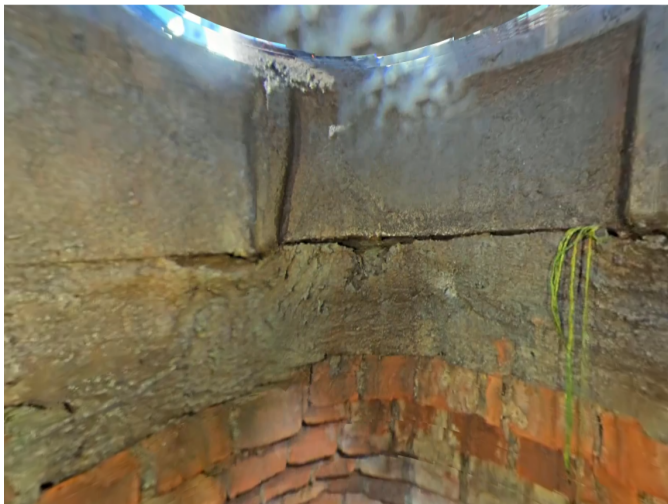
Code: **CC**
Description: **Crack Circumferential**

Distance: **0ft**
Structural Grade: **2**
O&M Grade: **0**
Clock Start/From: **12**
Clock To: **12**
1st Value:
2nd Value:
Value Percent:
Continuous Index:
Within Eight" of Joint: **True**
Remarks:

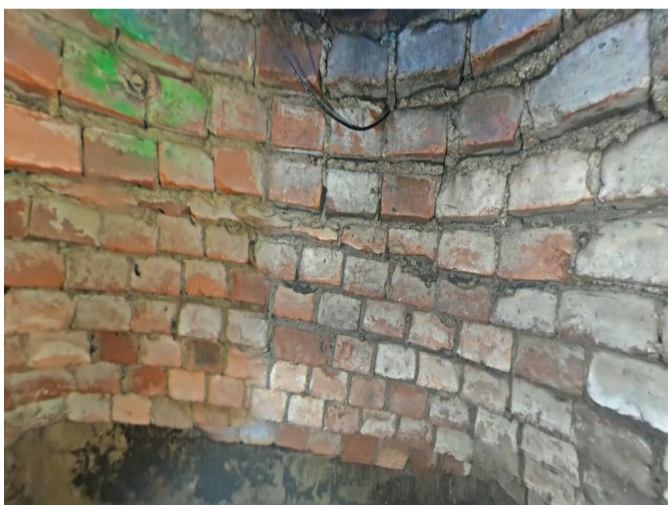
Code: **MMS**
Description: **Missing Mortar Small**

Distance: **1ft**
Structural Grade: **2**
O&M Grade: **0**
Clock Start/From: **12**
Clock To: **12**
1st Value:
2nd Value:
Value Percent:
Continuous Index:
Within Eight" of Joint: **False**
Remarks:

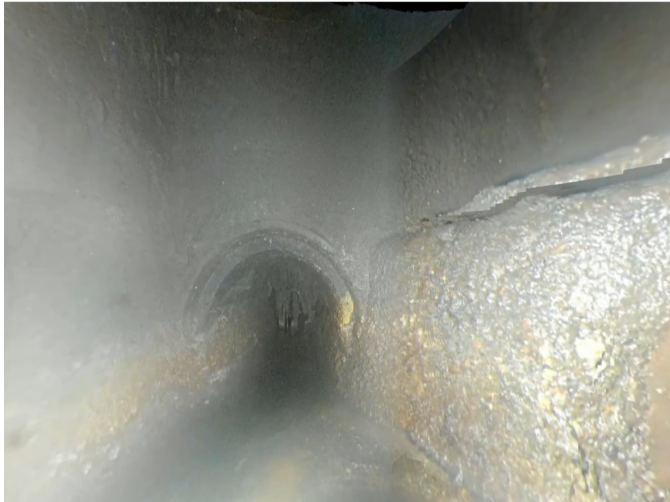
Code: **MGO**
Description: **Miscellaneous General Observation**

Distance: **7ft**
Structural Grade: **0**
O&M Grade: **0**
Clock Start/From:
Clock To:
1st Value:
2nd Value:
Value Percent:
Continuous Index:
Within Eight" of Joint: **False**
Remarks: **Start inspection**
