R-031A

S 2ND ST
New Bedford

Project: | New Bedford 3D Regulator Inspections

Condition Report

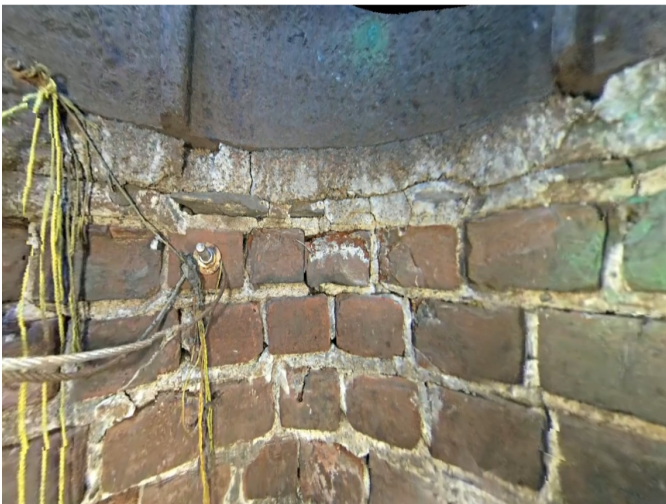
Code: **CC**
Description: **Crack Circumferential**

Distance: **0ft**
Structural Grade: **2**
O&M Grade: **0**
Clock Start/From: **12**
Clock To: **12**
1st Value:
2nd Value:
Value Percent:
Continuous Index:
Within Eight" of Joint: **True**
Remarks:

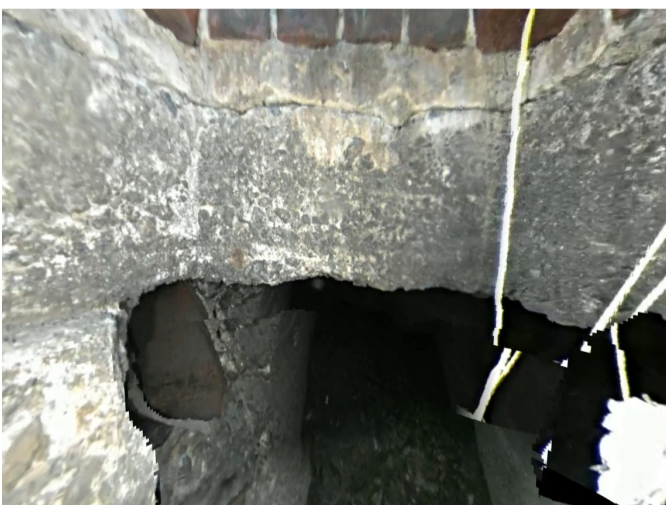
Code: **SAV**
Description: **Surface Damage Aggregate Visible**

Distance: **2ft**
Structural Grade: **2**
O&M Grade: **0**
Clock Start/From: **12**
Clock To: **12**
1st Value:
2nd Value:
Value Percent:
Continuous Index: **S01**
Within Eight" of Joint: **False**
Remarks:

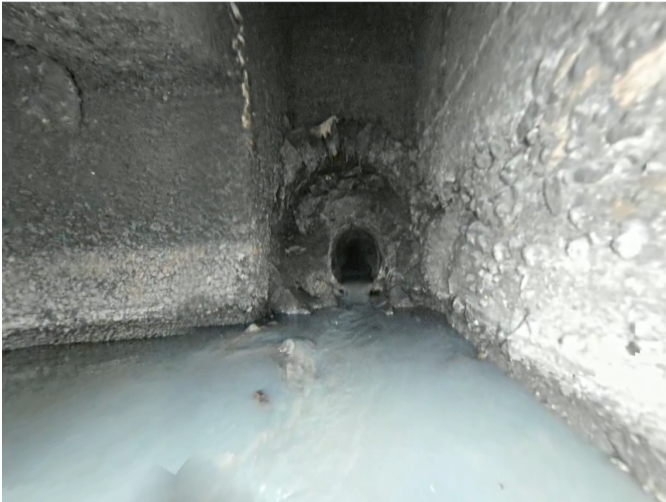
Code: **SAV**
Description: **Surface Damage
Aggregate Visible**

Distance: **5ft**
Structural Grade: **2**
O&M Grade: **0**
Clock Start/From: **12**
Clock To: **12**
1st Value:
2nd Value:
Value Percent:
Continuous Index: **F01**
Within Eight" of Joint: **False**
Remarks:

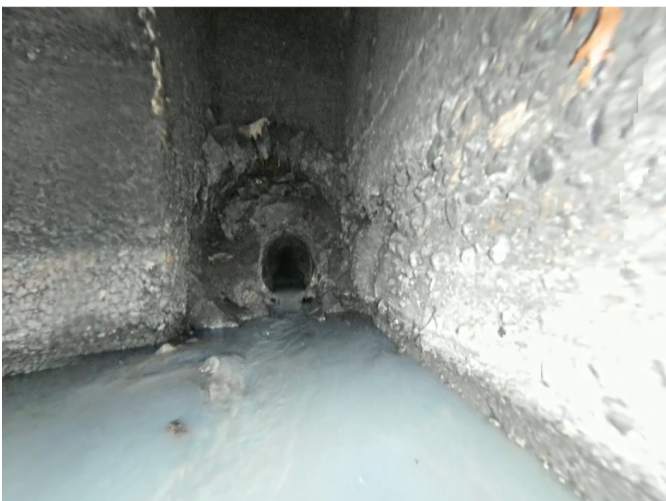
Code: **SAP**
Description: **Surface Damage
Aggregate Projecting**

Distance: **5ft**
Structural Grade: **3**
O&M Grade: **0**
Clock Start/From: **12**
Clock To: **12**
1st Value:
2nd Value:
Value Percent:
Continuous Index:
Within Eight" of Joint: **False**
Remarks:
