R-031B

S 2ND ST
New Bedford

Inspection Status: Remote Inspection
Inspection Level: Level 2

Project: | New Bedford 3D Regulator Inspections

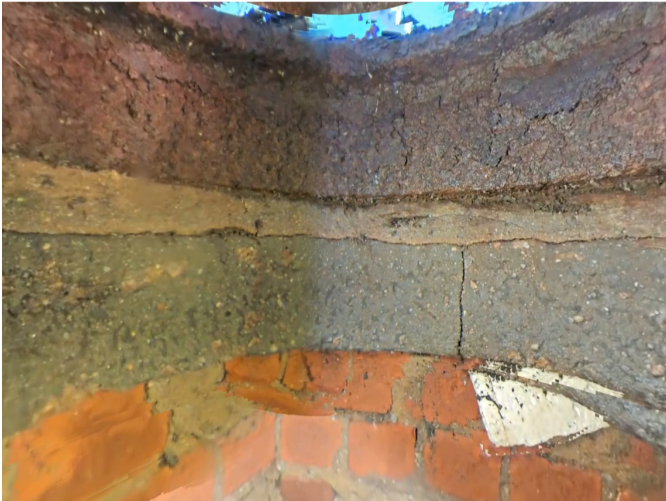
Code: **CC**
Description: **Crack Circumferential**

Distance: **0ft**
Structural Grade: **2**
O&M Grade: **0**
Clock Start/From: **12**
Clock To: **12**
1st Value:
2nd Value:
Value Percent:
Continuous Index:
Within Eight" of Joint: **True**
Remarks:

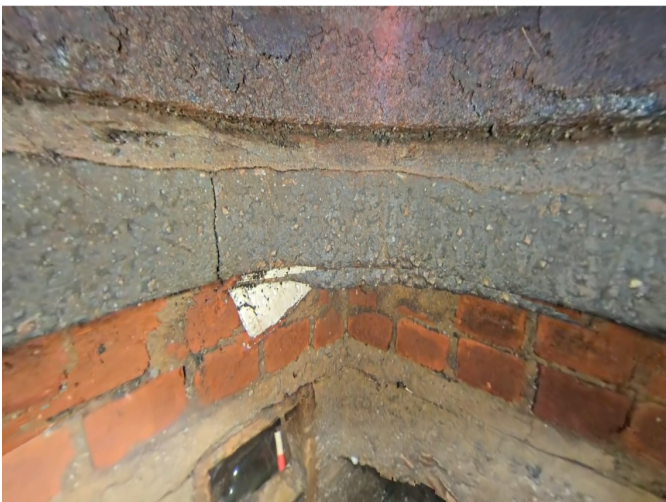
Code: **SAV**
Description: **Surface Damage Aggregate Visible**

Distance: **0ft**
Structural Grade: **2**
O&M Grade: **0**
Clock Start/From: **12**
Clock To: **12**
1st Value:
2nd Value:
Value Percent:
Continuous Index:
Within Eight" of Joint: **False**
Remarks:

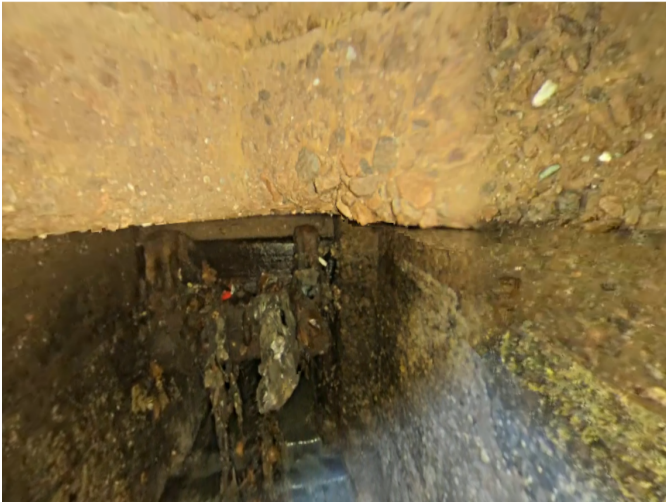
Code: **SAV**
Description: **Surface Damage
Aggregate Visible**

Distance: **2ft**
Structural Grade: **2**
O&M Grade: **0**
Clock Start/From: **12**
Clock To: **12**
1st Value:
2nd Value:
Value Percent:
Continuous Index: **S01**
Within Eight" of Joint: **False**
Remarks:

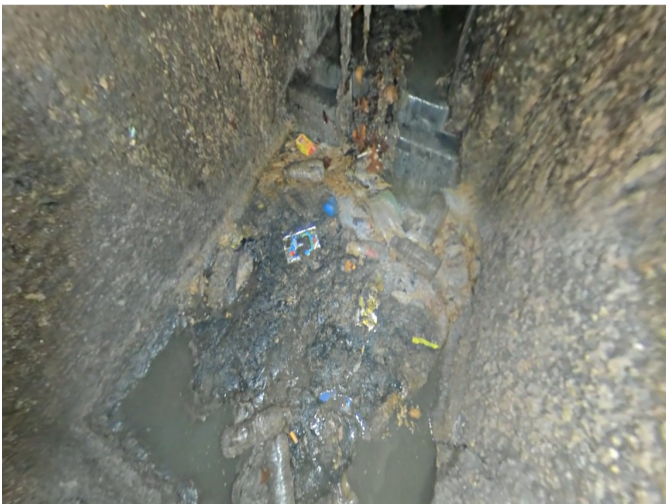
Code: **DAZ**
Description: **Deposits Attached Other**

Distance: **3ft**
Structural Grade: **0**
O&M Grade: **4**
Clock Start/From: **12**
Clock To: **12**
1st Value:
2nd Value:
Value Percent: **50**
Continuous Index:
Within Eight" of Joint: **False**
Remarks: **Mixed debris**

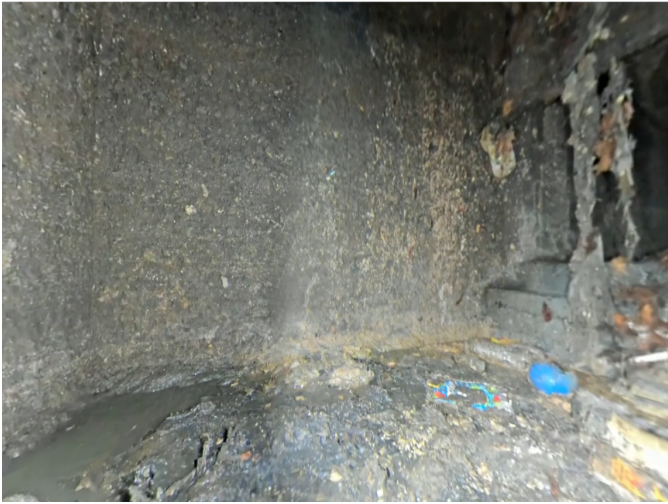
Code: **SAV**
Description: **Surface Damage
Aggregate Visible**

Distance: **5ft**
Structural Grade: **2**
O&M Grade: **0**
Clock Start/From: **12**
Clock To: **12**
1st Value:
2nd Value:
Value Percent:
Continuous Index: **F01**
Within Eight" of Joint: **False**
Remarks:
