# R-031C

S 2ND ST  
New Bedford

Inspection Status: Remote Inspection  
Inspection Level: Level 2

**Project:** | New Bedford 3D Regulator Inspections

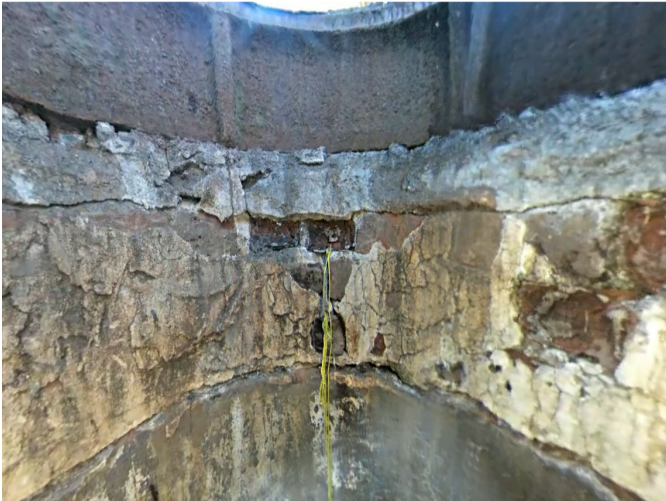
Code: **SSS**  
Description: **Surface Spalling of Damage**

Distance: **1ft**  
Structural Grade: **2**  
O&M Grade: **0**  
Clock Start/From: **12**  
Clock To: **12**  
1st Value:  
2nd Value:  
Value Percent:  
Continuous Index:  
Within Eight" of Joint: **False**  
Remarks:

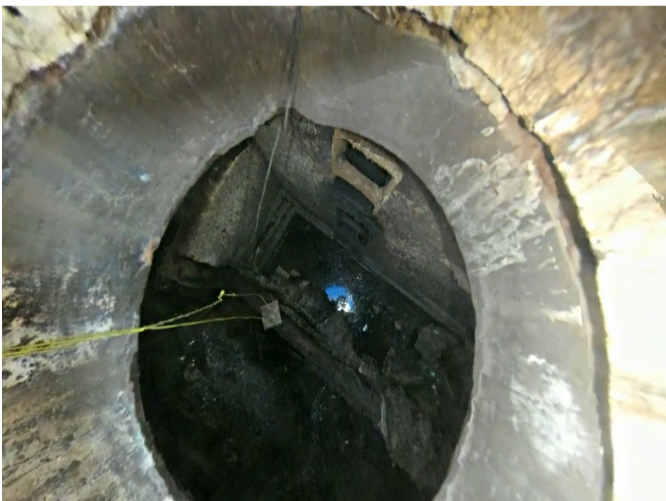
Code: **IS**  
Description: **Infiltration Stain**

Distance: **1ft**  
Structural Grade: **0**  
O&M Grade: **1**  
Clock Start/From: **12**  
Clock To: **12**  
1st Value:  
2nd Value:  
Value Percent:  
Continuous Index:  
Within Eight" of Joint: **False**  
Remarks:

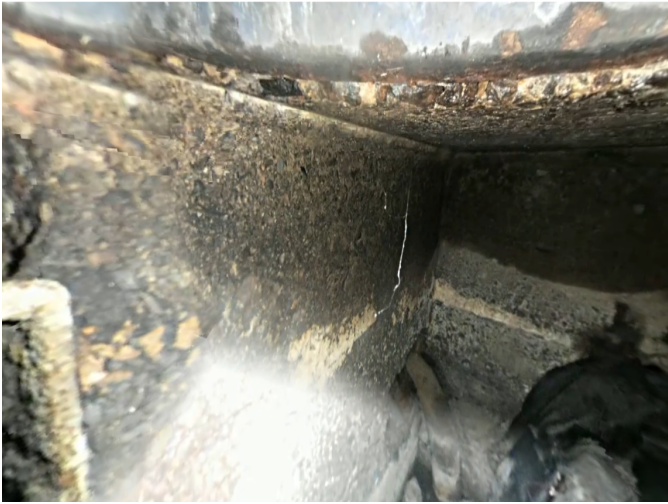
Code: **SAV**  
Description: **Surface Damage  
Aggregate Visible**

Distance: **2ft**  
Structural Grade: **2**  
O&M Grade: **0**  
Clock Start/From: **12**  
Clock To: **12**  
1st Value:  
2nd Value:  
Value Percent:  
Continuous Index: **S01**  
Within Eight" of Joint: **False**  
Remarks:

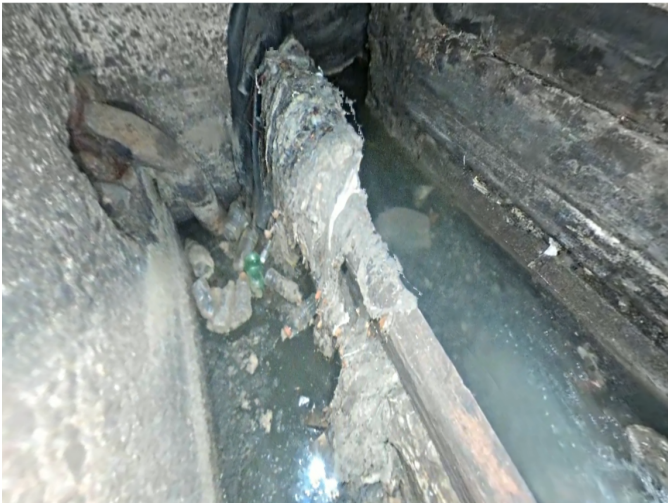
Code: **DSZ**  
Description: **Deposits Settled Other**

Distance: **3ft**  
Structural Grade: **0**  
O&M Grade: **3**  
Clock Start/From: **6**  
Clock To:  
1st Value:  
2nd Value:  
Value Percent: **25**  
Continuous Index:  
Within Eight" of Joint: **False**  
Remarks: **Ragging and trash**

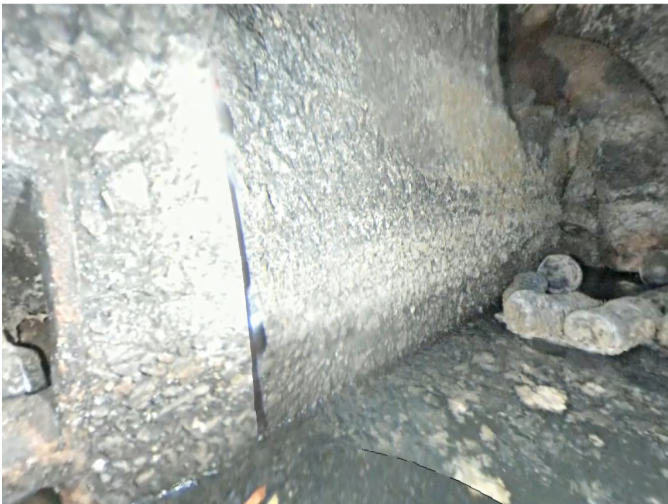
Code: **SAV**  
Description: **Surface Damage  
Aggregate Visible**

Distance: **6ft**  
Structural Grade: **2**  
O&M Grade: **0**  
Clock Start/From: **12**  
Clock To: **12**  
1st Value:  
2nd Value:  
Value Percent:  
Continuous Index: **F01**  
Within Eight" of Joint: **False**  
Remarks:
