R-031E

JFK MEMORIAL HWY
New Bedford

Inspection Status: Remote Inspection
Inspection Level: Level 2

Project: | New Bedford 3D Regulator Inspections

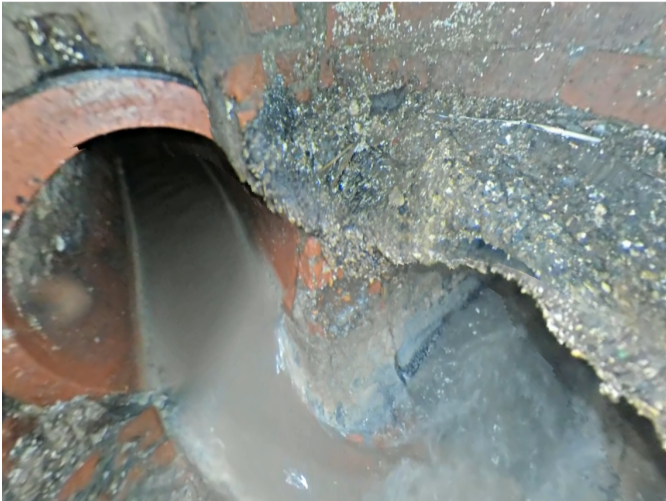
Code: **DAE**
Description: **Deposits Attached Encrustation**

Distance: **11ft**
Structural Grade: **0**
O&M Grade: **0**
Clock Start/From: **12**
Clock To: **12**
1st Value:
2nd Value:
Value Percent: **10**
Continuous Index:
Within Eight" of Joint: **False**
Remarks:
