R-032B

S 2ND ST
New Bedford

Inspection Status: Remote Inspection
Inspection Level: Level 2

Project: | New Bedford 3D Regulator Inspections

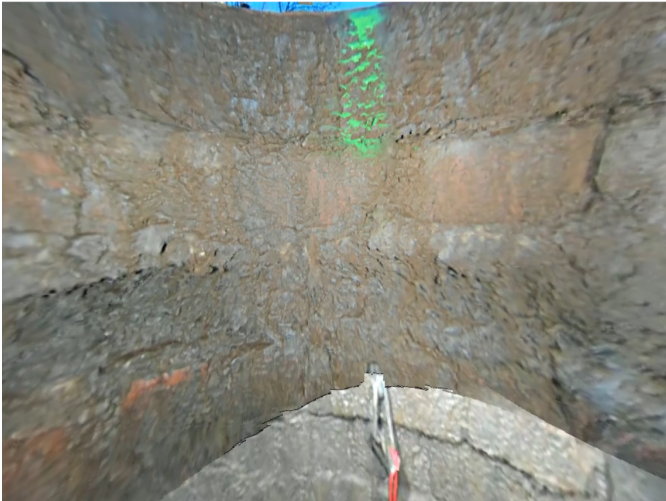
Code: **SRI**
Description: **Surface Damage Roughness Increased**

Distance: **0ft**
Structural Grade: **1**
O&M Grade: **0**
Clock Start/From: **12**
Clock To: **12**
1st Value:
2nd Value:
Value Percent:
Continuous Index: **S01**
Within Eight" of Joint: **False**
Remarks:

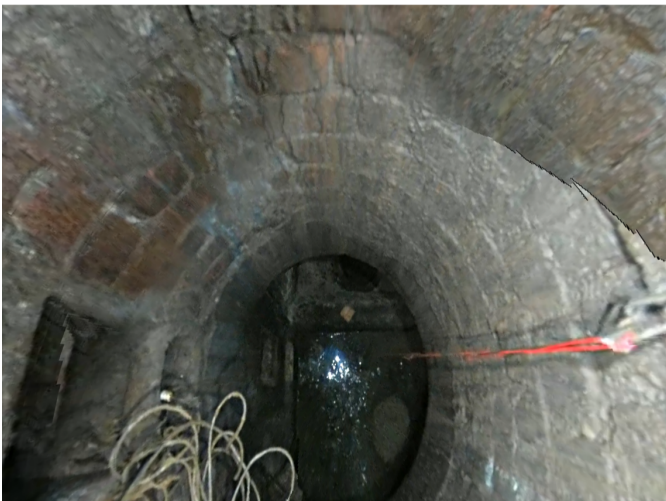
Code: **IS**
Description: **Infiltration Stain**

Distance: **0ft**
Structural Grade: **0**
O&M Grade: **1**
Clock Start/From: **12**
Clock To: **12**
1st Value:
2nd Value:
Value Percent:
Continuous Index: **S02**
Within Eight" of Joint: **False**
Remarks:

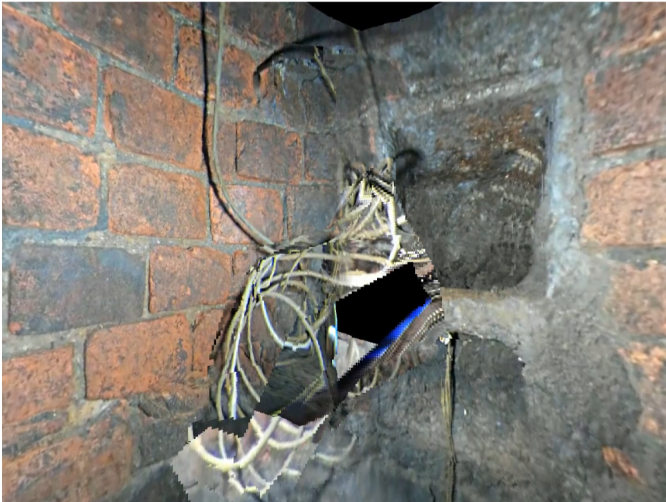
Code: **OBZ**
Description: **Obstruction Other**

Distance: **2ft**
Structural Grade: **0**
O&M Grade: **0**
Clock Start/From: **12**
Clock To:
1st Value:
2nd Value:
Value Percent: **10**
Continuous Index:
Within Eight" of Joint: **False**
Remarks: **Rope/wire**

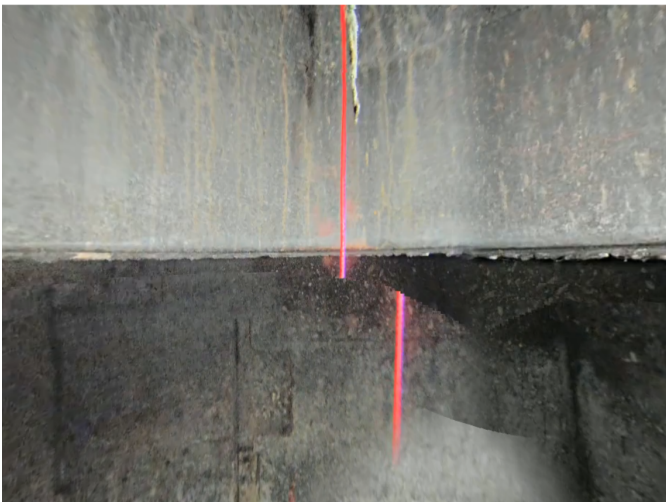
Code: **IS**
Description: **Infiltration Stain**

Distance: **3ft**
Structural Grade: **0**
O&M Grade: **1**
Clock Start/From: **12**
Clock To: **12**
1st Value:
2nd Value:
Value Percent:
Continuous Index: **F02**
Within Eight" of Joint: **False**
Remarks:

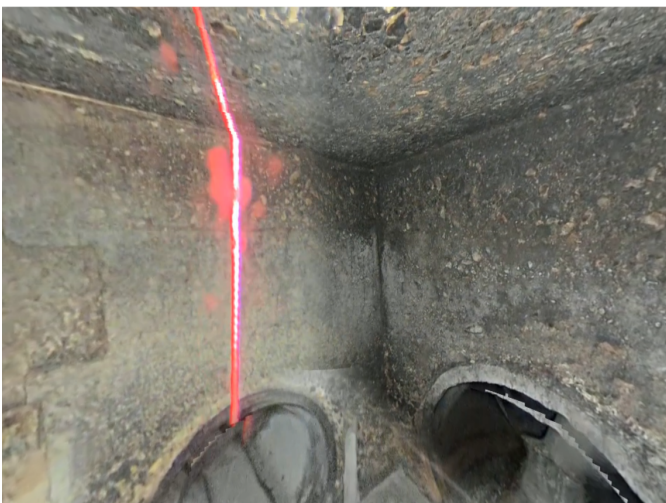
Code: **SRI**
Description: **Surface Damage
Roughness Increased**

Distance: **4ft**
Structural Grade: **1**
O&M Grade: **0**
Clock Start/From: **12**
Clock To: **12**
1st Value:
2nd Value:
Value Percent:
Continuous Index: **F01**
Within Eight" of Joint: **False**
Remarks:

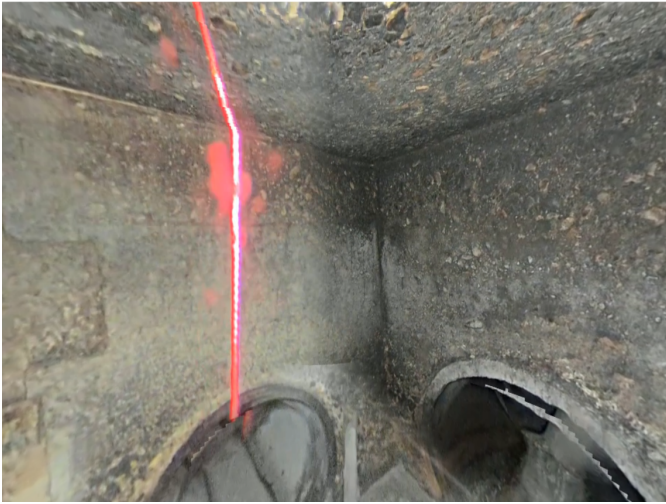
Code: **SAV**
Description: **Surface Damage
Aggregate Visible**

Distance: **4ft**
Structural Grade: **2**
O&M Grade: **0**
Clock Start/From: **12**
Clock To: **12**
1st Value:
2nd Value:
Value Percent:
Continuous Index: **S03**
Within Eight" of Joint: **False**
Remarks:

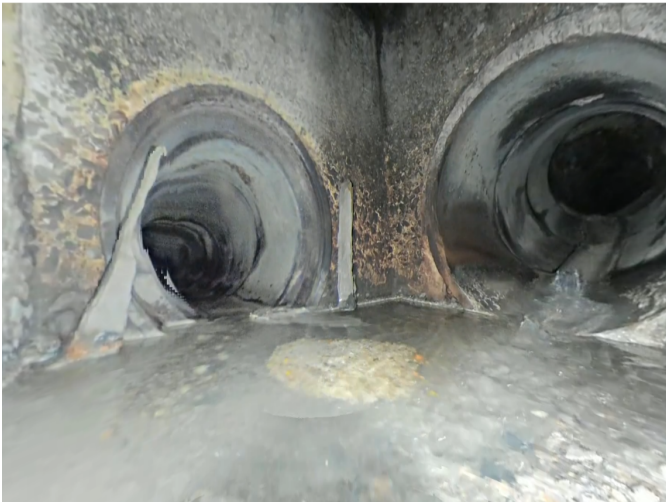
Code: **SAV**
Description: **Surface Damage
Aggregate Visible**

Distance: **7ft**
Structural Grade: **2**
O&M Grade: **0**
Clock Start/From: **12**
Clock To: **12**
1st Value:
2nd Value:
Value Percent:
Continuous Index: **F03**
Within Eight" of Joint: **False**
Remarks:
