R-032D

GRIFFIN ST
New Bedford

Inspection Status: Remote Inspection
Inspection Level: Level 2

Project: | New Bedford 3D Regulator Inspections

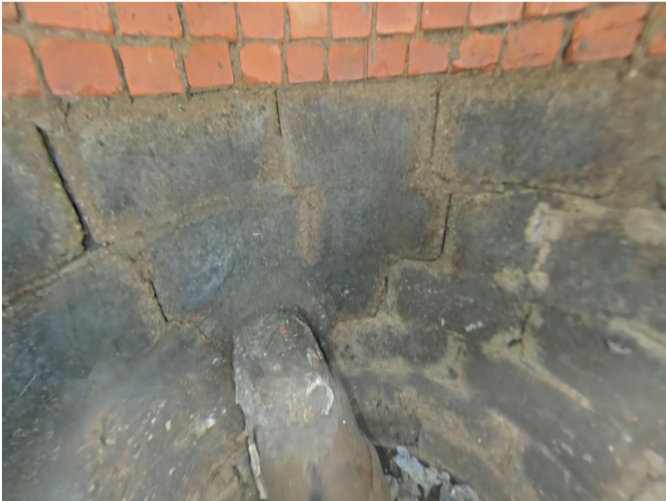
Code: **CM**
Description: **Crack Multiple**

Distance: **2ft**
Structural Grade: **3**
O&M Grade: **0**
Clock Start/From: **12**
Clock To: **12**
1st Value:
2nd Value:
Value Percent:
Continuous Index: **S01**
Within Eight" of Joint: **False**
Remarks:

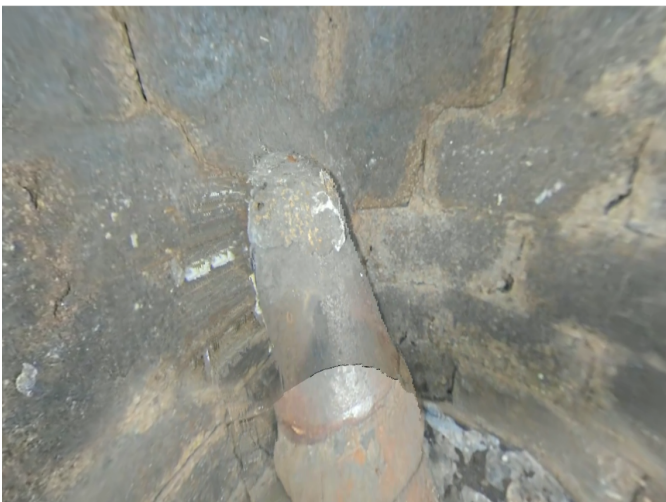
Code: **OBS**
Description: **Obstruction Built Into Structure**

Distance: **4ft**
Structural Grade: **0**
O&M Grade: **0**
Clock Start/From: **12**
Clock To:
1st Value:
2nd Value:
Value Percent: **35**
Continuous Index: **S02**
Within Eight" of Joint: **False**
Remarks:

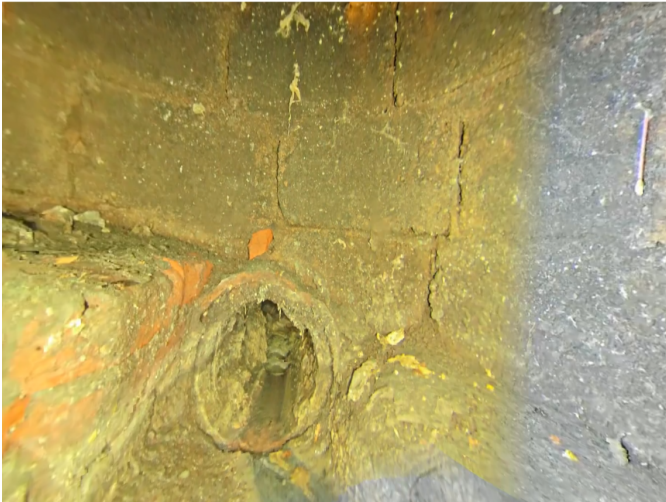
Code: **CM**
Description: **Crack Multiple**

Distance: **7ft**
Structural Grade: **3**
O&M Grade: **0**
Clock Start/From: **12**
Clock To: **12**
1st Value:
2nd Value:
Value Percent:
Continuous Index: **F01**
Within Eight" of Joint: **False**
Remarks:

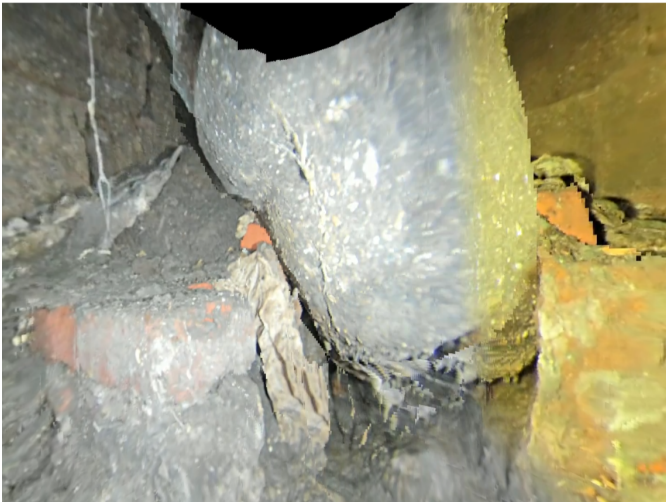
Code: **OBS**
Description: **Obstruction Built Into Structure**

Distance: **7ft**
Structural Grade: **0**
O&M Grade: **0**
Clock Start/From: **12**
Clock To:
1st Value:
2nd Value:
Value Percent: **35**
Continuous Index: **F02**
Within Eight" of Joint: **False**
Remarks:

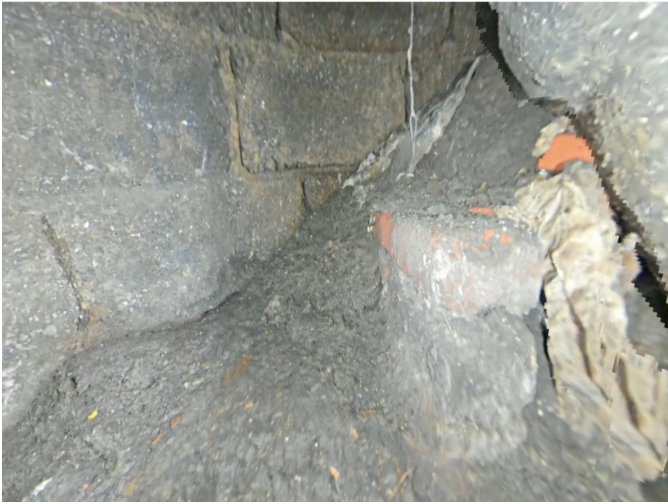
Code: **DSF**
Description: **Deposits Settled Fine**

Distance: **7ft**
Structural Grade: **0**
O&M Grade: **1**
Clock Start/From: **12**
Clock To: **12**
1st Value:
2nd Value:
Value Percent: **25**
Continuous Index:
Within Eight" of Joint: **False**
Remarks:
