# R-035A

HILLMAN ST  
New Bedford

**Project:** | New Bedford 3D Regulator Inspections

# Condition Report

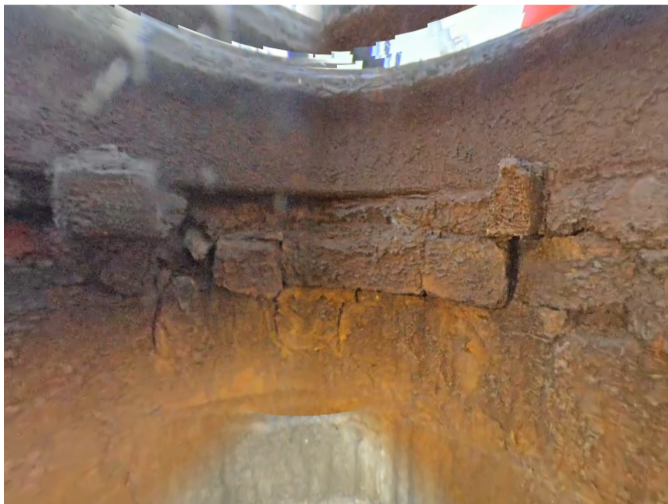
Code: **DB**  
Description: **Displaced Brick**

Distance: **0ft**  
Structural Grade: **3**  
O&M Grade: **0**  
Clock Start/From: **9**  
Clock To: **3**  
1st Value:  
2nd Value:  
Value Percent:  
Continuous Index:  
Within Eight" of Joint: **False**  
Remarks:

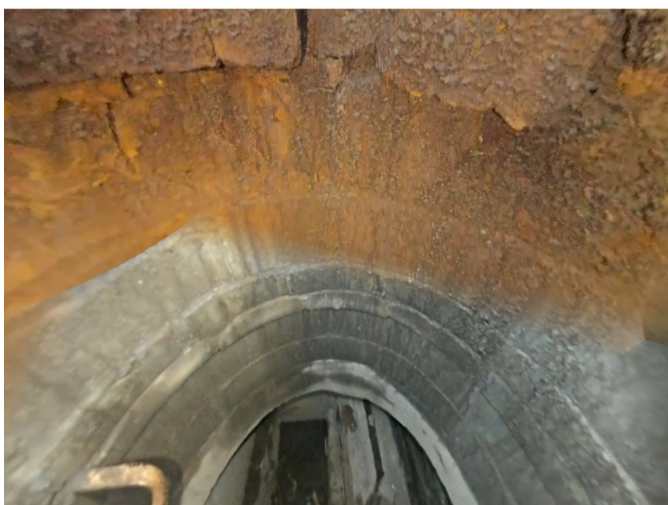
Code: **IS**  
Description: **Infiltration Stain**

Distance: **0ft**  
Structural Grade: **0**  
O&M Grade: **1**  
Clock Start/From: **12**  
Clock To: **12**  
1st Value:  
2nd Value:  
Value Percent:  
Continuous Index: **S01**  
Within Eight" of Joint: **False**  
Remarks:

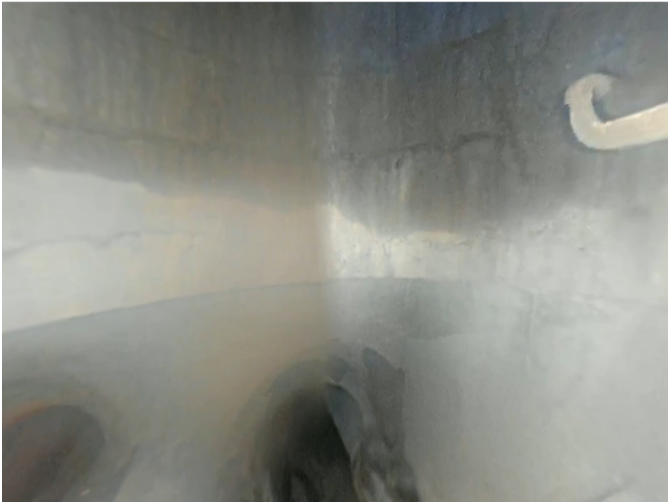
Code: **IS**  
Description: **Infiltration Stain**

Distance: **4ft**  
Structural Grade: **0**  
O&M Grade: **1**  
Clock Start/From: **12**  
Clock To: **12**  
1st Value:  
2nd Value:  
Value Percent:  
Continuous Index: **F01**  
Within Eight" of Joint: **False**  
Remarks:

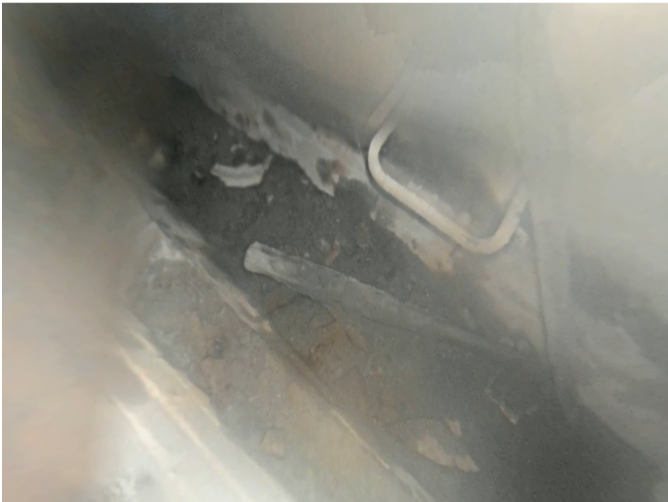
Code: **OBN**  
Description: **Obstruction Construction Debris**

Distance: **5ft**  
Structural Grade: **0**  
O&M Grade: **4**  
Clock Start/From: **12**  
Clock To:  
1st Value:  
2nd Value:  
Value Percent: **30**  
Continuous Index:  
Within Eight" of Joint: **False**  
Remarks:
