R-035B

MAXFIELD ST
New Bedford

Inspection Status: Remote Inspection
Inspection Level: Level 2

Project: | New Bedford 3D Regulator Inspections

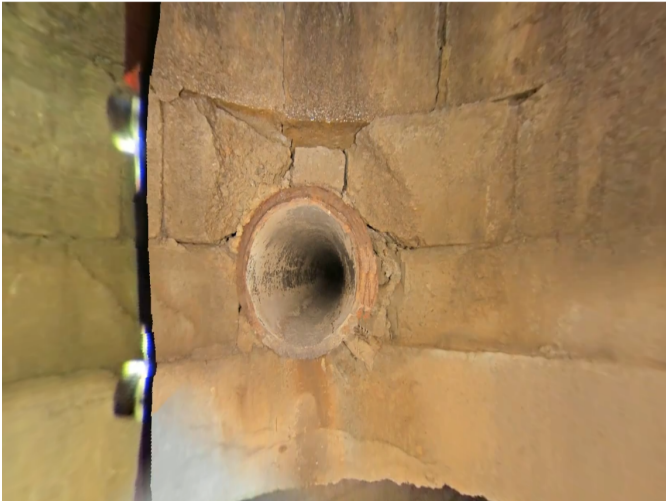
Code: **MMS**
Description: **Missing Mortar Small**

Distance: **1ft**
Structural Grade: **2**
O&M Grade: **0**
Clock Start/From: **1**
Clock To:
1st Value:
2nd Value:
Value Percent:
Continuous Index:
Within Eight" of Joint: **False**
Remarks:

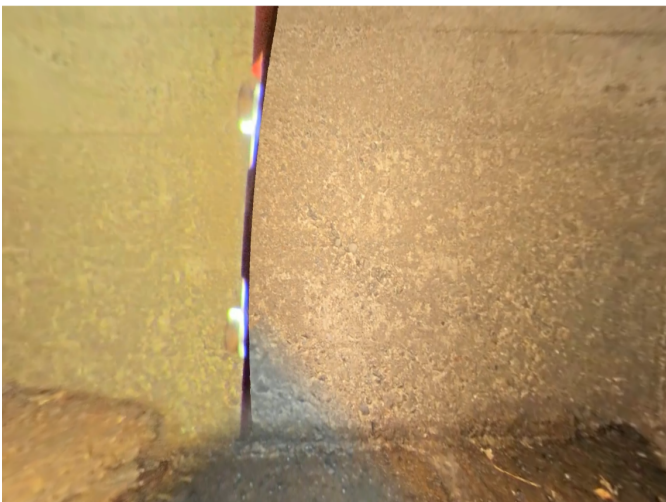
Code: **SAV**
Description: **Surface Damage Aggregate Visible**

Distance: **5ft**
Structural Grade: **2**
O&M Grade: **0**
Clock Start/From: **12**
Clock To: **12**
1st Value:
2nd Value:
Value Percent:
Continuous Index:
Within Eight" of Joint: **False**
Remarks:
