R-035C

A CUSHNET AVE
New Bedford

Project: | New Bedford 3D Regulator Inspections

Condition Report

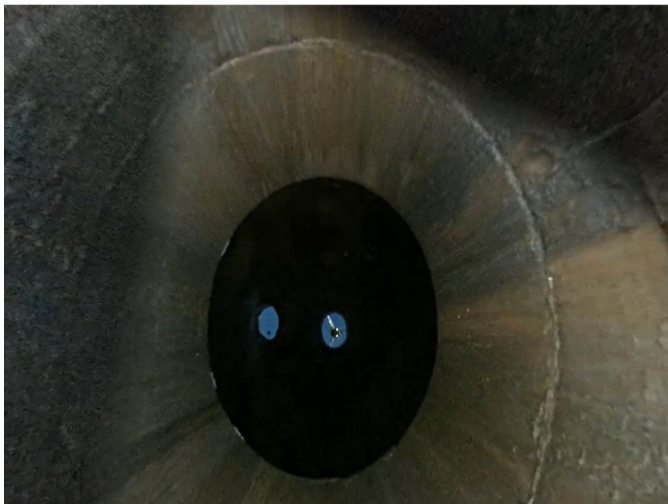
Code: **IS**
Description: **Infiltration Stain**

Distance: **0ft**
Structural Grade: **0**
O&M Grade: **1**
Clock Start/From: **12**
Clock To: **12**
1st Value:
2nd Value:
Value Percent:
Continuous Index: **S01**
Within Eight" of Joint: **False**
Remarks:

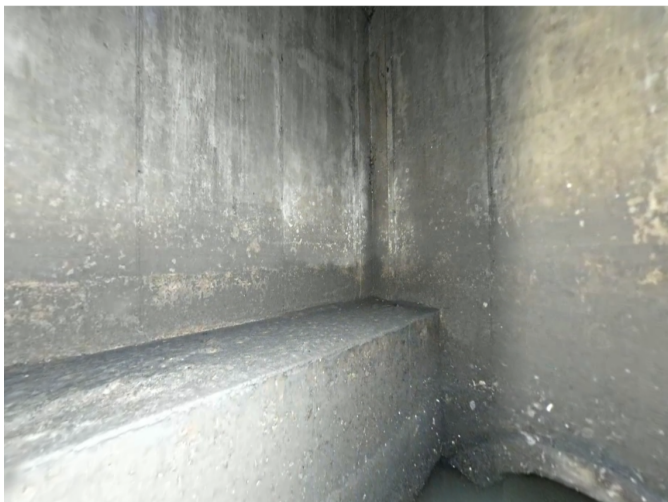
Code: **IS**
Description: **Infiltration Stain**

Distance: **8ft**
Structural Grade: **0**
O&M Grade: **1**
Clock Start/From: **12**
Clock To: **12**
1st Value:
2nd Value:
Value Percent:
Continuous Index: **F01**
Within Eight" of Joint: **False**
Remarks:
