R-036A

PURCHASE ST
New Bedford

Inspection Status: Remote Inspection
Inspection Level: Level 2

Project: | New Bedford 3D Regulator Inspections

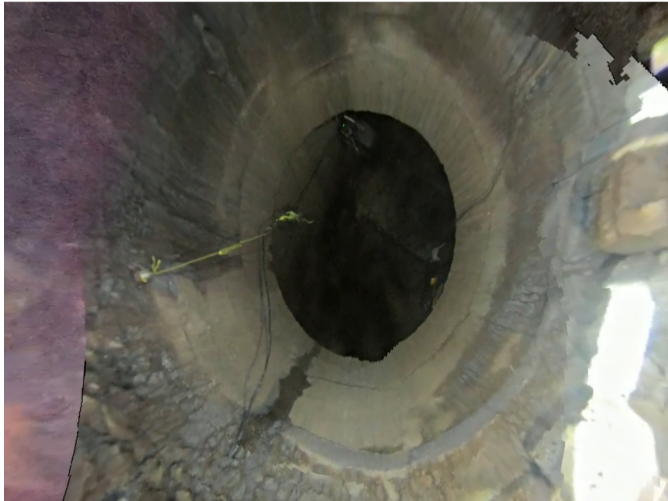
Code: **MGO**
Description: **Miscellaneous General Observation**

Distance: **0ft**
Structural Grade: **0**
O&M Grade: **0**
Clock Start/From:
Clock To:
1st Value:
2nd Value:
Value Percent:
Continuous Index:
Within Eight" of Joint: **False**
Remarks: **Start inspection**

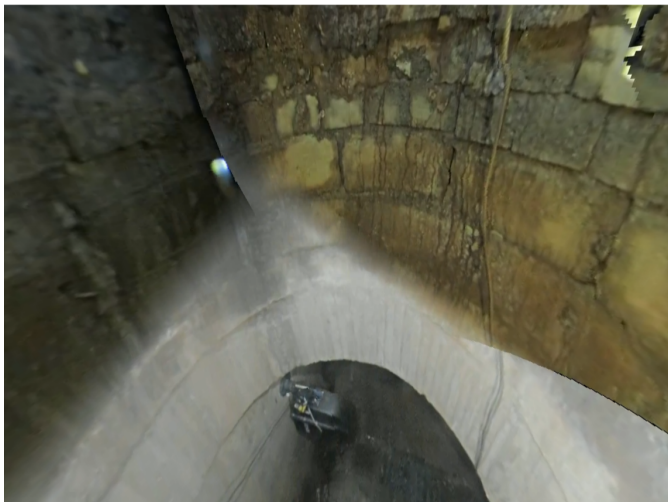
Code: **IS**
Description: **Infiltration Stain**

Distance: **0ft**
Structural Grade: **0**
O&M Grade: **1**
Clock Start/From: **12**
Clock To: **12**
1st Value:
2nd Value:
Value Percent:
Continuous Index: **S01**
Within Eight" of Joint: **False**
Remarks:

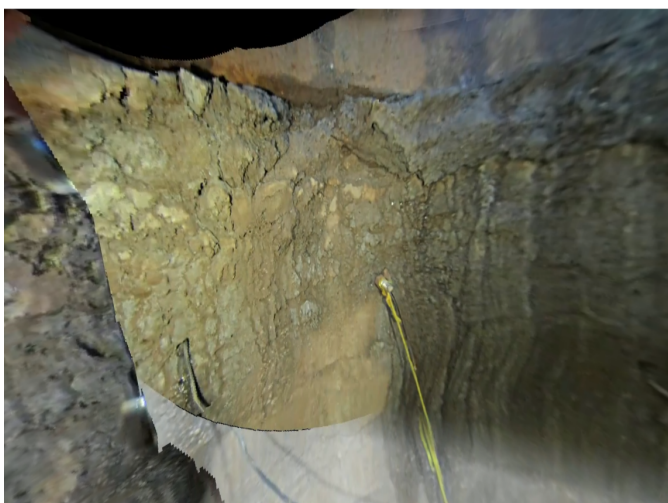
Code: **SRI**
Description: **Surface Damage Roughness Increased**

Distance: **0ft**
Structural Grade: **1**
O&M Grade: **0**
Clock Start/From: **12**
Clock To: **12**
1st Value:
2nd Value:
Value Percent:
Continuous Index:
Within Eight" of Joint: **False**
Remarks:

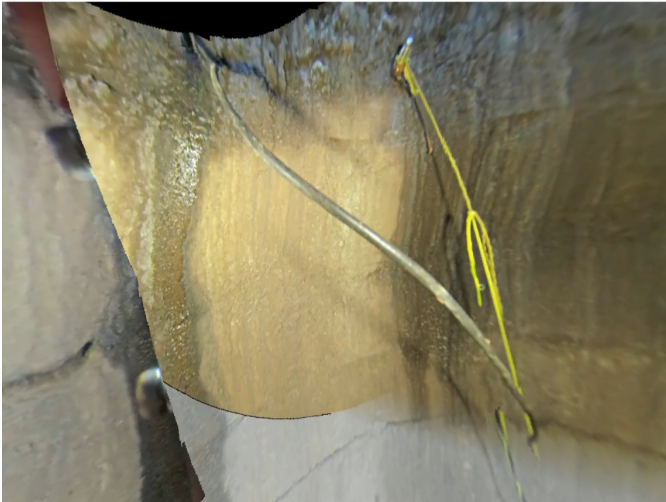
Code: **IW**
Description: **Infiltration Weeper**

Distance: **1ft**
Structural Grade: **0**
O&M Grade: **2**
Clock Start/From: **4**
Clock To:
1st Value:
2nd Value:
Value Percent:
Continuous Index:
Within Eight" of Joint: **False**
Remarks:

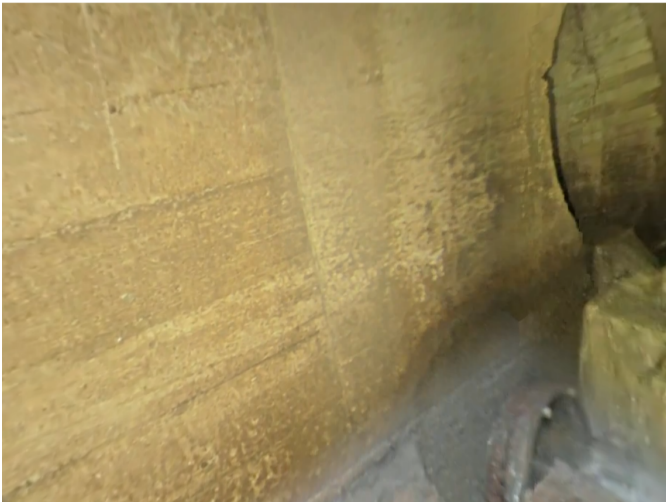
Code: **IS**
Description: **Infiltration Stain**

Distance: **7ft**
Structural Grade: **0**
O&M Grade: **1**
Clock Start/From: **12**
Clock To: **12**
1st Value:
2nd Value:
Value Percent:
Continuous Index: **F01**
Within Eight" of Joint: **False**
Remarks:

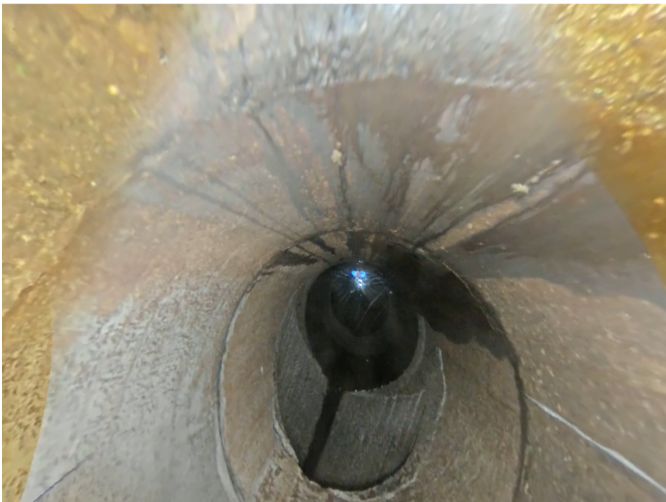
Code: **IW**
Description: **Infiltration Weeper**

Distance: **9ft**
Structural Grade: **0**
O&M Grade: **2**
Clock Start/From: **6**
Clock To: **8**
1st Value:
2nd Value:
Value Percent:
Continuous Index: **S02**
Within Eight" of Joint: **False**
Remarks:

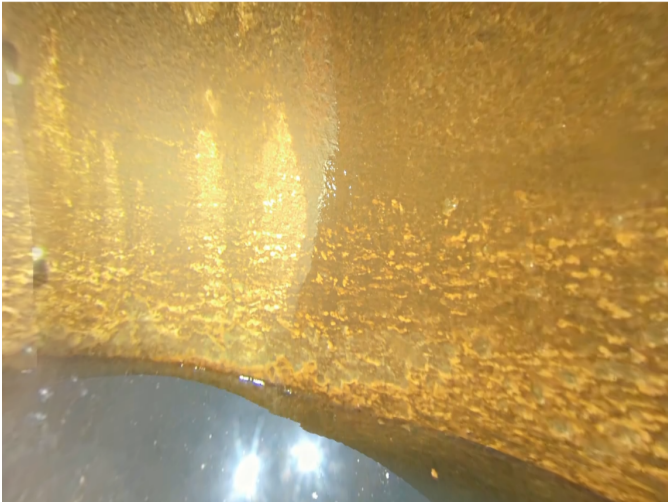
Code: **IW**
Description: **Infiltration Weeper**

Distance: **19ft**
Structural Grade: **0**
O&M Grade: **2**
Clock Start/From: **6**
Clock To: **8**
1st Value:
2nd Value:
Value Percent:
Continuous Index: **F02**
Within Eight" of Joint: **False**
Remarks:

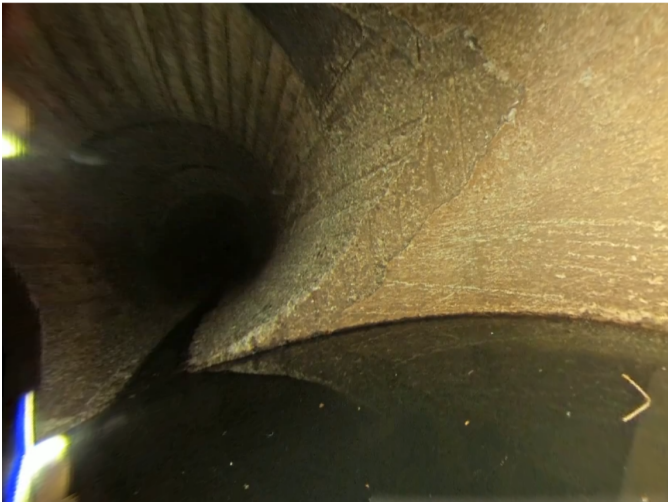
Code: **MGO**
Description: **Miscellaneous General Observation**

Distance: **19ft**
Structural Grade: **0**
O&M Grade: **0**
Clock Start/From:
Clock To:
1st Value:
2nd Value:
Value Percent:
Continuous Index:
Within Eight" of Joint: **False**
Remarks: **End inspection**
