R-037A

PURCHASE ST
New Bedford

Inspection Status: Remote Inspection
Inspection Level: Level 2

Project: | New Bedford 3D Regulator Inspections

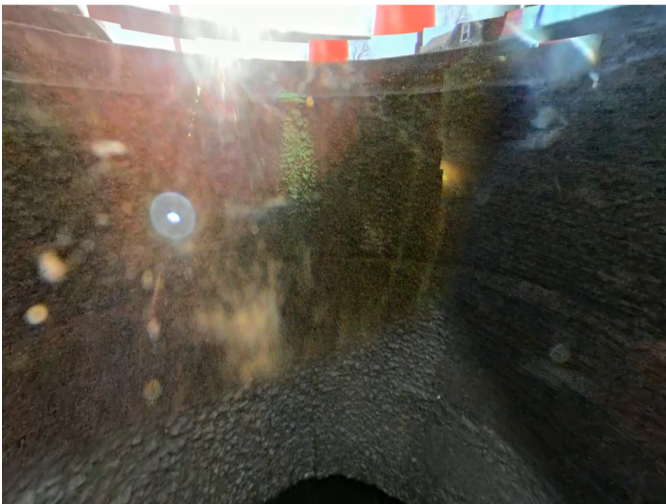
Code: **SRI**
Description: **Surface Damage Roughness Increased**

Distance: **0ft**
Structural Grade: **1**
O&M Grade: **0**
Clock Start/From: **12**
Clock To: **12**
1st Value:
2nd Value:
Value Percent:
Continuous Index: **S01**
Within Eight" of Joint: **False**
Remarks:

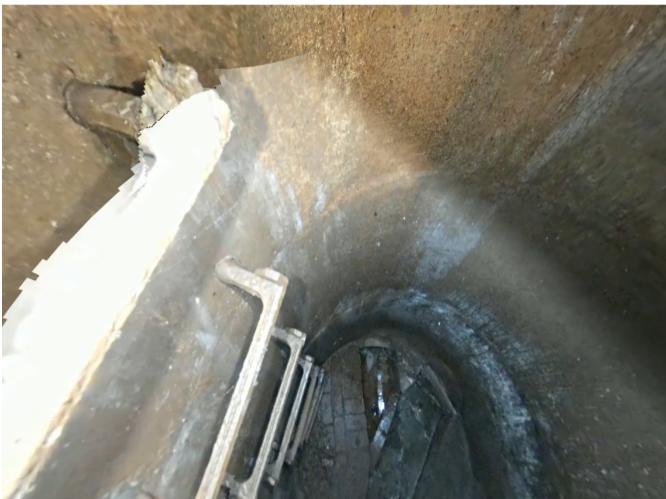
Code: **IS**
Description: **Infiltration Stain**

Distance: **2ft**
Structural Grade: **0**
O&M Grade: **1**
Clock Start/From: **12**
Clock To: **12**
1st Value:
2nd Value:
Value Percent:
Continuous Index: **S02**
Within Eight" of Joint: **False**
Remarks:

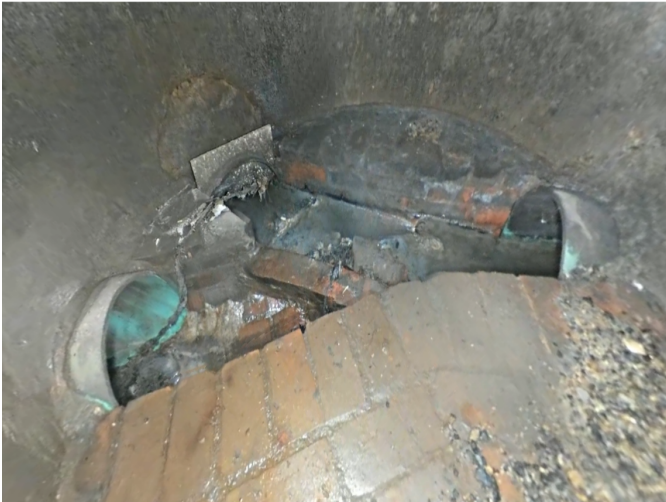
Code: **DSZ**
Description: **Deposits Settled Other**

Distance: **8ft**
Structural Grade: **0**
O&M Grade: **4**
Clock Start/From: **12**
Clock To:
1st Value:
2nd Value:
Value Percent: **50**
Continuous Index:
Within Eight" of Joint: **False**
Remarks: **Mixed debris in channel**

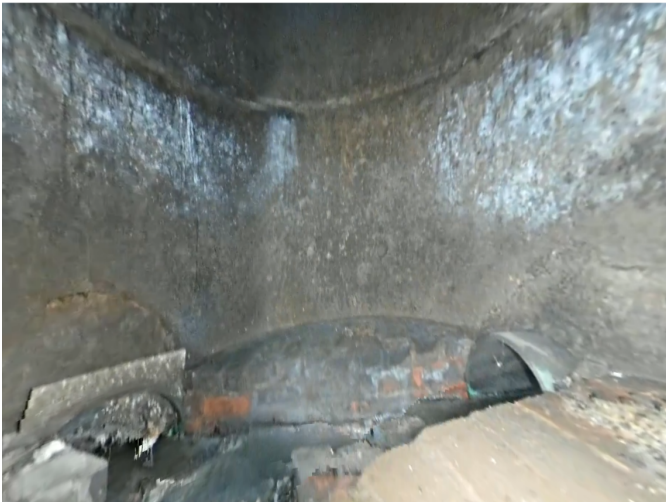
Code: **SRI**
Description: **Surface Damage Roughness Increased**

Distance: **9ft**
Structural Grade: **1**
O&M Grade: **0**
Clock Start/From: **12**
Clock To: **12**
1st Value:
2nd Value:
Value Percent:
Continuous Index: **F01**
Within Eight" of Joint: **False**
Remarks:

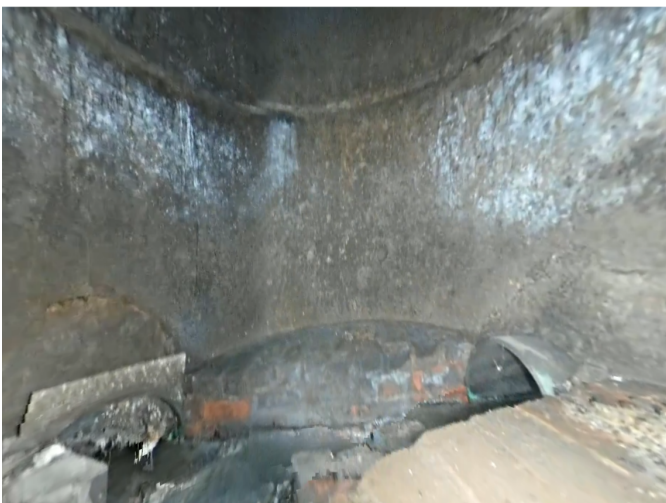
Code: **IS**
Description: **Infiltration Stain**

Distance: **9ft**
Structural Grade: **0**
O&M Grade: **1**
Clock Start/From: **12**
Clock To: **12**
1st Value:
2nd Value:
Value Percent:
Continuous Index: **F02**
Within Eight" of Joint: **False**
Remarks:
