R-037

WALNUT ST
New Bedford

Inspection Status: Remote Inspection
Inspection Level: Level 2

Project: | New Bedford 3D Regulator Inspections

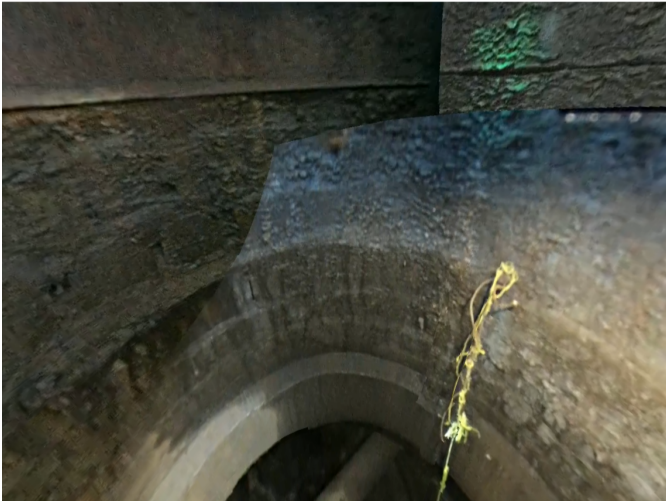
Code: **SRI**
Description: **Surface Damage Roughness Increased**

Distance: **0ft**
Structural Grade: **1**
O&M Grade: **0**
Clock Start/From: **12**
Clock To: **12**
1st Value:
2nd Value:
Value Percent:
Continuous Index: **S01**
Within Eight" of Joint: **False**
Remarks:

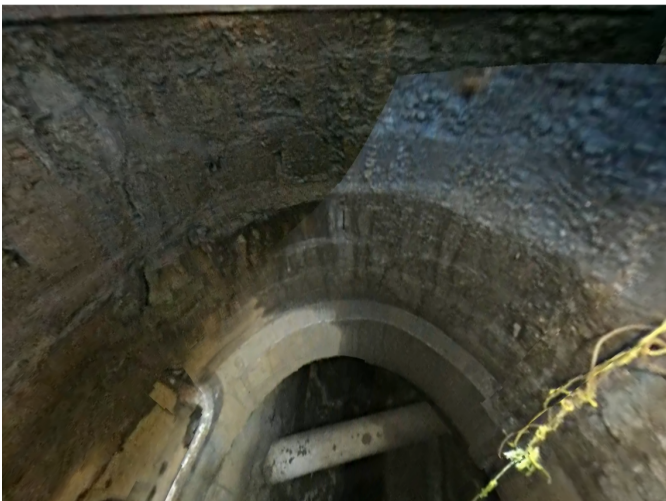
Code: **IS**
Description: **Infiltration Stain**

Distance: **0ft**
Structural Grade: **0**
O&M Grade: **1**
Clock Start/From: **12**
Clock To: **12**
1st Value:
2nd Value:
Value Percent:
Continuous Index: **S02**
Within Eight" of Joint: **False**
Remarks:

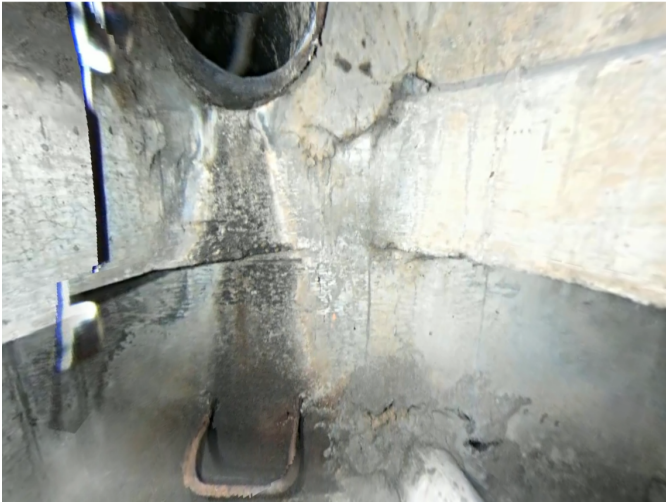
Code: **IS**
Description: **Infiltration Stain**

Distance: **3ft**
Structural Grade: **0**
O&M Grade: **1**
Clock Start/From: **12**
Clock To: **12**
1st Value:
2nd Value:
Value Percent:
Continuous Index: **F02**
Within Eight" of Joint: **False**
Remarks:

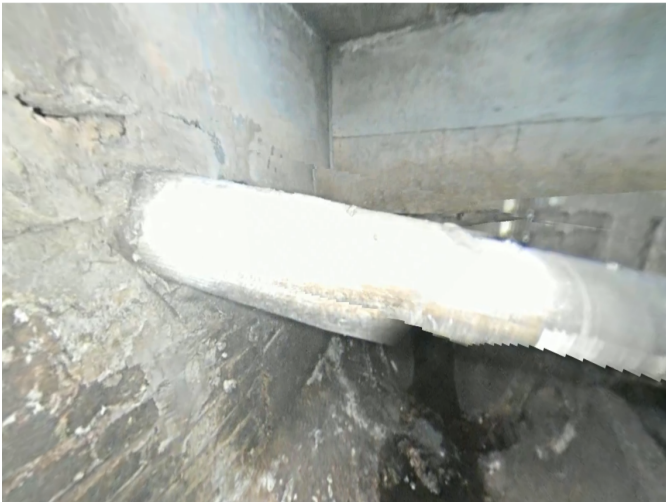
Code: **OBS**
Description: **Obstruction Built Into Structure**

Distance: **5ft**
Structural Grade: **0**
O&M Grade: **0**
Clock Start/From: **9**
Clock To:
1st Value:
2nd Value:
Value Percent: **30**
Continuous Index:
Within Eight" of Joint: **False**
Remarks: **Pipe through wall**

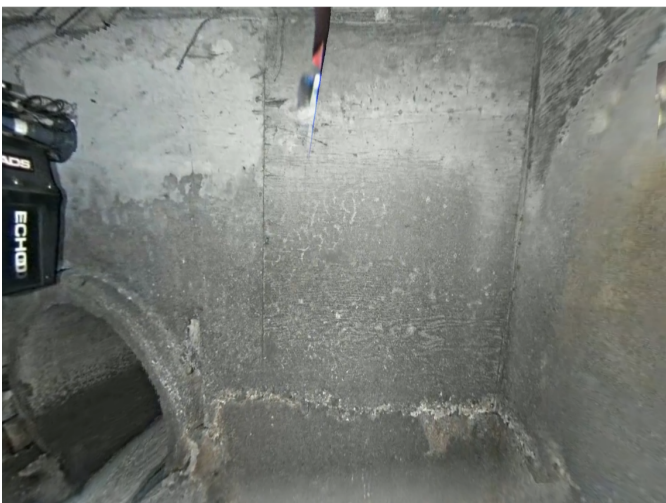
Code: **SRI**
Description: **Surface Damage Roughness Increased**

Distance: **5ft**
Structural Grade: **1**
O&M Grade: **0**
Clock Start/From: **12**
Clock To: **12**
1st Value:
2nd Value:
Value Percent:
Continuous Index: **F01**
Within Eight" of Joint: **False**
Remarks:

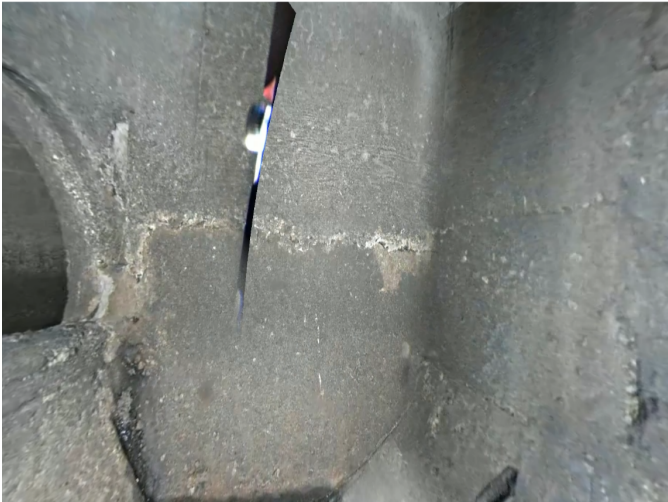
Code: **CC**
Description: **Crack Circumferential**

Distance: **6ft**
Structural Grade: **2**
O&M Grade: **0**
Clock Start/From: **12**
Clock To: **3**
1st Value:
2nd Value:
Value Percent:
Continuous Index:
Within Eight" of Joint: **False**
Remarks:
