# R-040A

GOGGESHALL ST  
New Bedford

**Project:** | New Bedford 3D Regulator Inspections

# Condition Report

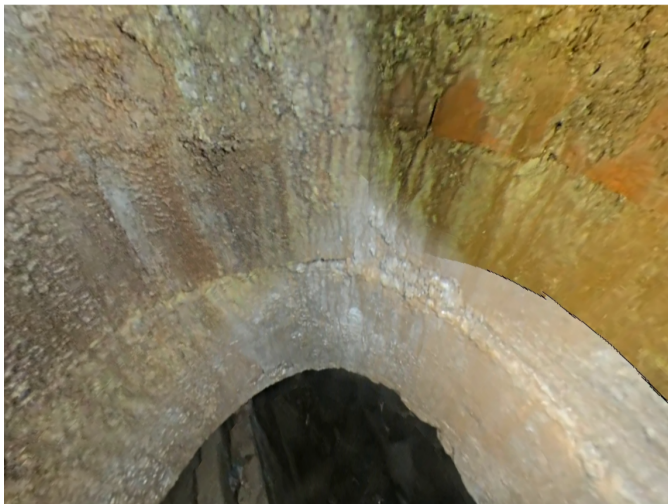
Code: **IS**  
Description: **Infiltration Stain**

Distance: **0ft**  
Structural Grade: **0**  
O&M Grade: **1**  
Clock Start/From: **12**  
Clock To: **12**  
1st Value:  
2nd Value:  
Value Percent:  
Continuous Index: **S02**  
Within Eight" of Joint: **False**  
Remarks:

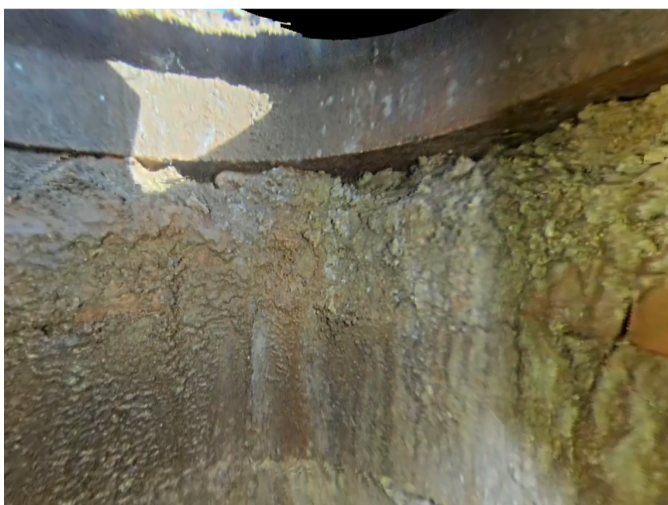
Code: **SRI**  
Description: **Surface Damage Roughness Increased**

Distance: **0ft**  
Structural Grade: **1**  
O&M Grade: **0**  
Clock Start/From: **12**  
Clock To: **12**  
1st Value:  
2nd Value:  
Value Percent:  
Continuous Index: **S01**  
Within Eight" of Joint: **False**  
Remarks:

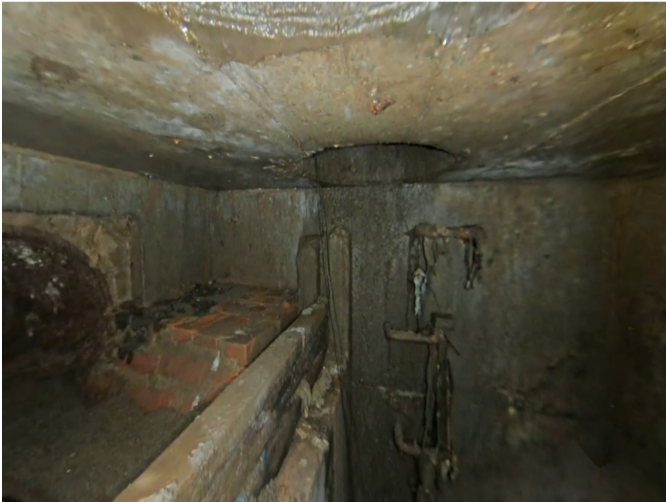
Code: **IS**  
Description: **Infiltration Stain**

Distance: **2ft**  
Structural Grade: **0**  
O&M Grade: **1**  
Clock Start/From: **12**  
Clock To: **12**  
1st Value:  
2nd Value:  
Value Percent:  
Continuous Index: **F02**  
Within Eight" of Joint: **False**  
Remarks:

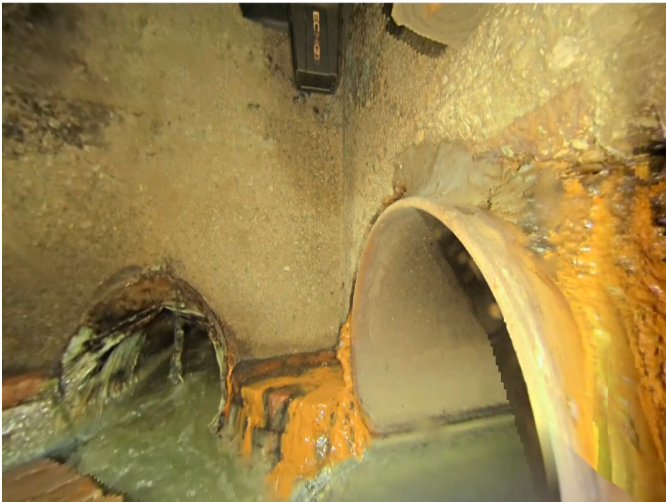
Code: **SRI**  
Description: **Surface Damage  
Roughness Increased**

Distance: **14ft**  
Structural Grade: **1**  
O&M Grade: **0**  
Clock Start/From: **12**  
Clock To: **12**  
1st Value:  
2nd Value:  
Value Percent:  
Continuous Index: **F01**  
Within Eight" of Joint: **False**  
Remarks:
