R-041A

BELLEVILLE AVE
New Bedford

Inspection Status: Remote Inspection
Inspection Level: Level 2

Project: | New Bedford 3D Regulator Inspections

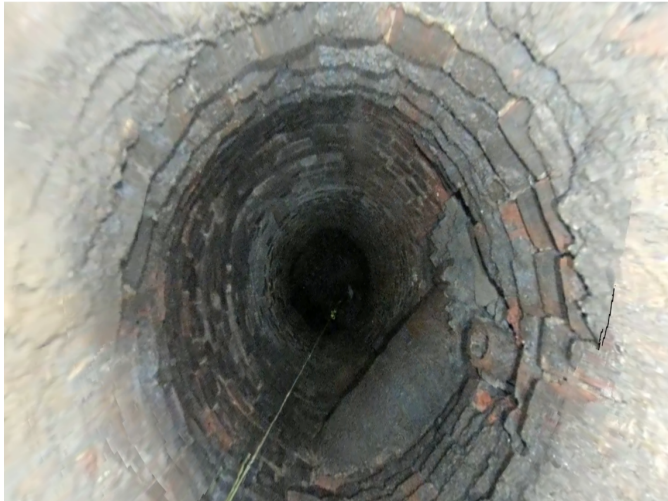
Code: **MGO**
Description: **Miscellaneous General Observation**

Distance: **0ft**
Structural Grade: **0**
O&M Grade: **0**
Clock Start/From:
Clock To:
1st Value:
2nd Value:
Value Percent:
Continuous Index:
Within Eight" of Joint: **False**
Remarks: **Start inspection**

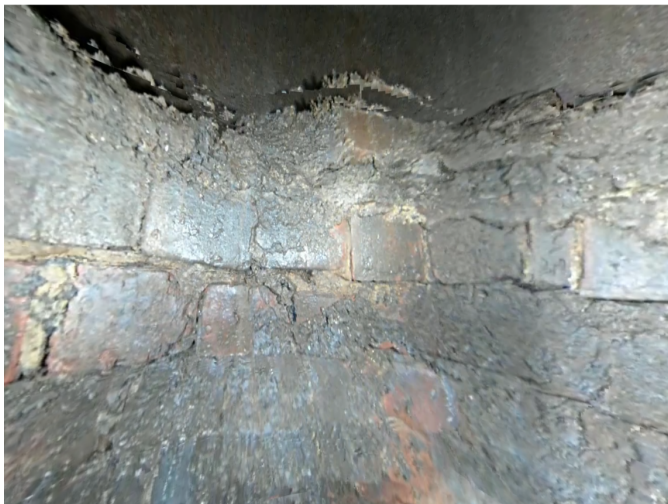
Code: **SRI**
Description: **Surface Damage Roughness Increased**

Distance: **1ft**
Structural Grade: **1**
O&M Grade: **0**
Clock Start/From: **12**
Clock To: **12**
1st Value:
2nd Value:
Value Percent:
Continuous Index: **S01**
Within Eight" of Joint: **False**
Remarks:

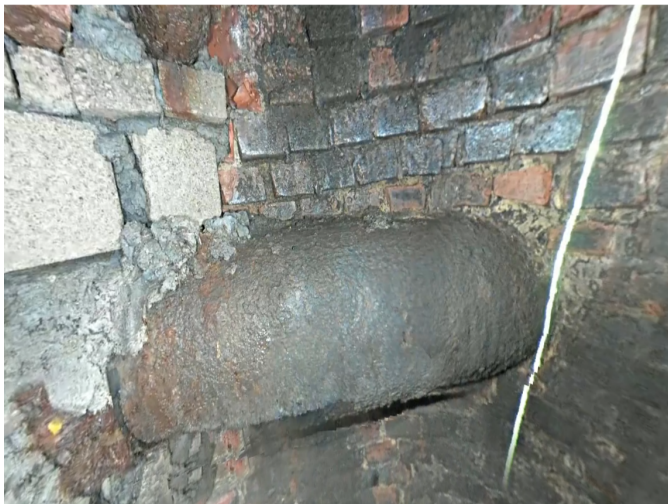
Code: **OBS**
Description: **Obstruction Built Into Structure**

Distance: **2ft**
Structural Grade: **0**
O&M Grade: **0**
Clock Start/From: **3**
Clock To:
1st Value:
2nd Value:
Value Percent: **20**
Continuous Index:
Within Eight" of Joint: **False**
Remarks: **Pipe through wall**

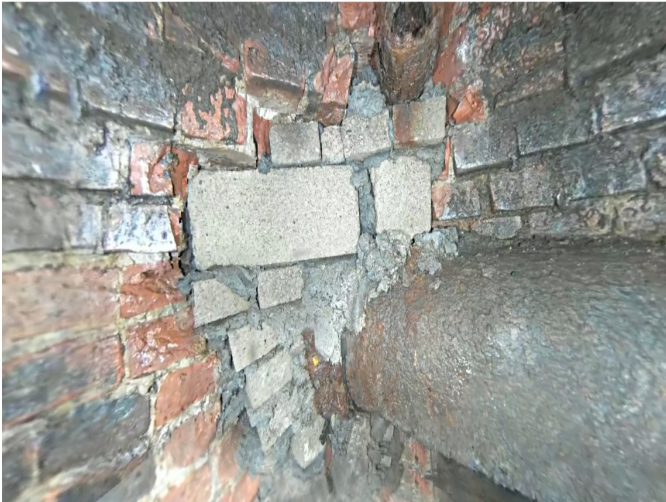
Code: **RPP**
Description: **Point Repair Patch**

Distance: **2ft**
Structural Grade: **0**
O&M Grade: **0**
Clock Start/From: **12**
Clock To:
1st Value:
2nd Value:
Value Percent:
Continuous Index:
Within Eight" of Joint: **False**
Remarks: **Concrete block patch on pipe break in joint**

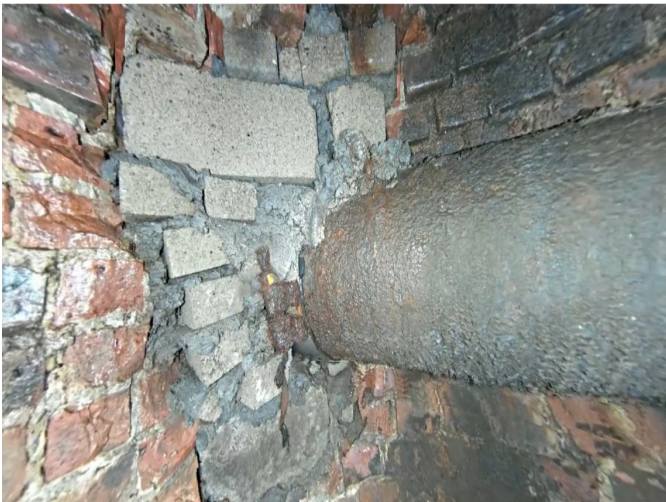
Code: **SRI**
Description: **Surface Damage Roughness Increased**

Distance: **3ft**
Structural Grade: **1**
O&M Grade: **0**
Clock Start/From: **12**
Clock To: **12**
1st Value:
2nd Value:
Value Percent:
Continuous Index: **F01**
Within Eight" of Joint: **False**
Remarks:

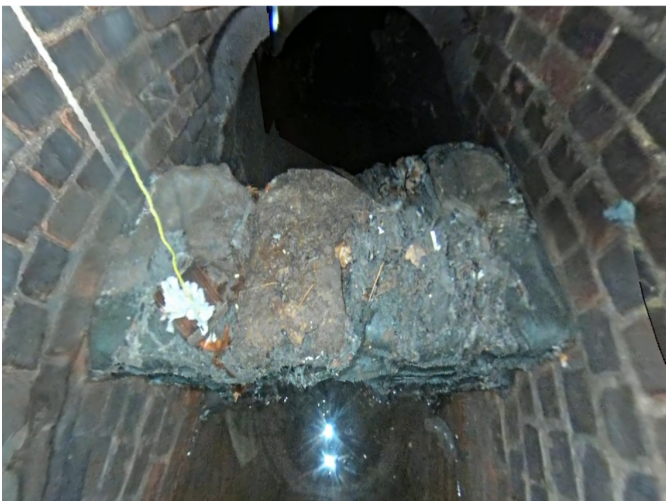
Code: **OBS**
Description: **Obstruction Built Into Structure**

Distance: **8ft**
Structural Grade: **0**
O&M Grade: **5**
Clock Start/From: **12**
Clock To:
1st Value:
2nd Value:
Value Percent: **85**
Continuous Index:
Within Eight" of Joint: **False**
Remarks: **Sandbag wall in channel**

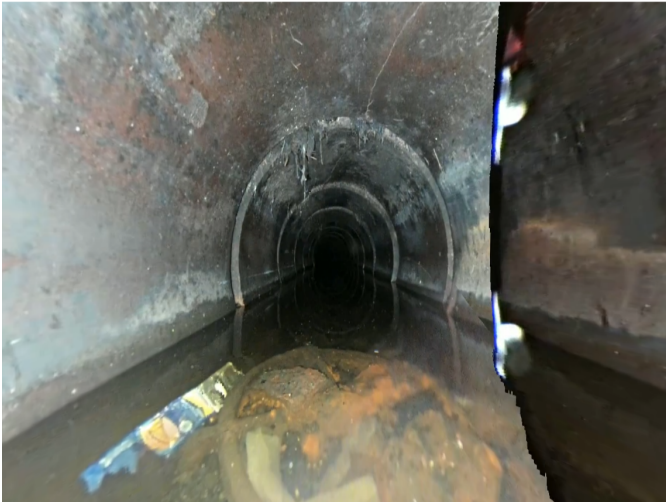
Code: **MGO**
Description: **Miscellaneous General Observation**

Distance: **11ft**
Structural Grade: **0**
O&M Grade: **0**
Clock Start/From:
Clock To:
1st Value:
2nd Value:
Value Percent:
Continuous Index:
Within Eight" of Joint: **False**
Remarks: **End inspection**

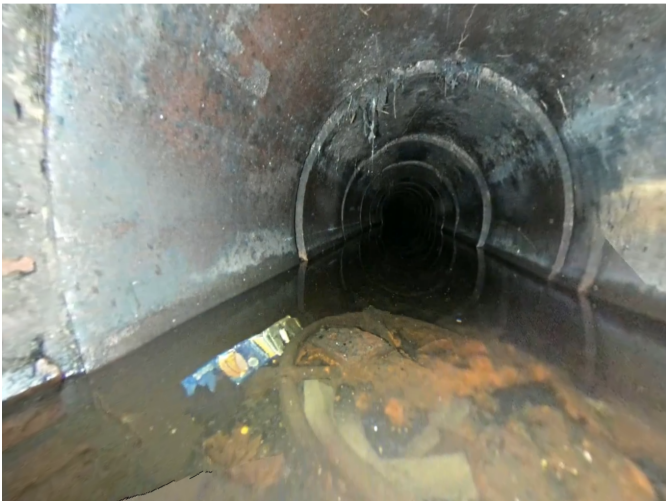
Code: **DSZ**
Description: **Deposits Settled Other**

Distance: **11ft**
Structural Grade: **0**
O&M Grade: **3**
Clock Start/From: **12**
Clock To: **12**
1st Value:
2nd Value:
Value Percent: **25**
Continuous Index:
Within Eight" of Joint: **False**
Remarks: **debris, junk**
