# R-041B

BELLEVILLE AVE  
New Bedford

Inspection Status: Remote Inspection  
Inspection Level: Level 2

**Project:** | New Bedford 3D Regulator Inspections

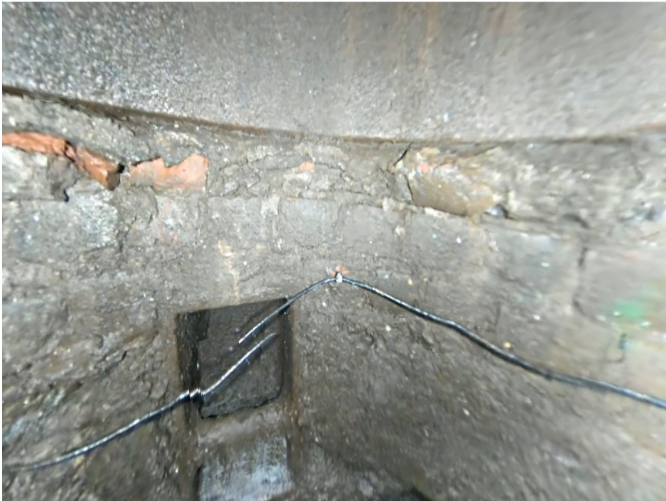
Code: **SRI**  
Description: **Surface Damage Roughness Increased**

Distance: **0ft**  
Structural Grade: **1**  
O&M Grade: **0**  
Clock Start/From: **12**  
Clock To: **12**  
1st Value:  
2nd Value:  
Value Percent:  
Continuous Index:  
Within Eight" of Joint: **False**  
Remarks:

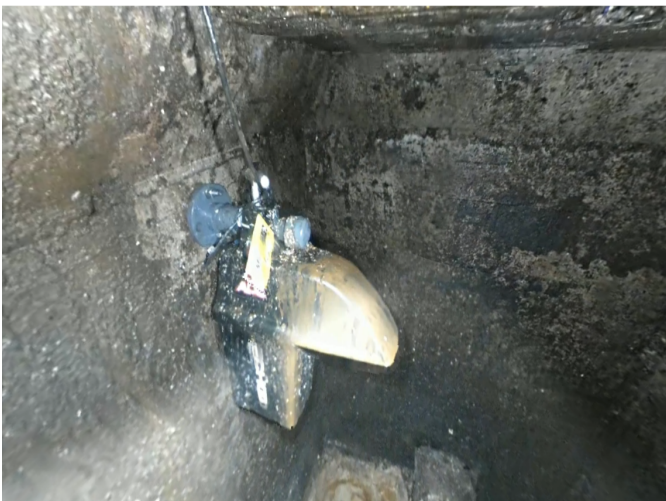
Code: **OBS**  
Description: **Obstruction Built Into Structure**

Distance: **2ft**  
Structural Grade: **0**  
O&M Grade: **0**  
Clock Start/From: **6**  
Clock To:  
1st Value:  
2nd Value:  
Value Percent: **25**  
Continuous Index:  
Within Eight" of Joint: **False**  
Remarks:

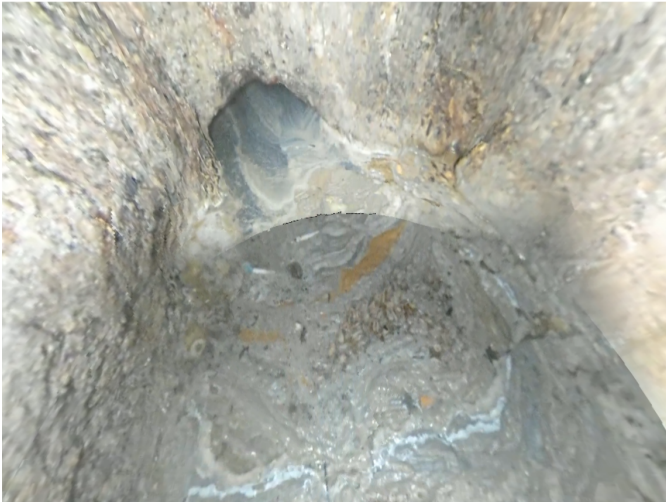
Code: **DAGS**  
Description: **Deposits Attached Grease**

Distance: **7ft**  
Structural Grade: **0**  
O&M Grade: **4**  
Clock Start/From: **12**  
Clock To:  
1st Value:  
2nd Value:  
Value Percent: **75**  
Continuous Index:  
Within Eight" of Joint: **False**  
Remarks:
