R-055

UNION ST  
New Bedford

Inspection Status: Remote Inspection  
Inspection Level: Level 2

Project: | New Bedford 3D Regulator Inspections

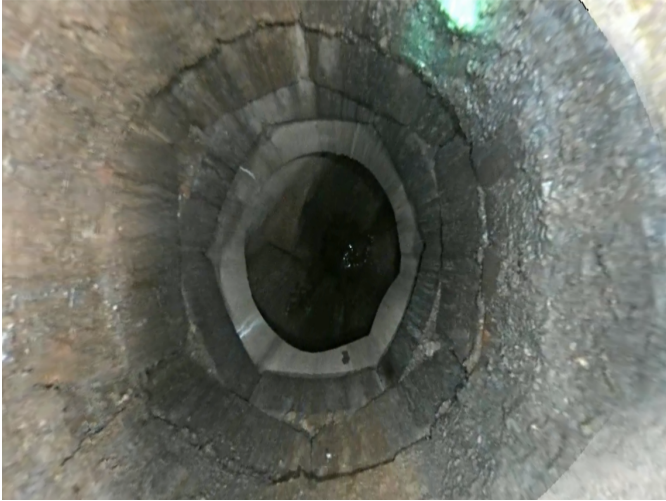
Code: **MGO**  
Description: **Miscellaneous General Observation**

Distance: **0ft**  
Structural Grade: **0**  
O&M Grade: **0**  
Clock Start/From:  
Clock To:  
1st Value:  
2nd Value:  
Value Percent:  
Continuous Index:  
Within Eight" of Joint: **False**  
Remarks: **Start inspection**

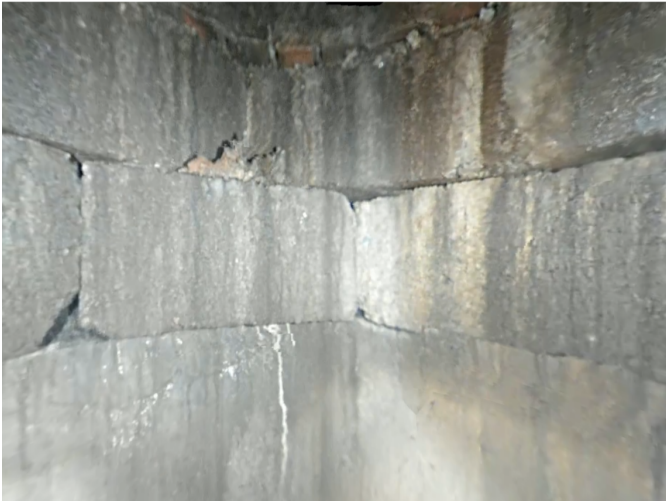
Code: **MMS**  
Description: **Missing Mortar Small**

Distance: **1ft**  
Structural Grade: **2**  
O&M Grade: **0**  
Clock Start/From: **12**  
Clock To: **12**  
1st Value:  
2nd Value:  
Value Percent:  
Continuous Index:  
Within Eight" of Joint: **False**  
Remarks:

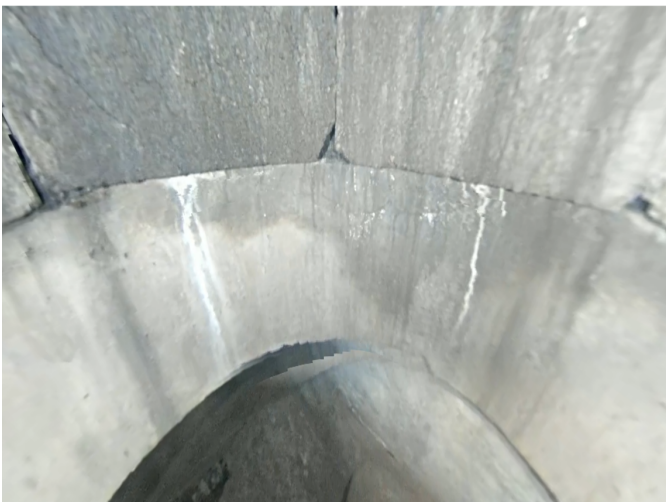
Code: **IS**  
Description: **Infiltration Stain**

Distance: **1ft**  
Structural Grade: **0**  
O&M Grade: **1**  
Clock Start/From: **12**  
Clock To: **12**  
1st Value:  
2nd Value:  
Value Percent:  
Continuous Index: **S01**  
Within Eight" of Joint: **False**  
Remarks:

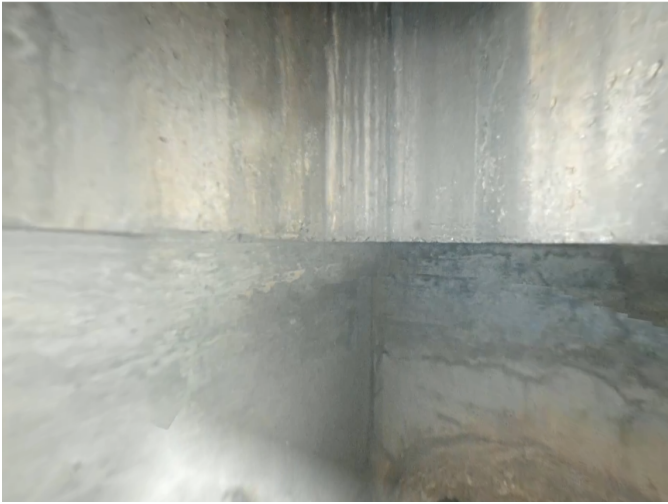
Code: **IS**  
Description: **Infiltration Stain**

Distance: **3ft**  
Structural Grade: **0**  
O&M Grade: **1**  
Clock Start/From: **12**  
Clock To: **12**  
1st Value:  
2nd Value:  
Value Percent:  
Continuous Index: **F01**  
Within Eight" of Joint: **False**  
Remarks:

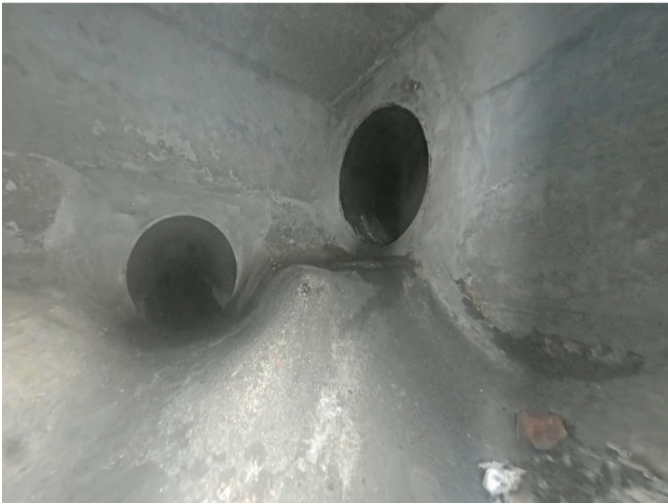
Code: **MGO**  
Description: **Miscellaneous General Observation**

Distance: **6ft**  
Structural Grade: **0**  
O&M Grade: **0**  
Clock Start/From:  
Clock To:  
1st Value:  
2nd Value:  
Value Percent:  
Continuous Index:  
Within Eight" of Joint: **False**  
Remarks: **End inspection**
