CSO SPEC SHEET

CSO FIELD PHOTOS

Structure#: Regulator 004B

Location: Orchard St. and Cove Rd.

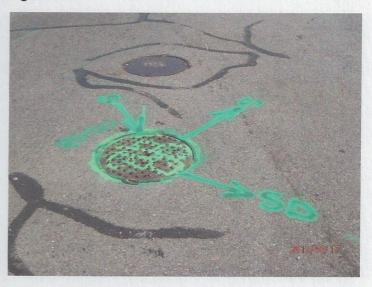
Figure 1.

- **Figure 1:** Street view of open manhole to regulator 004B showing sewer incoming and outgoing directions as well as the storm drain outfall.
- Figure 2: Inside view of manhole. A- Sewer; B- Weir Wall; C- Storm Drain; D- Break in weir wall.
- Figure 3: Street view of Regulator 004B, Facing the Northwest towards carwash.
- Figure 4: Google Earth image of intersection where Regulator 004B is located. A- Regulator 004B
