R-004D

RIVET ST
New Bedford

Inspection Status: Remote Inspection
Inspection Level: Level 2

Project: | New Bedford 3D Regulator Inspections
Owner: New Bedford, MA
Customer: CDM Smith

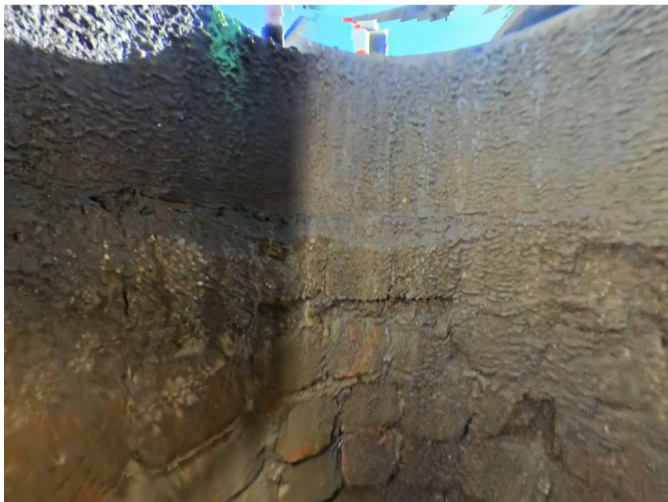
Code: **SRI**
Description: **Surface Damage Roughness Increased**

Distance: **0ft**
Structural Grade: **1**
O&M Grade: **0**
Clock Start/From: **12**
Clock To: **12**
1st Value:
2nd Value:
Value Percent:
Continuous Index:
Within Eight" of Joint: **False**
Remarks:

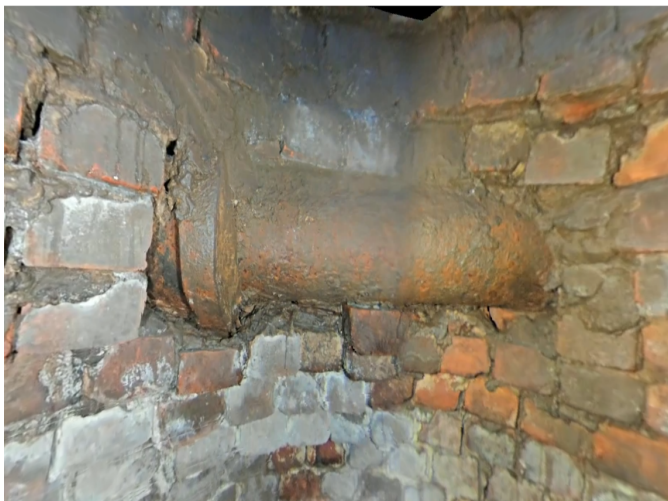
Code: **OBS**
Description: **Obstruction Built Into Structure**

Distance: **3ft**
Structural Grade: **0**
O&M Grade: **0**
Clock Start/From: **6**
Clock To:
1st Value:
2nd Value:
Value Percent: **15**
Continuous Index:
Within Eight" of Joint: **False**
Remarks: **Pipe through wall**
