# **CSO SPEC SHEET**

Structure #: REG 005 A

**Date:** 08/20/2012 **Insp. By:** AH and AK

#### Location: At the Intersection of Dudley St and French Rodney Blvd.

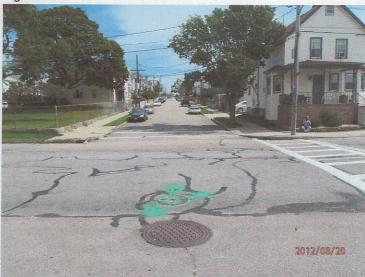
Figure 1.

- Figure 1: Street view of Regulator 005 A. Facing East.
- Figure 2: Inside view of manhole. A-Storm Drain; B- Weir Wall; C- Sewer.
- Figure 3: Street view of Regulator 005 A. Facing Clark's Cove.
- Figure 4: Google Earth image of Regulator 005 A. A- REG 005A; B- CSO 005 outfall pipe.
