# R-005A

DUDLEY ST  
New Bedford

Inspection Status: Remote Inspection  
Inspection Level: Level 2

Project: | New Bedford 3D Regulator Inspections

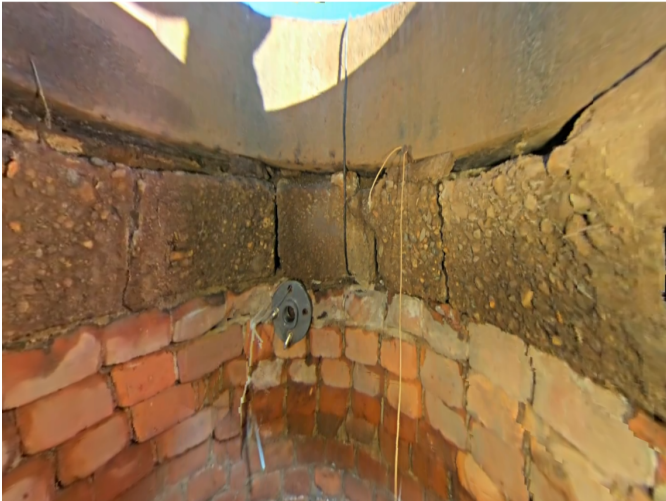
Code: **CM**  
Description: **Crack Multiple**

Distance: **0ft**  
Structural Grade: **3**  
O&M Grade: **0**  
Clock Start/From: **12**  
Clock To: **12**  
1st Value:  
2nd Value:  
Value Percent:  
Continuous Index:  
Within Eight" of Joint: **False**  
Remarks:

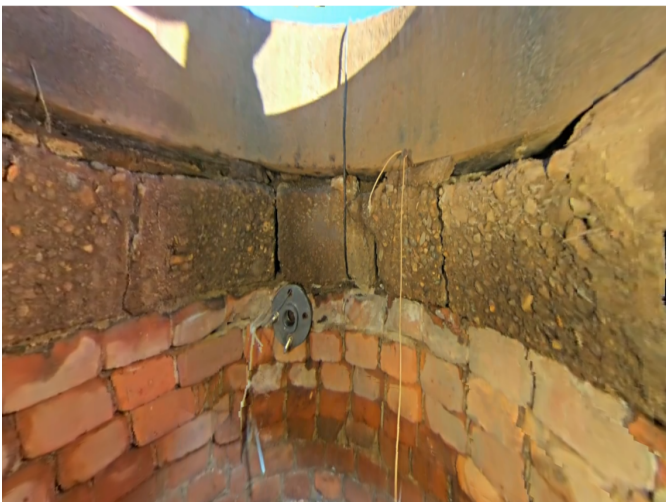
Code: **SAV**  
Description: **Surface Damage Aggregate Visible**

Distance: **0ft**  
Structural Grade: **2**  
O&M Grade: **0**  
Clock Start/From: **12**  
Clock To: **12**  
1st Value:  
2nd Value:  
Value Percent:  
Continuous Index:  
Within Eight" of Joint: **False**  
Remarks:

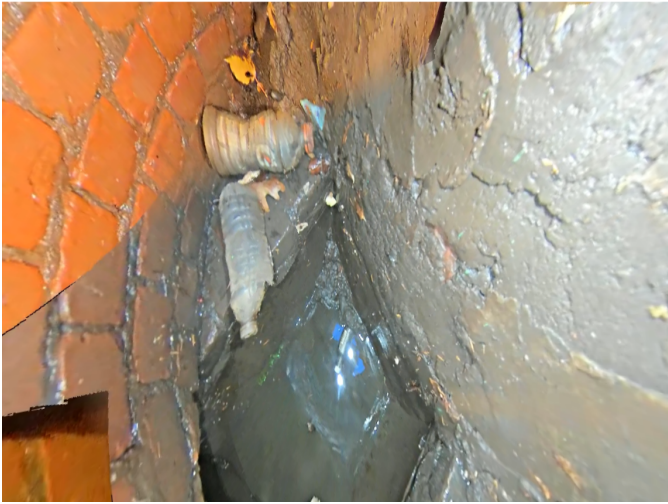
Code: **DSZ**  
Description: **Deposits Settled Other**

Distance: **4ft**  
Structural Grade: **0**  
O&M Grade: **2**  
Clock Start/From: **12**  
Clock To:  
1st Value:  
2nd Value:  
Value Percent: **20**  
Continuous Index:  
Within Eight" of Joint: **False**  
Remarks: **Trash in bottom of manhole**
