### **CSO SPEC SHEET**

Structure #: REG 006 D

**Date:** 08/22/2012 **Insp. By:** AH and AK

#### **CSO FIELD PHOTOS**

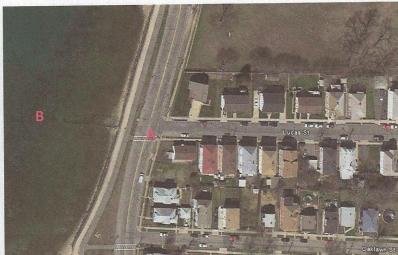
Figure 4.

Figure 4: Google Earth image of Regulator 006 C. A- REG 006B; B- CSO 006 outfall pipe.
