New Bedford Regulator Specification Sheet

Regulator #: R-012A

Location: Ricketson St. at E. Rodney French Blvd.

Date: 6/25/25

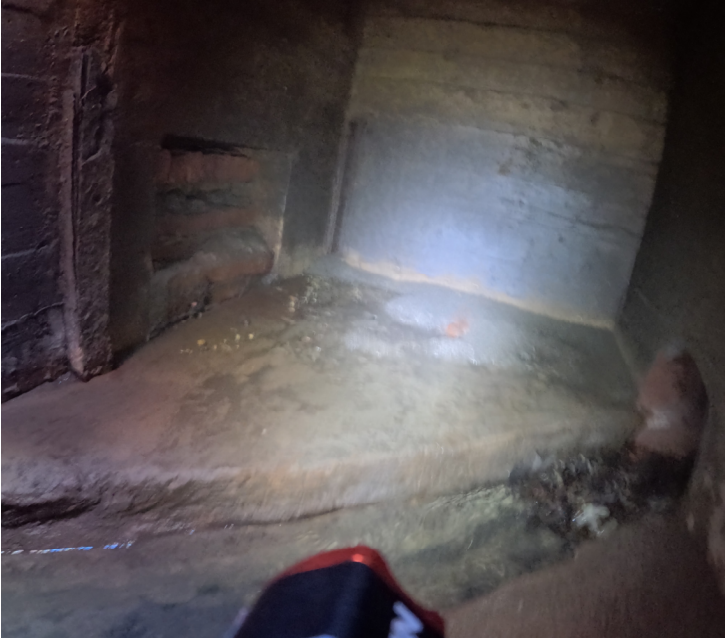
Figure 1

Notes: Only the inlet chamber was scanned by Redzone in 2023. Other chamber dimensions were taken from record drawing -6639A -ROD FR BLV. The tide gate has fallen off and is present in the overflow chamber. The overflow outlet is bricked up. The float is present but not functional, see Figure 2.

Figure 1: Inside of R-012A. Inlet and bricked up overflow visible.

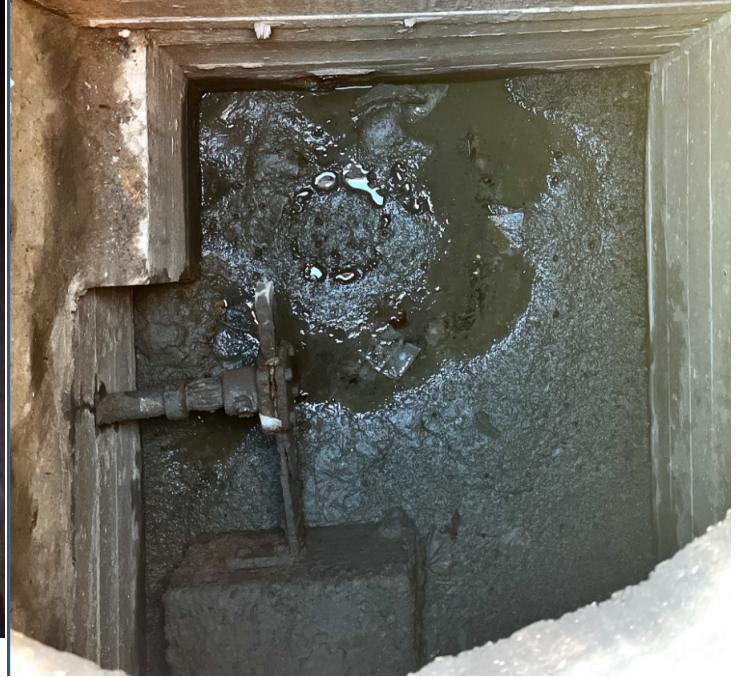
Figure 2

Figure 2: Inside of R-012A Dry Weather Flow Chamber. Float mechanism visible.
