R-012B

BELLEVUE ST
New Bedford

Inspection Status: Remote Inspection
Inspection Level: Level 2

Project: | New Bedford 3D Regulator Inspections

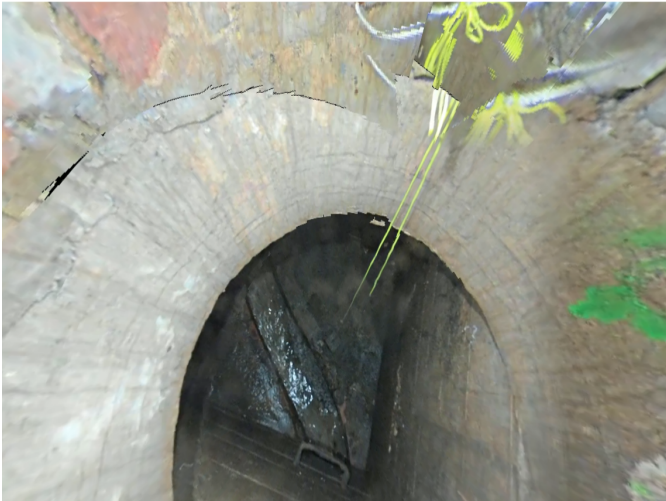
Code: **IS**
Description: **Infiltration Stain**

Distance: **0ft**
Structural Grade: **0**
O&M Grade: **1**
Clock Start/From: **12**
Clock To: **12**
1st Value:
2nd Value:
Value Percent:
Continuous Index: **S01**
Within Eight" of Joint: **False**
Remarks:

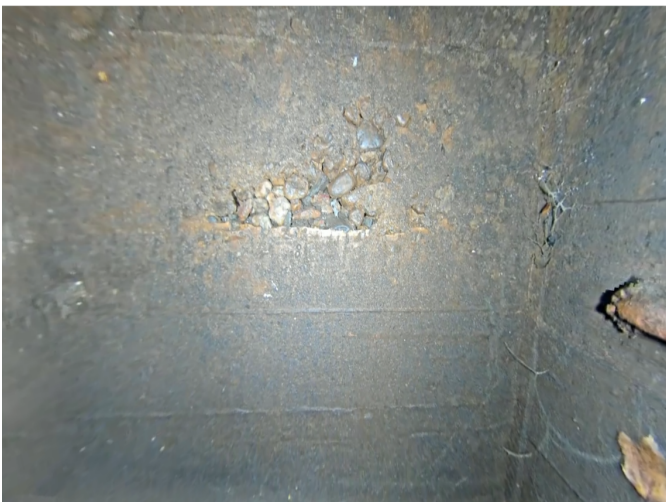
Code: **SAM**
Description: **Surface Damage Aggregate Missing**

Distance: **4ft**
Structural Grade: **4**
O&M Grade: **0**
Clock Start/From: **4**
Clock To:
1st Value:
2nd Value:
Value Percent:
Continuous Index:
Within Eight" of Joint: **False**
Remarks:

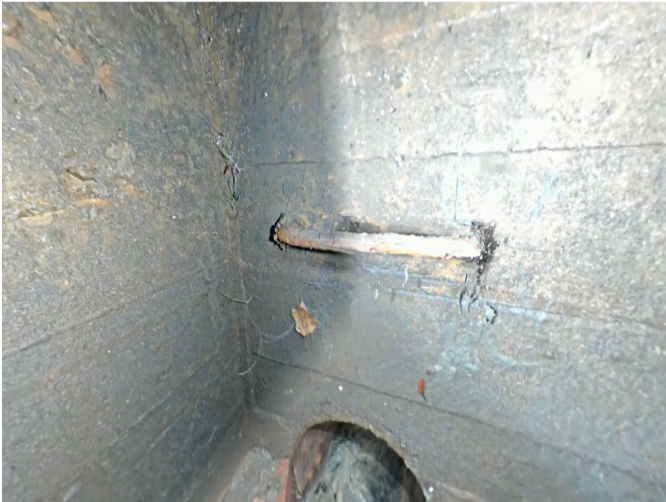
Code: **IS**
Description: **Infiltration Stain**

Distance: **4ft**
Structural Grade: **0**
O&M Grade: **1**
Clock Start/From: **12**
Clock To: **12**
1st Value:
2nd Value:
Value Percent:
Continuous Index: **F01**
Within Eight" of Joint: **False**
Remarks:
