# New Bedford Regulator Specification Sheet

**Regulator #:** R-013A

**Location:** Aquidneck St. at E. Rodney French Blvd.

**Date:** 6/25/25

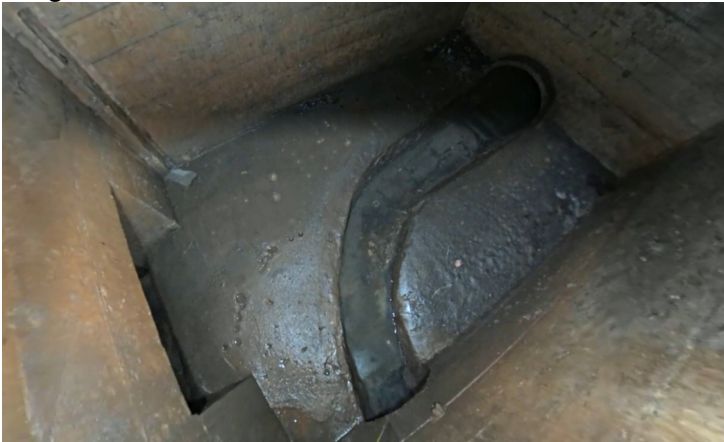
**Figure 1**

**Notes:** Only the inlet chamber was scanned by Redzone in 2023. Other dimensions and elevations were estimated from record drawing-6639A ROD FR BLVD. Tide gate is in good condition, see Figures 1 and 2. It is possible the overflow is blocked further downstream of this structure.

**Figure 1:** Inside of R-013A Regulator Chamber. Inflow, dry weather flow, and overflow visible.

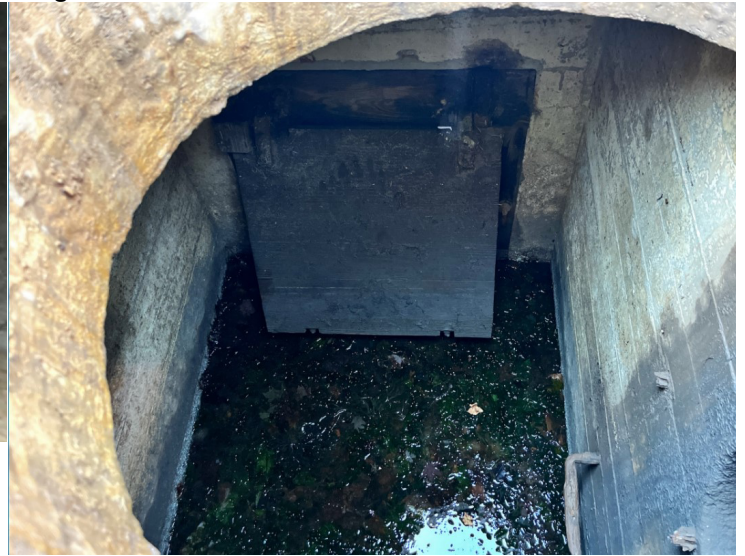
**Figure 2**

**Tide Gate Status:** Wooden flap gate in good condition

**Figure 2:** Inside of R-013A Overflow Chamber. Tide gate visible.

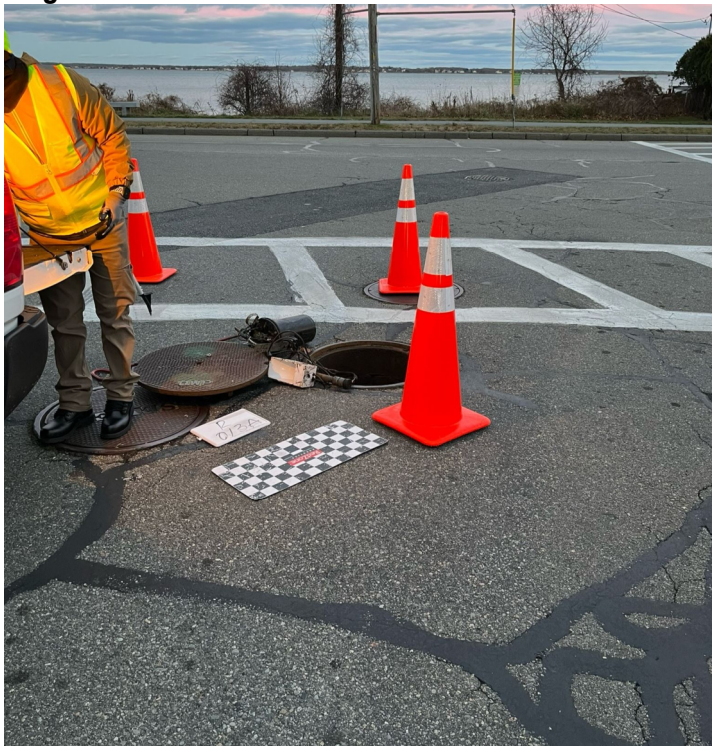
**Figure 3**

**Figure 3:** Location of manhole facing east at east end of Aquidneck Street.

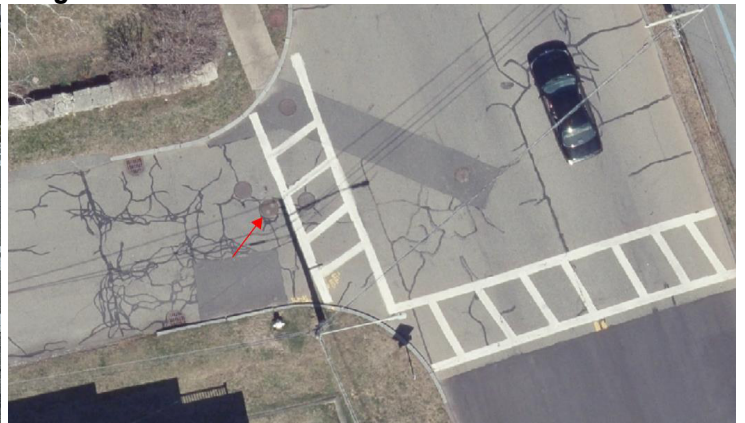
**Figure 4**

**Figure 4:** Aerial location with arrow pointing to corresponding manhole.
