New Bedford Regulator Specification Sheet

Regulator #: R-015A

Location: Butler St. at E. Rodney French Blvd.

Date: 6/25/25

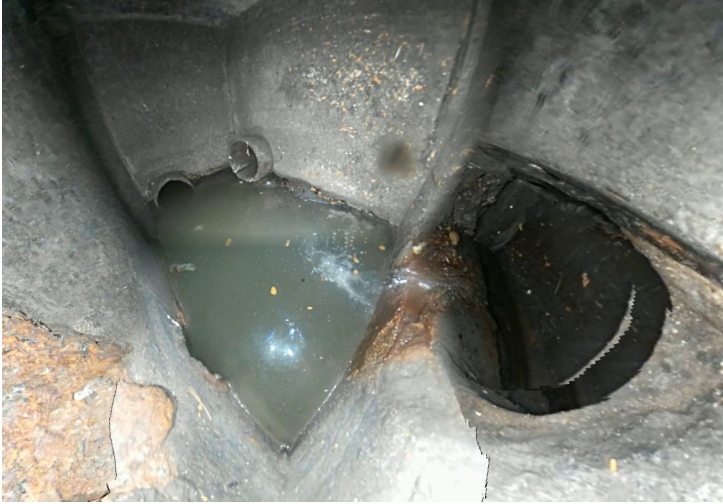
Figure 1

Figure 1: Inside of R-015A Regulator Chamber. Inlets, dry weather outlet, and overflow visible.

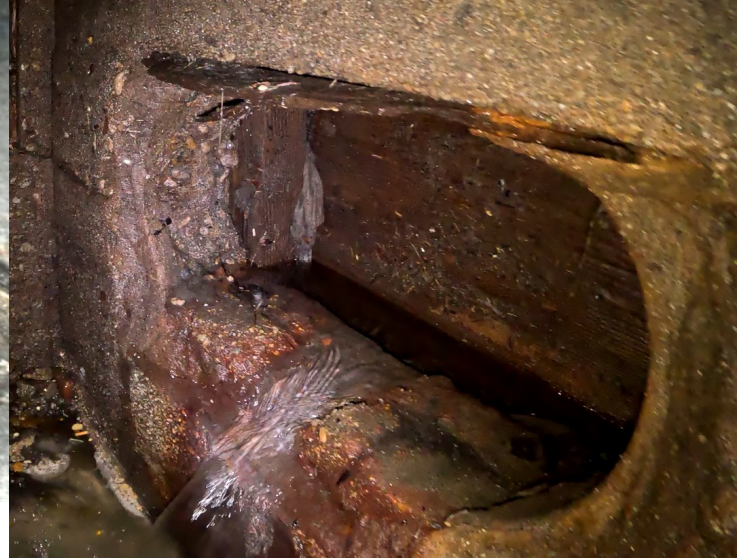
Figure 2

Figure 2: Inside of R-015A Regulator Chamber. Close-up of tidal infiltration through closed tide gate.

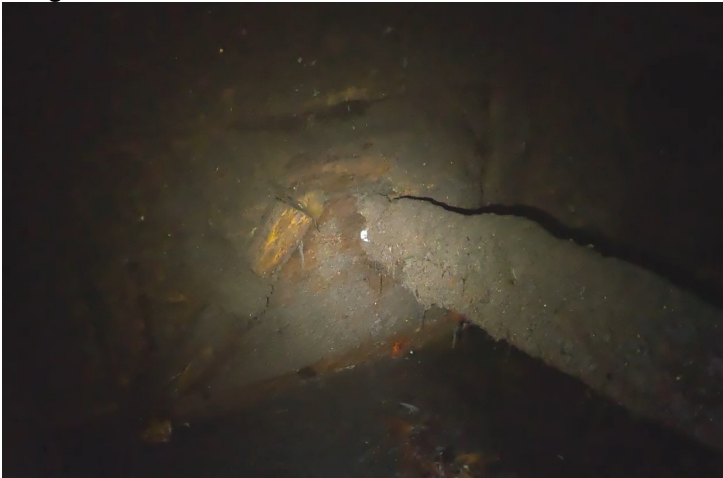
Figure 3

Tide Gate Status: Wooden flap gate held close by wooden beam

Figure 3: Inside of R-015A Overflow Chamber. Tide gate propped closed with wooden beam.
