# New Bedford Regulator Specification Sheet

**Regulator #:** R-016A

**Location:** Frederick St. at E. Rodney French Blvd.

**Date:** 6/25/25

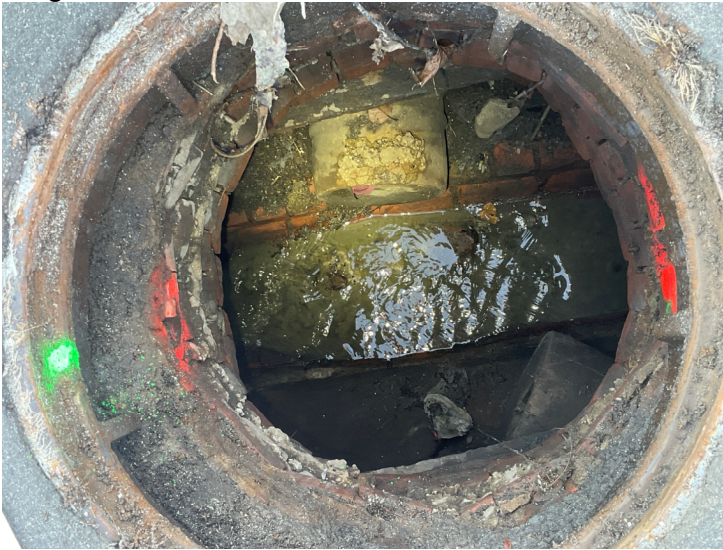
**Figure 1**

**Figure 1:** Inside of R-016A. Dry weather flow visible.

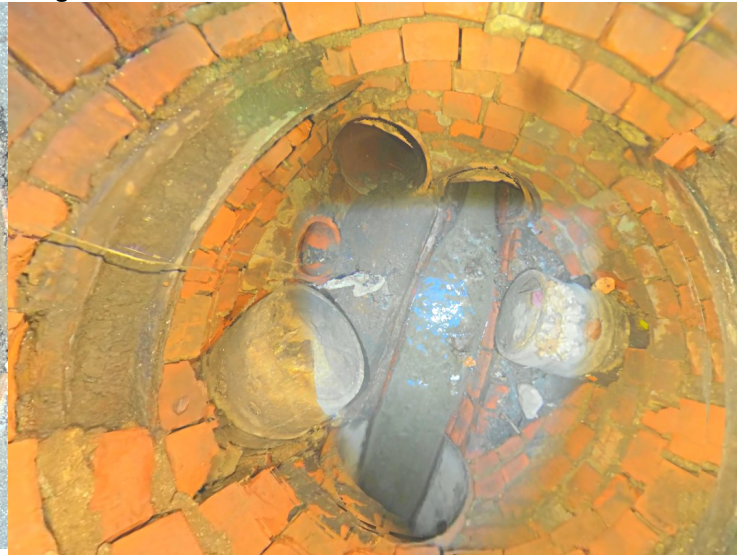
**Figure 2**

**Figure 2:** Inside of R-016A. All pipes visible.

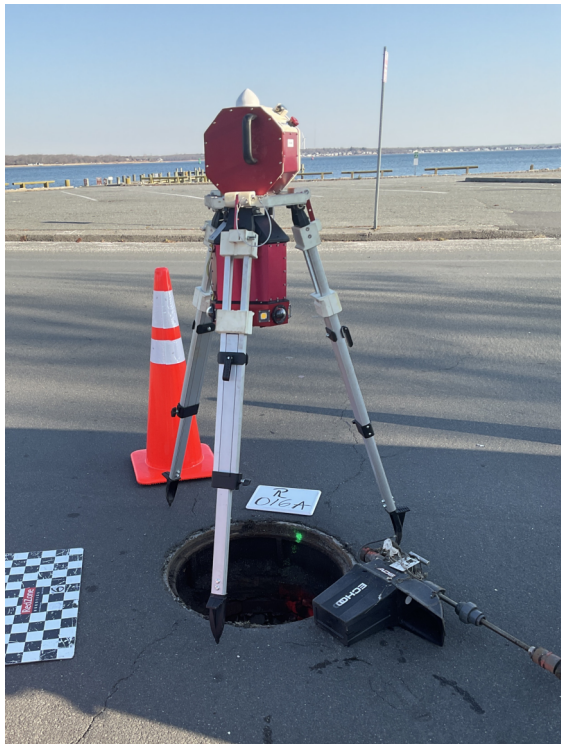
**Figure 3**

**Figure 3:** Location of manhole facing east at the east end of Frederick Street towards bay.
