# New Bedford Regulator Specification Sheet

**Regulator #:** R-017A

**Location:** Rodney St. at E. Rodney French Blvd.

**Date:** 6/25/25

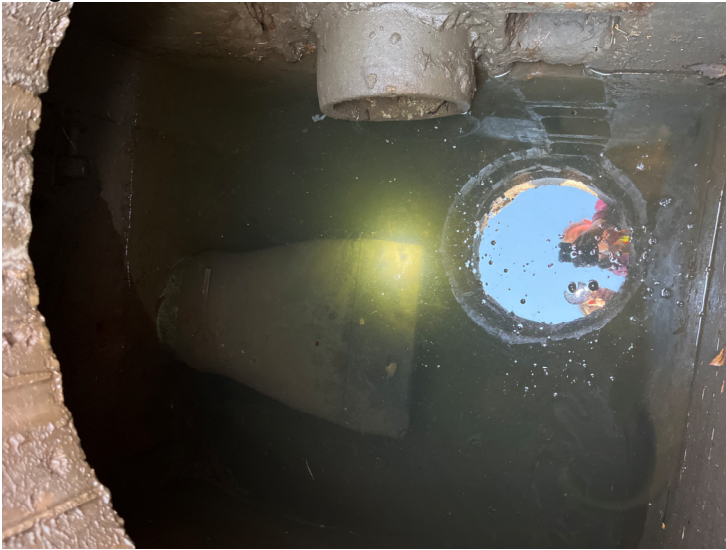
**Figure 1**

**Tide Gate Status:** Duckbill in overflow chamber

**Notes:** Only the inlet chamber was scanned by Redzone in 2023. Other dimensions and elevations were taken from record drawings P3467 and B-636. The tide gate was replaced with a 12" opening to duckbill gate. Tidal backflow through duckbill gate observed during high tide. An undocumented pipe in the overflow chamber is assumed to be a storm drain connection.

**Figure 1:** Inside of R-017A Overflow Chamber. Duckbill submerged during high tide.

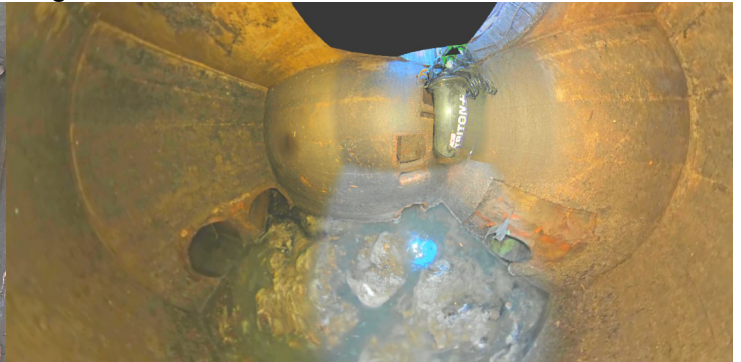
**Figure 2**

**Figure 2:** 360 photo of Inside of R-017A Regulator Chamber.
