# New Bedford Regulator Specification Sheet

**Regulator #:** R-017C

**Location:** E. Rodney French Blvd. at David St.

**Date:** 6/25/25

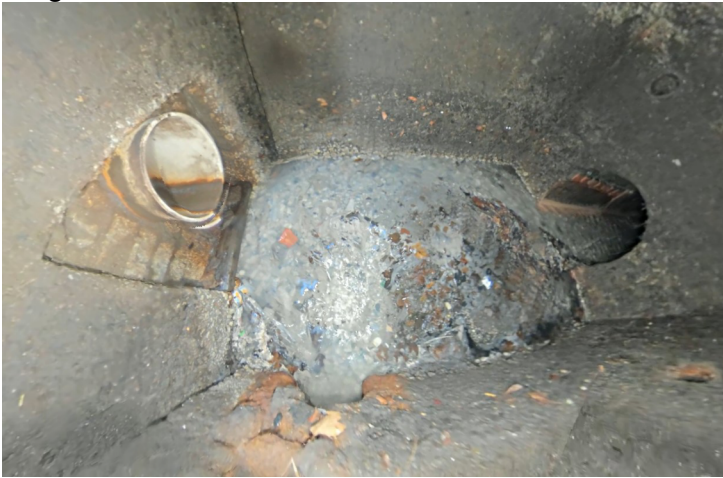
**Figure 1**

**Figure 1:** Inside of R-017C Regulator Chamber. Inlet, dry weather flow, and overflow visible.

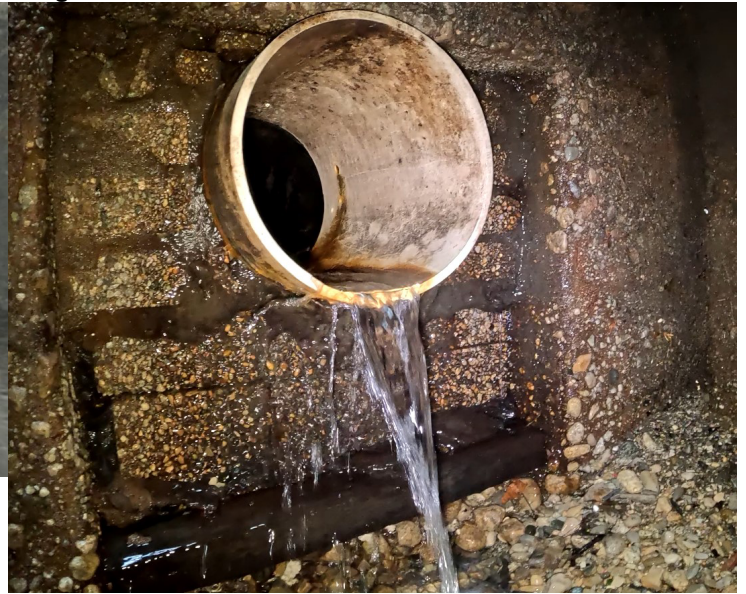
**Figure 2**

**Notes:** Only inlet chamber was scanned by Redzone in 2023. Other dimensions and elevations were taken from record drawings P3467 and B-636. The tide gate was replaced with 12" opening to a duckbill gate. Tidal backflow through duckbill gate observed during high tide. There is one meter by the inflow and one meter in the old regulator chamber which should be moved.

**Figure 2:** Inside of R-017C Regulator Chamber. Close-up on tidal infiltration through duckbill check valve during high tide.

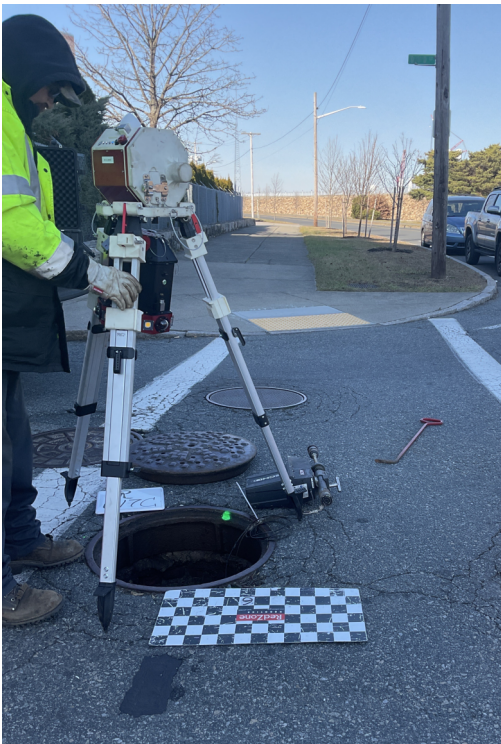
**Figure 3**

**Figure 3:** Location of manhole, facing northwest along E. Rodney French Blvd.
