# **New Bedford Regulator Specification Sheet**

Regulator #: R-020A

**Location:** Wamsutta St. west of Rt. 18 **Date:** 6/25/25

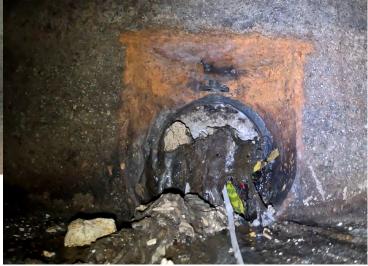
Figure 2

**Notes:** Redzone scanned the inlet chamber in 2023. The second chamber is on the other side of the fence only accessible from Route 18. During Feb 2025 fieldwork, it was discovered that the dry weather outlet was blocked by debris (Figure 2) and a stop plank was missing (not shown). The overflow chamber needs to be cleaned. All other dimensions taken from drawings from MassDOT.

Figure 2: Inside Regulator Chamber of R-020A. Redzone scan taken Dec 2023

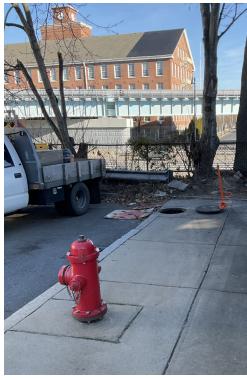
Figure 3

Figure 3: Location of manhole facing east at the end of Wamsutta St. on west side of Route 18.
