## **CSO SPEC SHEET**

Structure #: REG 026 A

Date: 09/19/2012

#### Structure#: REG 026 A

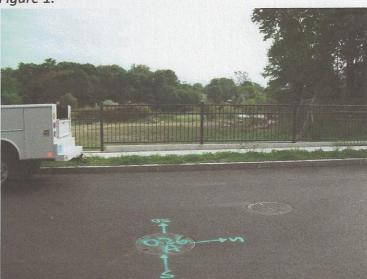
Figure 1.

- Figure 1: View of Regulator 026 A. Facing the Acushnet River.
- Figure 2: Inside view of manhole. A- Sewer; B- Weir Wall; C- Storm Drain.
- Figure 3: Google Earth Image of location of Regulator 026 A. A- Reg 026 A. B- CSO 026 Outfall.

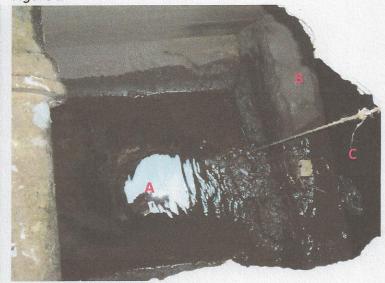
Figure 2.

Needed Repair Description: Tide water is Flowing OVER WEIR WALL INTO Sewer	Date:	Completed Repairs	Date:
Tide water is Flowing OVER	9/18		
WEIR WALL INto Sewer	19/1/8		
			19
