Project JACOBS ENG WO652463
4/16/2024

Pipe Segment Reference	4/16/2024 7:55:34 AM	Lateral Upstream Access Point	MH1
City	NEW BEDFORD	Lateral Downstream Access Point	OUTFALL
Street	RIVER ROAD	Profile	Egg Shaped 63/48inch
Total Length	130.0	Material	Reinforced Concrete Pipe

Inspection report					
Date: 4/16/2024	Work Order:	Weather:	Surveyed By: JAKE CONNALLY	Certificate Number: P0037360	Pipe Segment Ref.: 4/16/2024 7:55:34 AM
Year laid:	Pre-cleaning: No Pre-Cleaning	Direction: Upstream	Pipe Joint Length:	Total Length: 130.0 '	Length Surveyed: 130.0 '

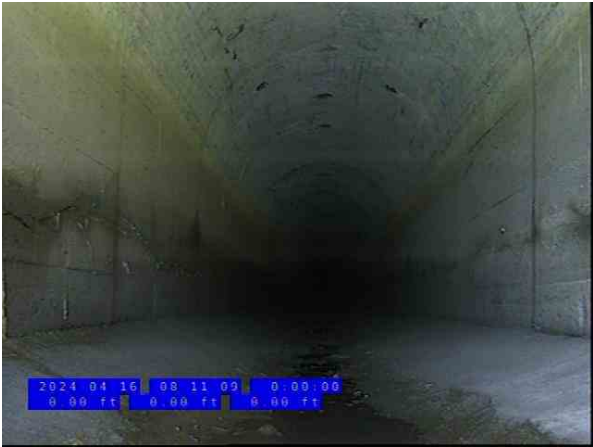
1, 00:00:00, 0.00ft

End of Pipe / OUTFALL

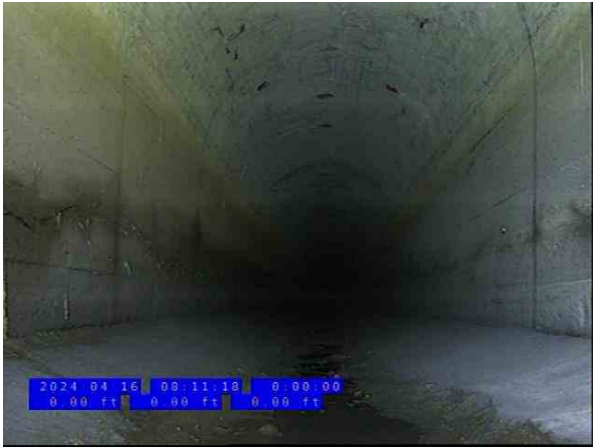
2, 00:00:05, 0.00ft

Water Level, 0% of the vertical dimension

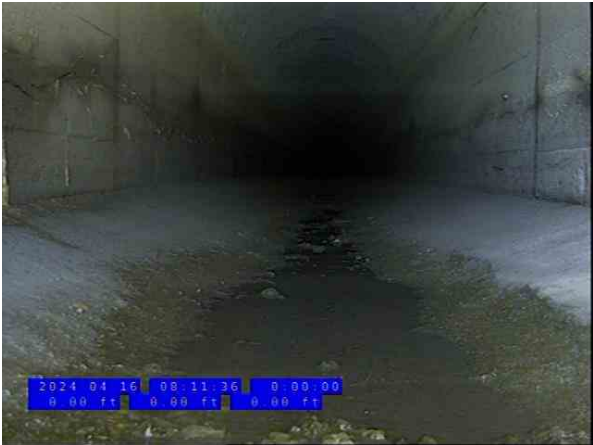
3, 00:00:12, 0.00ft

Deposits Settled Fine, 5% of cross sectional area from 4 o'clock to 8 o'clock, Start

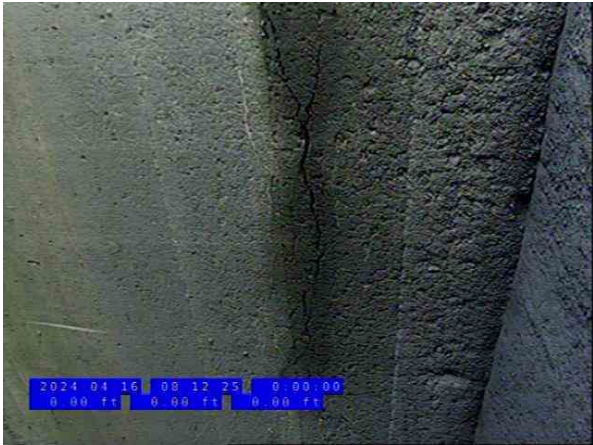
4, 00:00:52, 0.00ft

Crack Multiple from 12 o'clock to 12 o'clock, Start

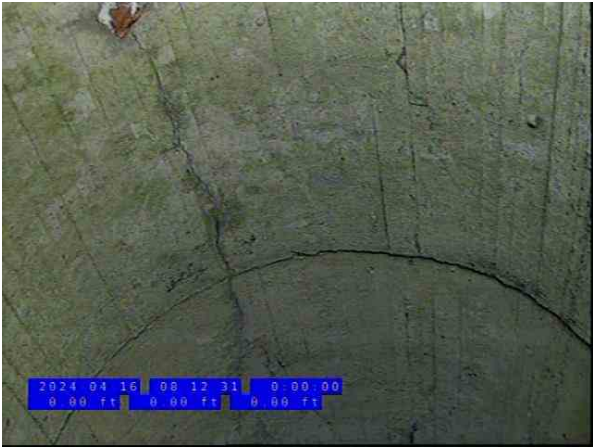
5, 00:00:52, 0.00ft

Crack Multiple from 12 o'clock to 12 o'clock, Start

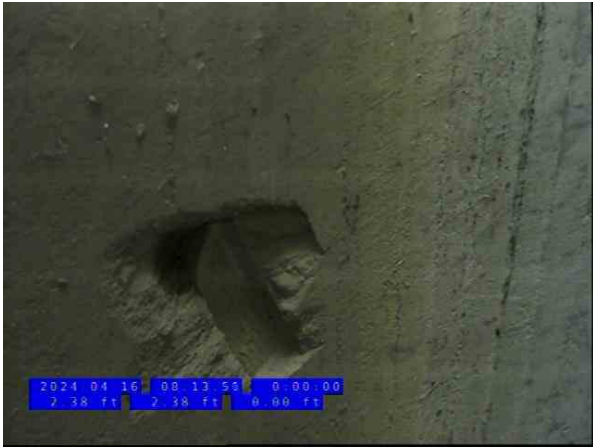
6, 00:01:38, 2.38ft

Surface Damage Missing Wall at 10 o'clock

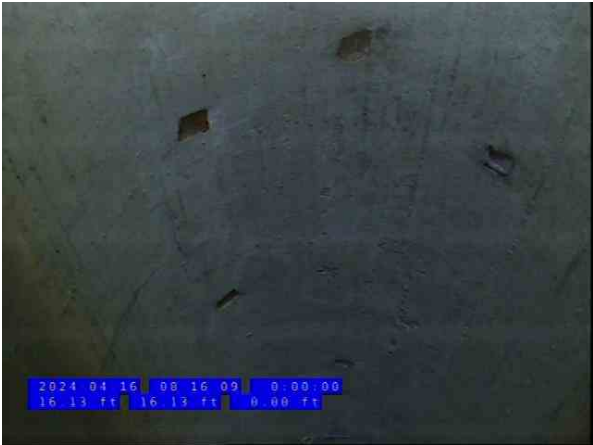
7, 00:03:35, 16.13ft

Miscellaneous General Observation / POSSIBLE HOLE.
COULD BE FOR GROUND WATER

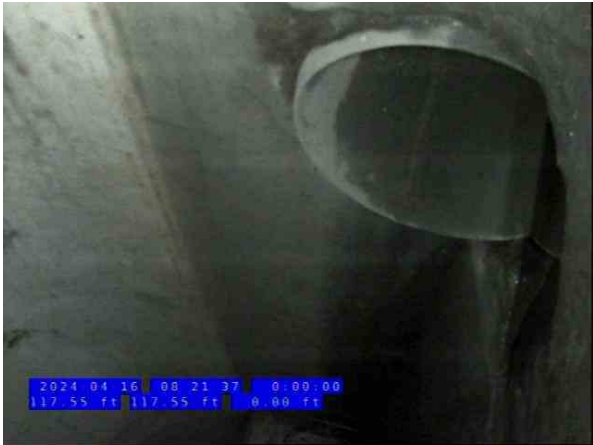
8, 00:08:03, 117.55ft

Tap Break-in/Hammer at 4 o'clock, dia/height: 15inch / 12-15

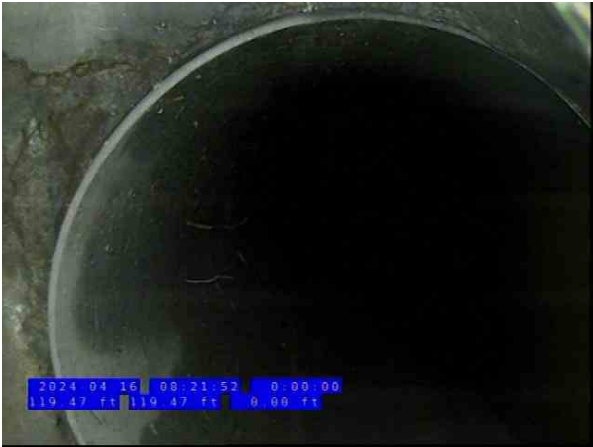
9, 00:08:03, 117.55ft
Tap Break-in/Hammer at 4 o'clock, dia/height: 15inch / 12-15

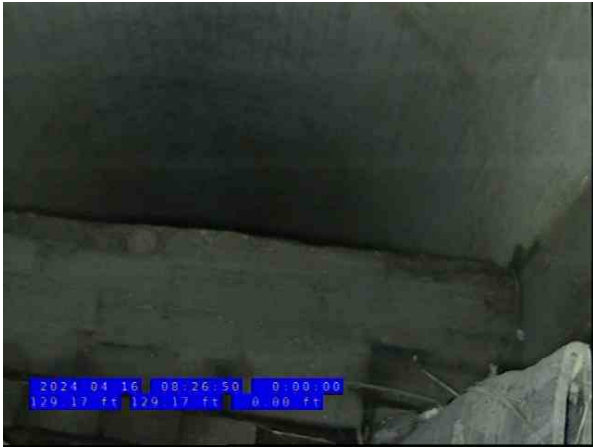
10, 00:13:07, 129.00ft
Deposits Settled Fine, 5% of cross sectional area from 4 o'clock to 8 o'clock, Finish

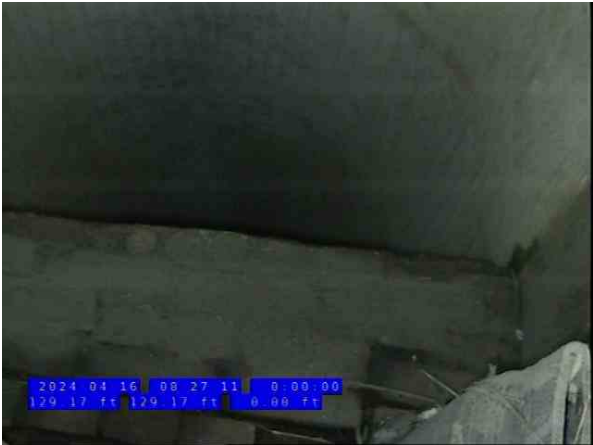
11, 00:13:11, 129.00ft
Crack Multiple from 12 o'clock to 12 o'clock, Finish

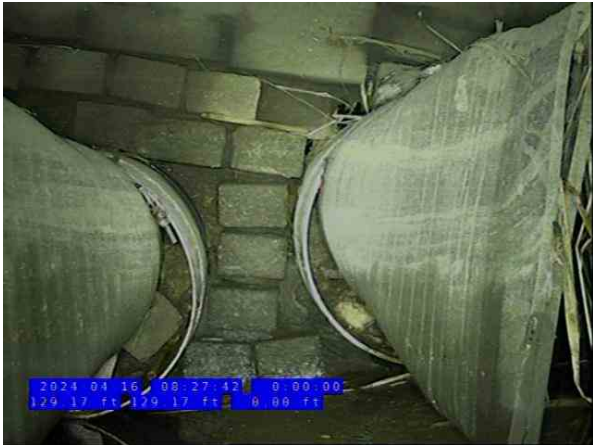
12, 00:13:23, 129.00ft
Miscellaneous General Observation / SEPERATION

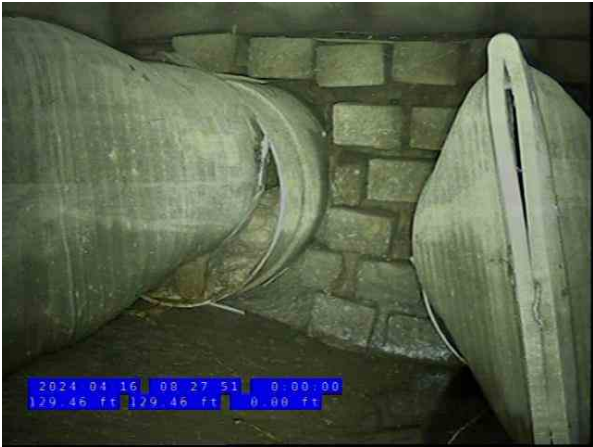
13, 00:13:23, 129.00ft
Miscellaneous General Observation / SEPERATION

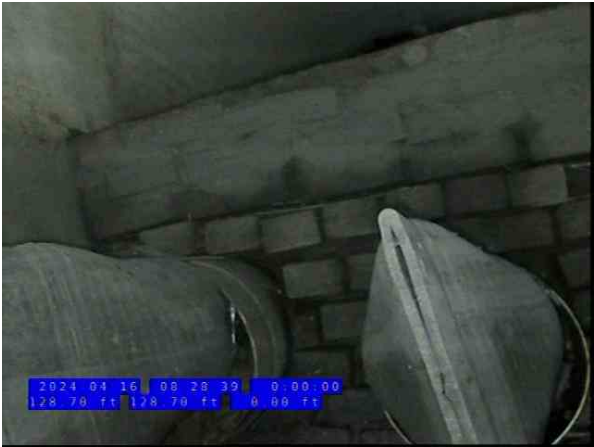
14, 00:14:09, 130.00ft
Obstruction Brick or Masonry, 55% of cross sectional area from 3 o'clock to 9 o'clock

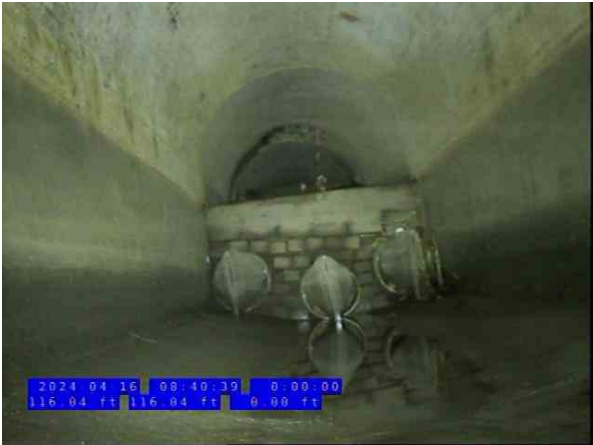
15, 00:17:50, 130.00ft
Manhole / MH1
