CSO SPEC SHEET

Structure #: REG 027 A

CSO FIELD PHOTOS

Location: Mill Rd. Between Mazeppa St. and Jireh St.

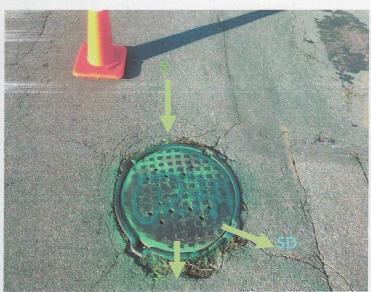
Figure 1.

Figure 1: View of Regulator 027 A. Facing North.

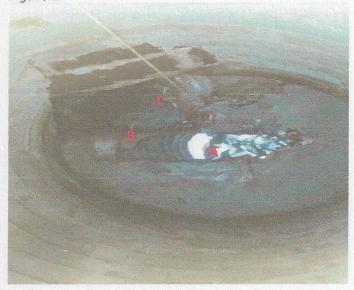
Figure 2.

Figure 2: Inside view of manhole. A- Sewer; B- Weir Wall; C- Storm Drain.
