# R-027C

BELLEVILLE AVE  
New Bedford

Inspection Status: Remote Inspection  
Inspection Level: Level 2

**Project:** | New Bedford 3D Regulator Inspections

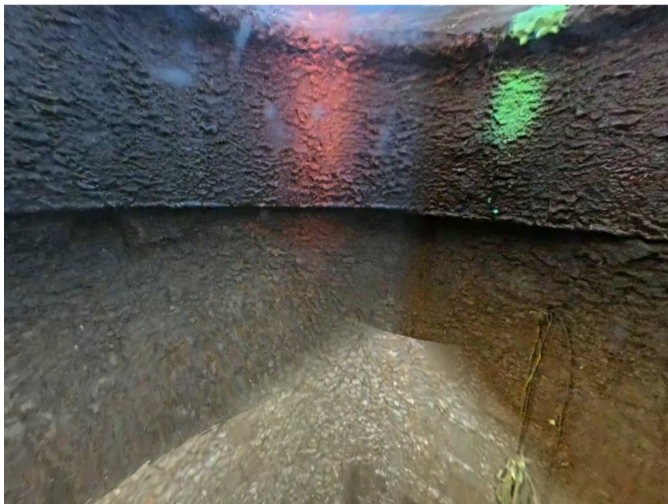
| Graph | Position | Code | Observation | Video (sec) | Grade |
|---|---|---|---|---|---|
| | 0.5ft | SRI | Surface Damage Roughness Increased | 6.27 | S 1 |

Code: **SRI**  
Description: **Surface Damage Roughness Increased**

Distance: **0ft**  
Structural Grade: **1**  
O&M Grade: **0**  
Clock Start/From: **12**  
Clock To: **12**  
1st Value:  
2nd Value:  
Value Percent:  
Continuous Index: **S01**  
Within Eight" of Joint: **False**  
Remarks:

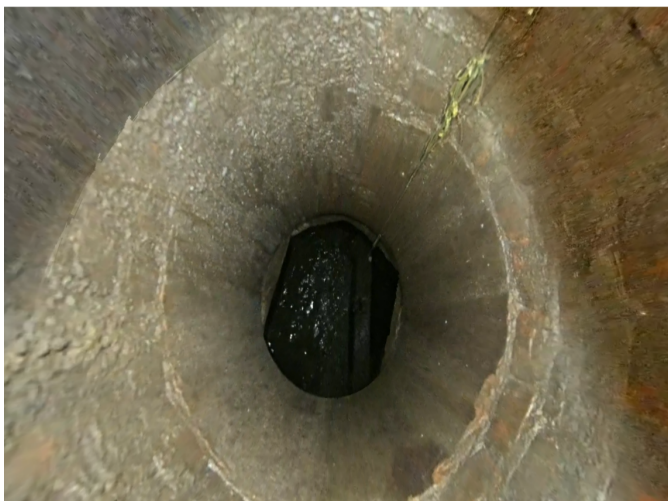
| Graph | Position | Code | Observation | Video (sec) | Grade |
|---|---|---|---|---|---|
| | 0.5ft | IS | Infiltration Stain | 6.27 | M 1 |

Code: **IS**  
Description: **Infiltration Stain**

Distance: **0ft**  
Structural Grade: **0**  
O&M Grade: **1**  
Clock Start/From: **12**  
Clock To: **12**  
1st Value:  
2nd Value:  
Value Percent:  
Continuous Index: **S02**  
Within Eight" of Joint: **False**  
Remarks:

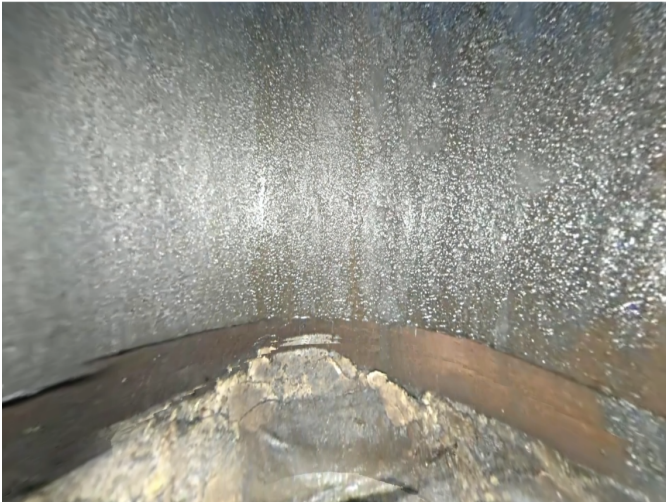
| Graph | Position | Code | Observation | Video (sec) | Grade |
|---|---|---|---|---|---|
| | 3.4ft | SRI | Surface Damage Roughness Increased | 12.07 | S 1 |

Code: **SRI**  
Description: **Surface Damage  
Roughness Increased**

Distance: **3ft**  
Structural Grade: **1**  
O&M Grade: **0**  
Clock Start/From: **12**  
Clock To: **12**  
1st Value:  
2nd Value:  
Value Percent:  
Continuous Index: **F01**  
Within Eight" of Joint: **False**  
Remarks:

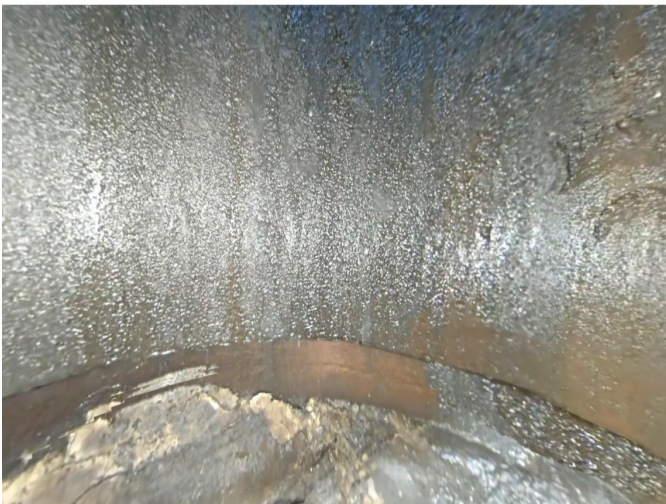
| Graph | Position | Code | Observation | Video (sec) | Grade |
|---|---|---|---|---|---|
| | 3.4ft | IS | Infiltration Stain | 12.07 | M 1 |

Code: **IS**  
Description: **Infiltration Stain**

Distance: **3ft**  
Structural Grade: **0**  
O&M Grade: **1**  
Clock Start/From: **12**  
Clock To: **12**  
1st Value:  
2nd Value:  
Value Percent:  
Continuous Index: **F02**  
Within Eight" of Joint: **False**  
Remarks:
