# New Bedford Regulator Specification Sheet

**Regulator #:** R-031A

**Location:** S. Second St. at Grinnell St.

**Date:** 6/25/25

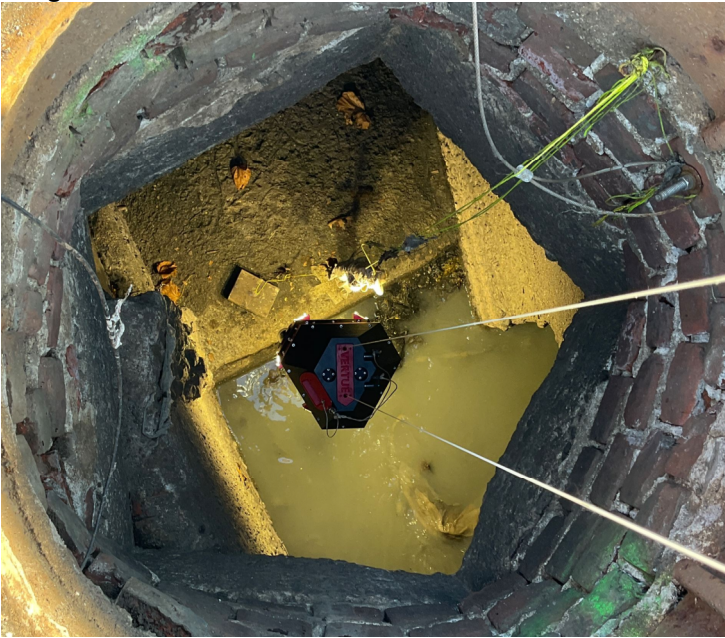
**Figure 1**

**Notes:** Overflow block is placed on a sill. Scan and inspection shows knocked off tide gate before the dry weather outlet. Plan 6640 indicates that the chute should be 24" wide x 18" high, but it only measures 12" wide by 10" high and is partially bricked up according to the scan. Plan 8184A is not correct- it does not show the correct orientation of the structure.

**Figure 1:** Inside of R-031A. Dry weather connection and block visible.

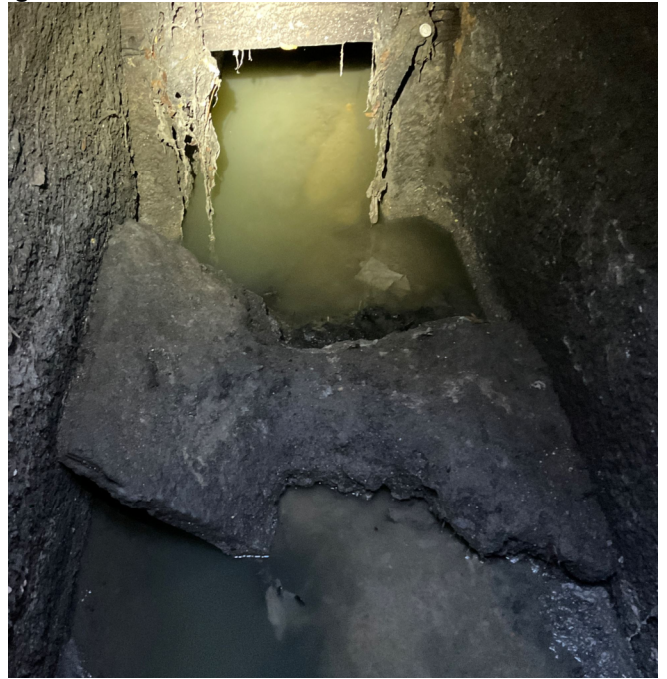
**Figure 2**

**Figure 2:** Inside of R-031A adjacent chamber. Dry weather connection and irregular weir visible.
