New Bedford Regulator Specification Sheet

Regulator #: R-031C

Location: Howland St. and S. Second St.

Date: 6/25/25

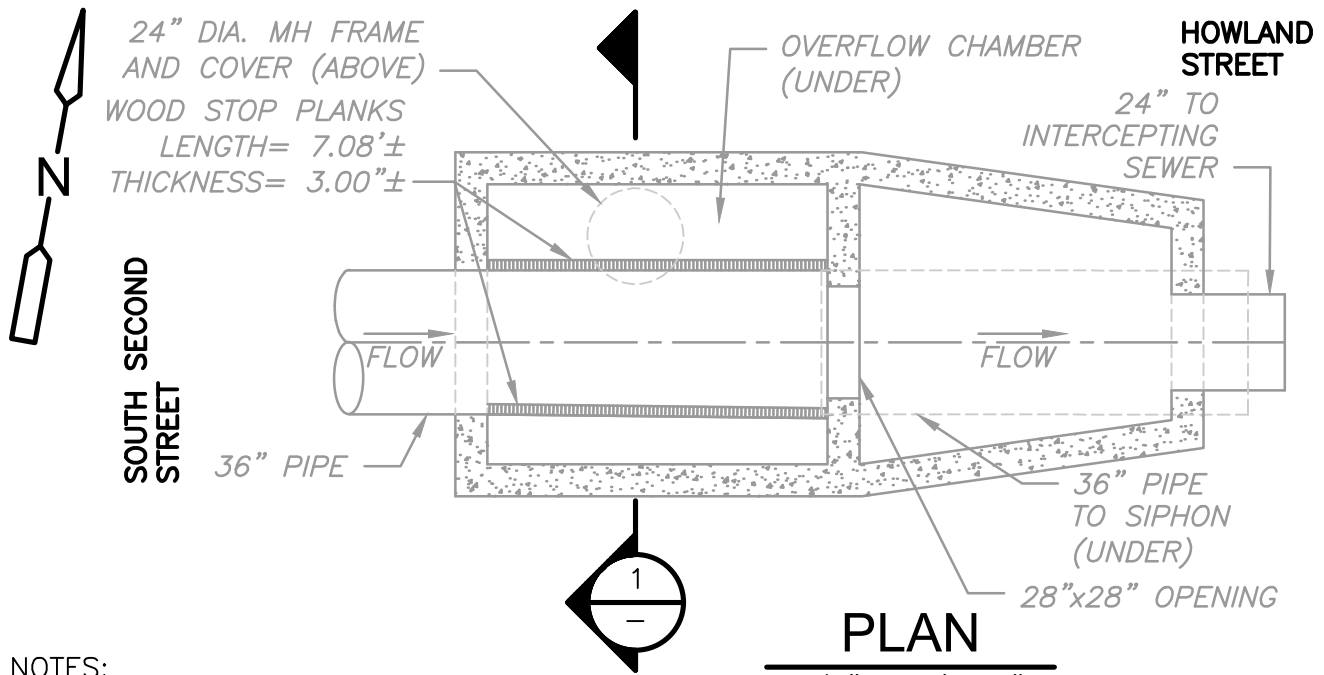
1. ELEVATIONS SHOWN ARE IN NEW BEDFORD CITY DATUM.
2. STANDING WATER OBSERVED 7' FROM RIM DURING DRY WEATHER INSPECTION ON 12/14/2023.
3. MANHOLE NEEDS CLEANING.

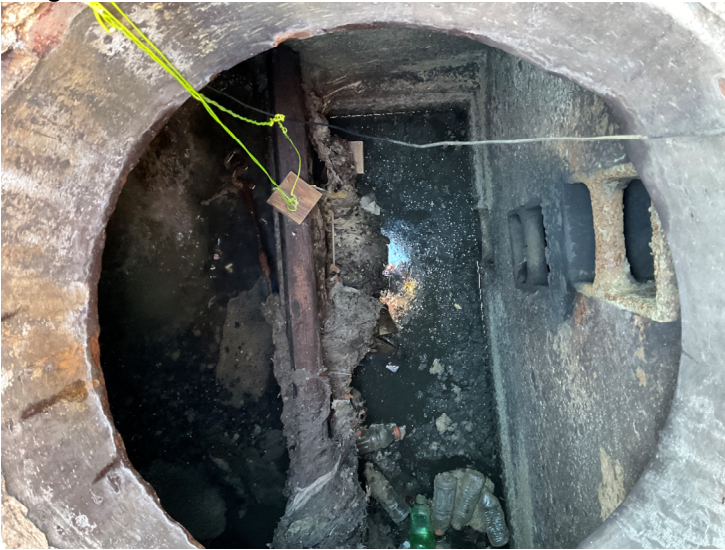
Figure 1

Figure 1: Inside of R-031C. Weir, overflow chamber, and dry weather flow visible.

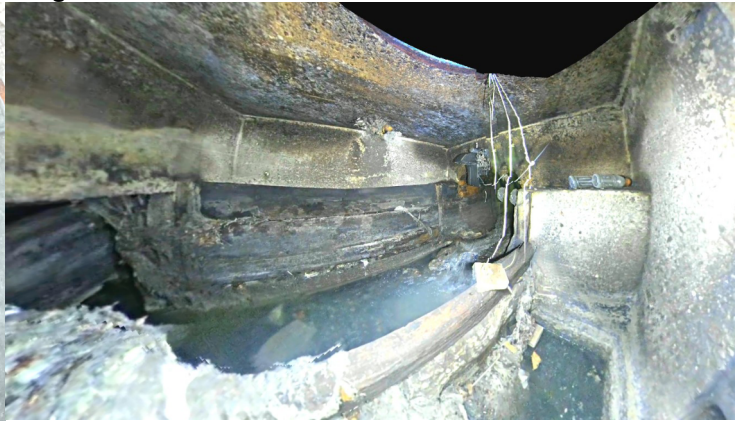
Figure 2

Figure 2: Inside of R-031C. Dry weather connection visible.
