R-031D

GRINNELL ST
New Bedford

Inspection Status: Remote Inspection
Inspection Level: Level 2

Project: | New Bedford 3D Regulator Inspections

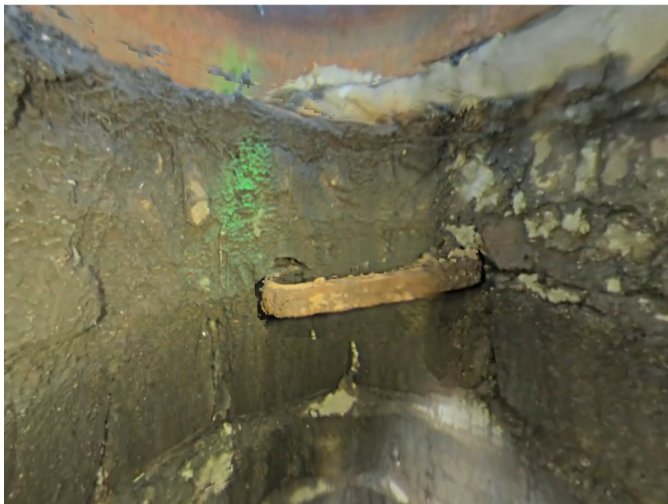
Code: **SRI**
Description: **Surface Damage Roughness Increased**

Distance: **1ft**
Structural Grade: **1**
O&M Grade: **0**
Clock Start/From: **12**
Clock To: **12**
1st Value:
2nd Value:
Value Percent:
Continuous Index: **S01**
Within Eight" of Joint: **False**
Remarks:

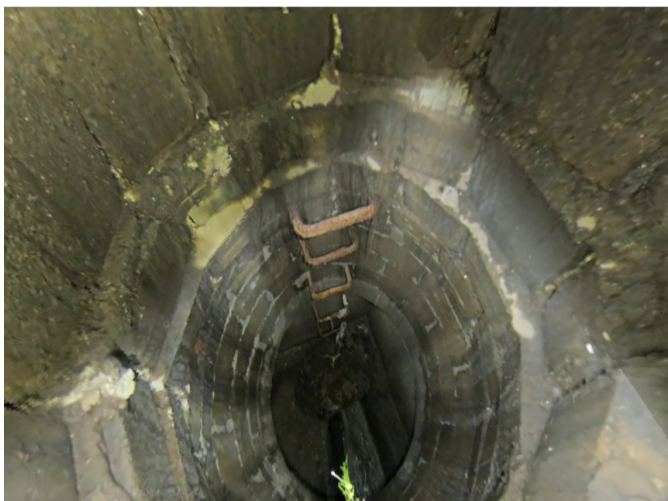
Code: **IS**
Description: **Infiltration Stain**

Distance: **1ft**
Structural Grade: **0**
O&M Grade: **1**
Clock Start/From: **12**
Clock To: **12**
1st Value:
2nd Value:
Value Percent:
Continuous Index: **S02**
Within Eight" of Joint: **False**
Remarks:

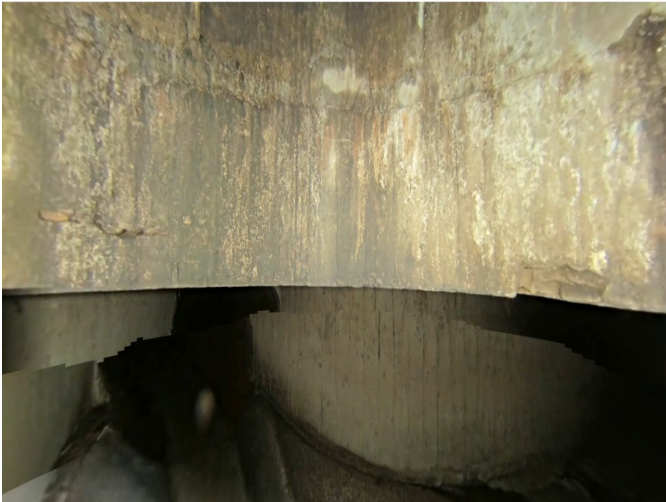
Code: **SRI**
Description: **Surface Damage
Roughness Increased**

Distance: **7ft**
Structural Grade: **1**
O&M Grade: **0**
Clock Start/From: **12**
Clock To: **12**
1st Value:
2nd Value:
Value Percent:
Continuous Index: **F01**
Within Eight" of Joint: **False**
Remarks:

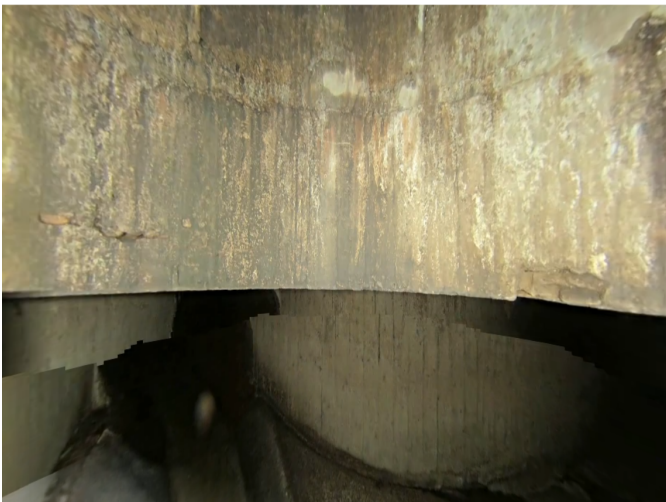
Code: **IS**
Description: **Infiltration Stain**

Distance: **7ft**
Structural Grade: **0**
O&M Grade: **1**
Clock Start/From: **12**
Clock To: **12**
1st Value:
2nd Value:
Value Percent:
Continuous Index: **F02**
Within Eight" of Joint: **False**
Remarks:
