CSO SPEC SHEET

Structure #: REG 032 A

Date: 09/04/2012

Location: At the Intersection of Cannon St and Second St.

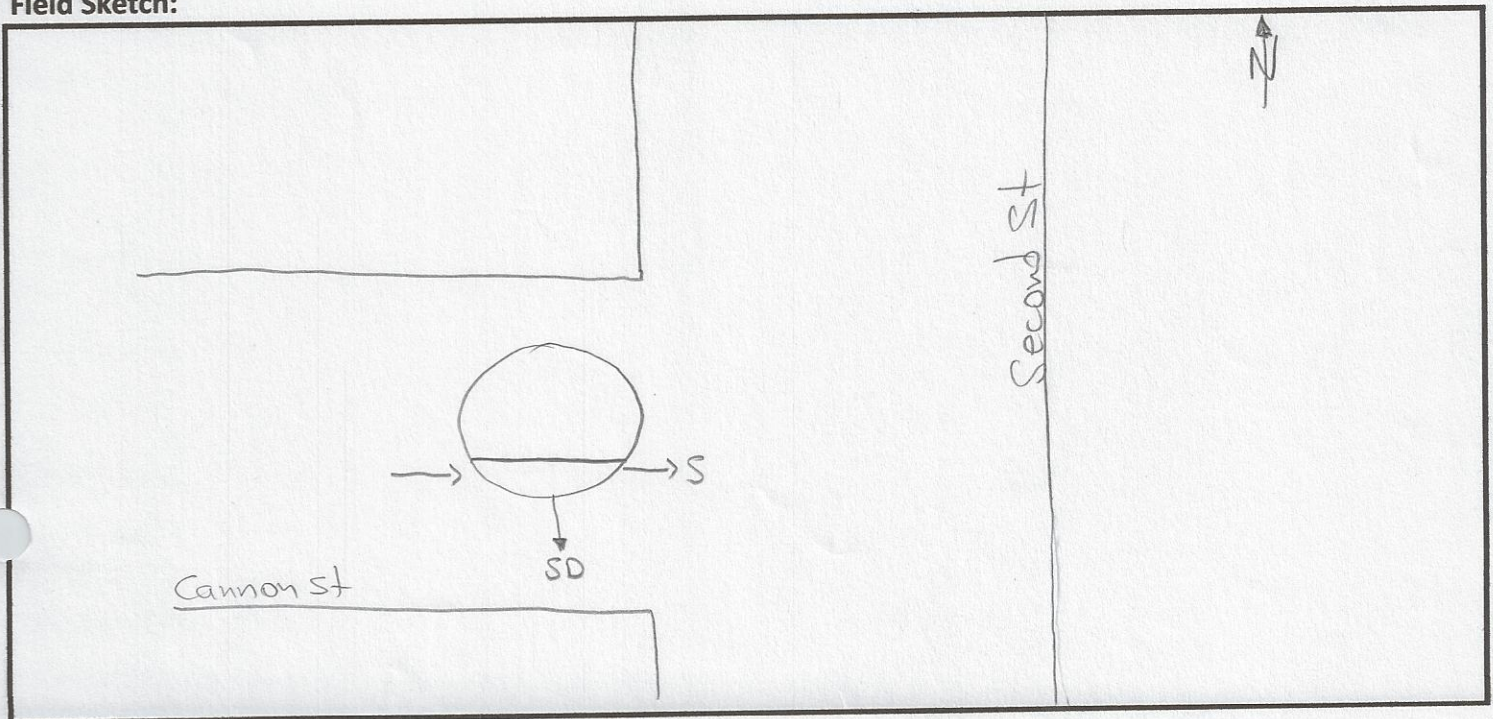
Field Sketch:

Comments: No Repairs Needed. Double Decker System. When sewer overflows it goes underneath the concrete Block.

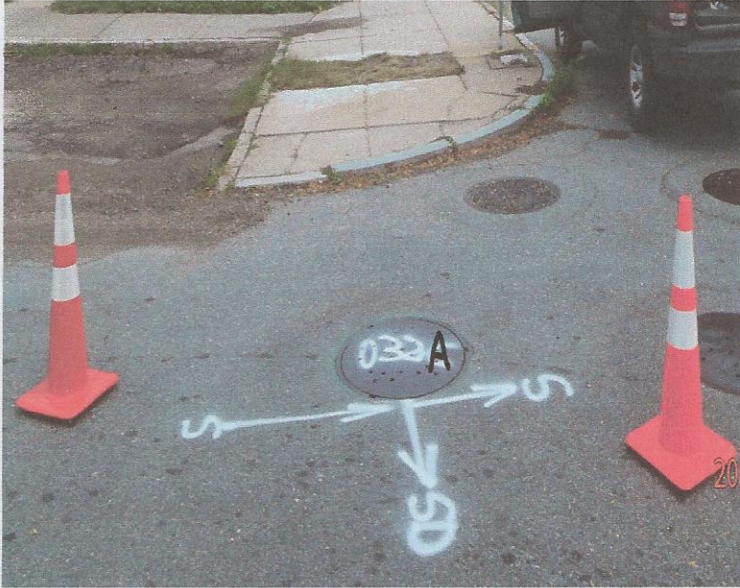
Figure 1.

Figure 1: View of Regulator 032 A. Facing North.

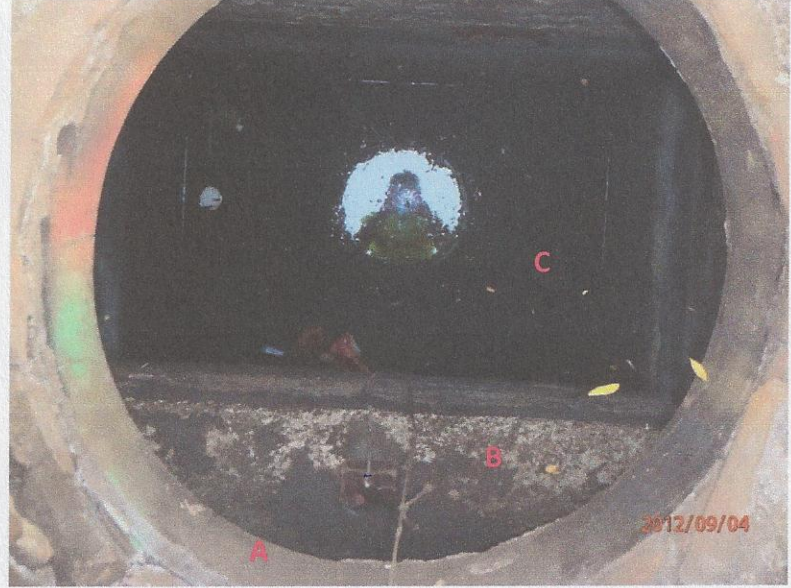
Figure 2.

Figure 2: Inside view of manhole. A- Sewer; B- Weir Wall; C- Storm Drain.
