R-032A

S 2ND ST
New Bedford

Inspection Status: Remote Inspection
Inspection Level: Level 2

Project: | New Bedford 3D Regulator Inspections

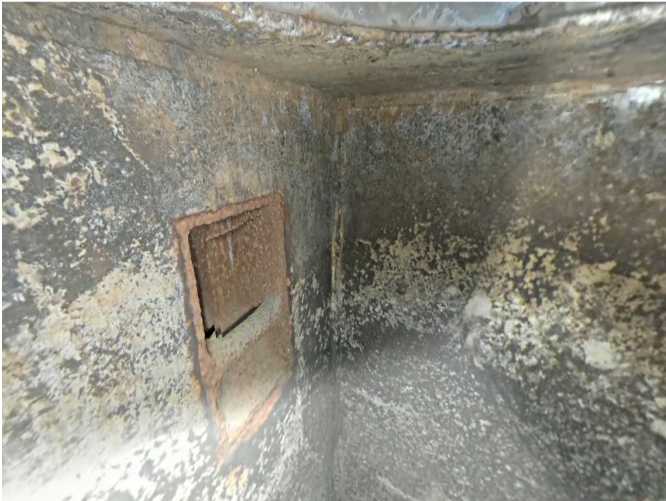
Code: **SRI**
Description: **Surface Damage Roughness Increased**

Distance: **2ft**
Structural Grade: **1**
O&M Grade: **0**
Clock Start/From: **12**
Clock To: **12**
1st Value:
2nd Value:
Value Percent:
Continuous Index: **S01**
Within Eight" of Joint: **False**
Remarks:

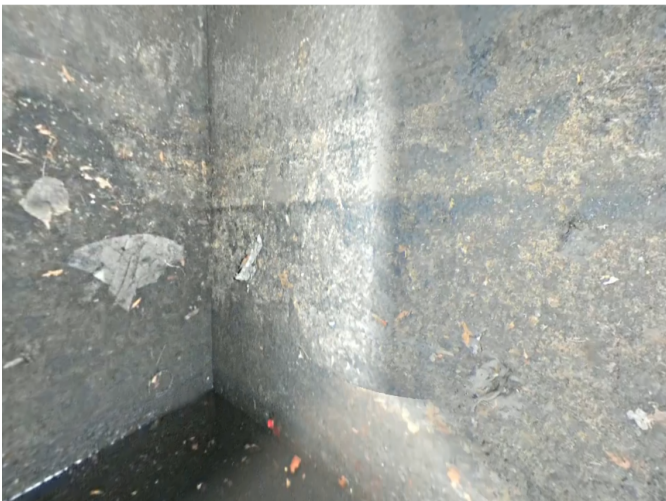
Code: **SRI**
Description: **Surface Damage Roughness Increased**

Distance: **8ft**
Structural Grade: **1**
O&M Grade: **0**
Clock Start/From: **12**
Clock To: **12**
1st Value:
2nd Value:
Value Percent:
Continuous Index: **F01**
Within Eight" of Joint: **False**
Remarks:
