CSO SPEC SHEET

Structure #: REG 041 B

Date: 09/19/2012

CSO FIELD PHOTOS

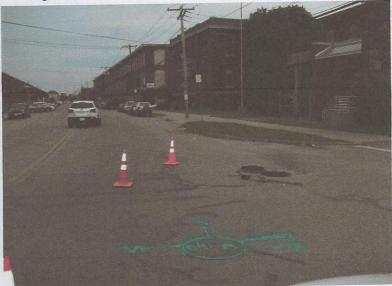
Figure 1.

- Figure 1: View of Regulator 041 B. Facing North.
- Figure 2: Inside view of manhole. A- Sewer; B- Weir Wall; C- Storm Drain.
- Figure 3: Google Earth Image of location of Regulator 041 B. A- Reg 041 B. B- CSO 041 Outfall.

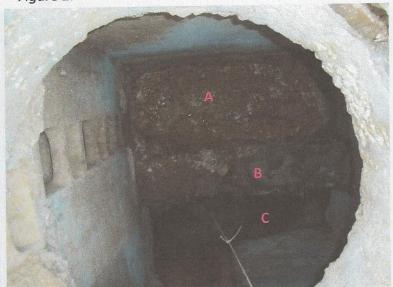
Figure 2.

| tructure Type: Concrete Weir Wall | Regulator Type: Block Regulator | | |
|---|---|--|--|
| Comments: No Repairs Needed. | | | |
