APPLICATION No.: 13184

LOCATION: 212 Nash Rd. S.S. R. of Ashley Blvd

OWNER: Norman Fehault

212 Nash Street- New Bedford
Items to Fix, Repair or Replace:

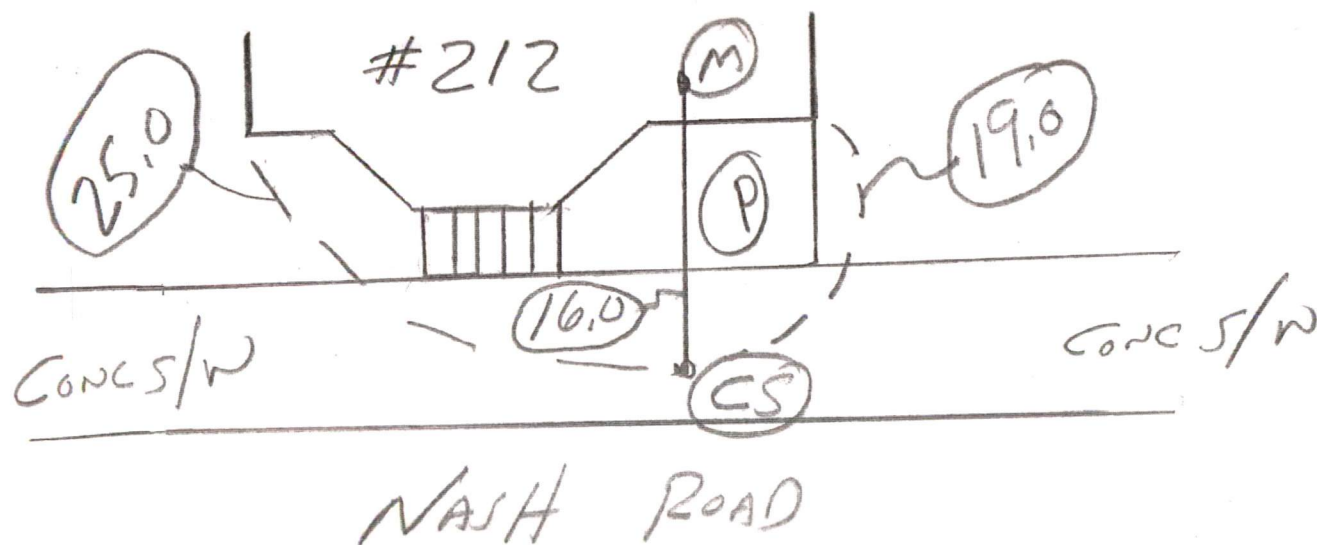
June 29, 1970 Renewed from $\frac{1}{2}$ ft. outside curb stop to
5 ft. inside curb stop.

5 $\frac{1}{2}$ ft. - 3/4" Copper tubing 3/4" Curb stop
2 wipe joints

1/15/86: Renewed from main to property line. Stock: 16ft. 3/4"
copper tubing 1 - 3/4" curb stop 1 - Caldwell stop box
1 - 3/4 x 5/8 lead to cop adapt. xxs 1 - 3/4x5/8 Fig. 413

05/16/2018 Lead Service Replacement Program
Phase 1, Contractor P Gioioso & Son

Type CU, Diameter 1in, Water pressure 69
Distance from main to curb stop (ft) N/A

Distance from curb stop to meter (Ft) 17.0

Distance from curb face to curb stop (ft) 2.5

Depth of service (Ft) 3.8

Total length of new pipe installed (ft) 20.0

Stop replace: no corporation replaced: no

ball valve replace: yes size 1"

1/15/86: TAP REAMED
