# New Bedford Regulator Specification Sheet

**Regulator #:** R-004A

**Location:** Cove Rd at Rockdale Ave.

**Date:** 6/25/25

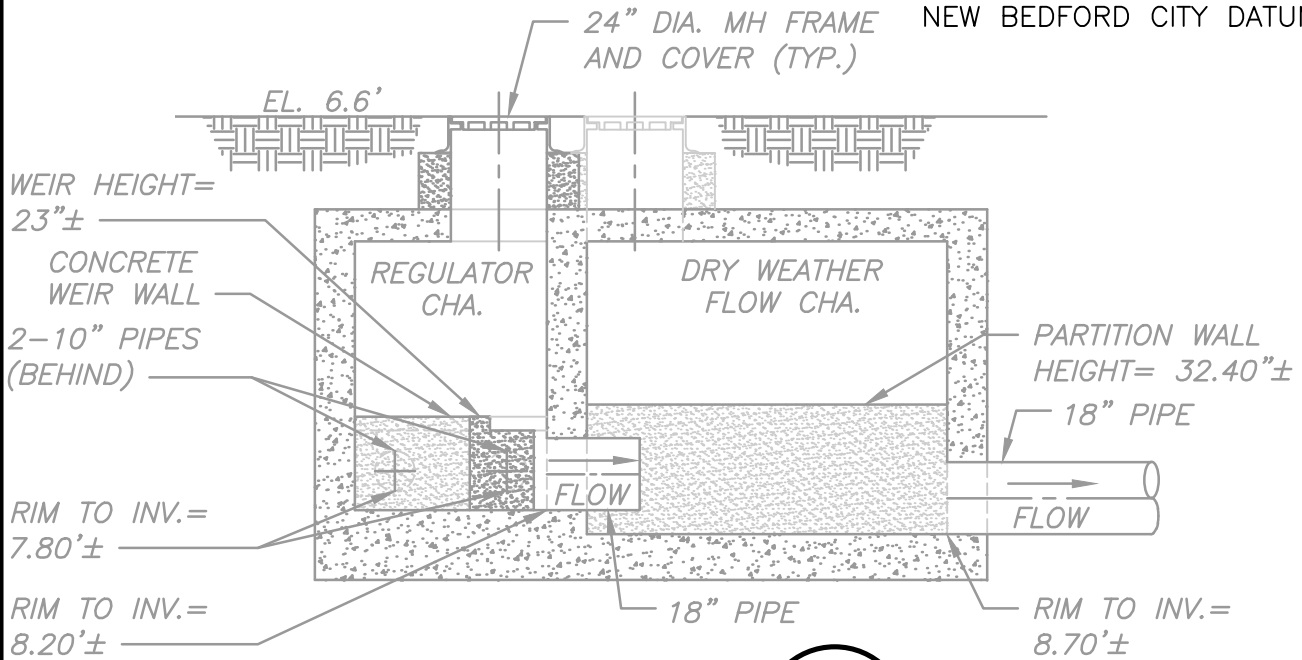
**SECTION 2**  
1/4" = 1'-0"  
SH.1

**NOTE:**  
ELEVATIONS SHOWN ARE IN  
NEW BEDFORD CITY DATUM.

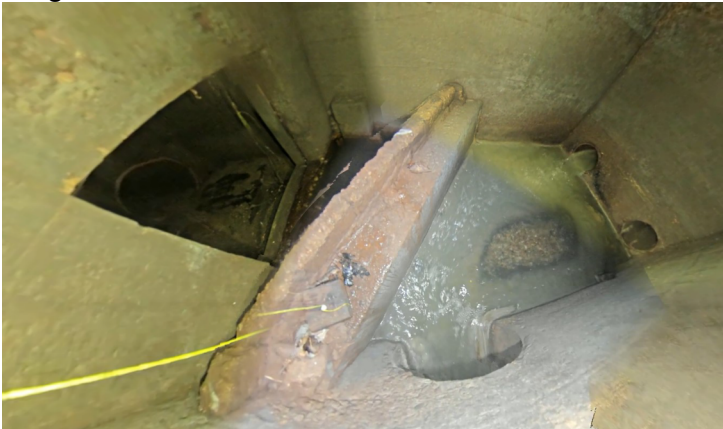
**Figure 1**

**Figure 1:** Inside of R-004A Regulator Chamber. Two inlets, the dry weather outlet, and weir are visible. The overflow outlet tide gate has been knocked down and is partially visible in neighboring overflow chamber.

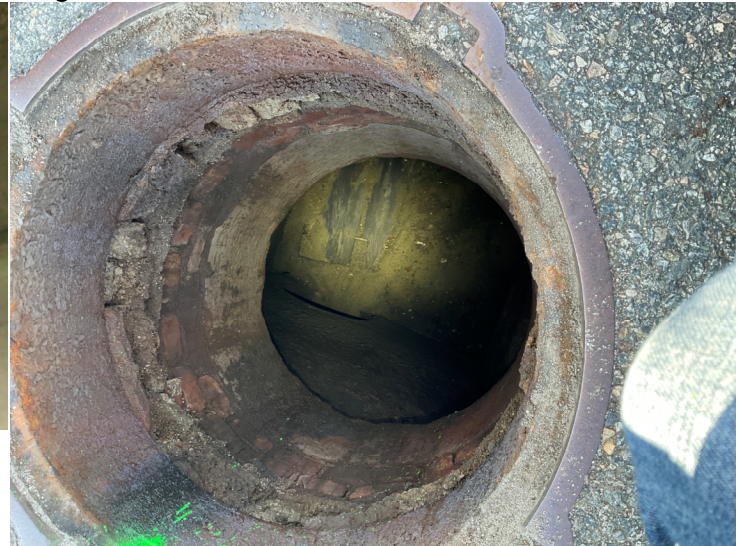
**Figure 2**

**Notes:** The 18" dry weather outlet connects to 24" pipe running underneath regulator chamber down cove road (P8176). The 4" pipe connecting Inlet Chamber and Old Float Chamber is blocked by a wooden plug and buried by sediment. Tide gate was knocked off its hinges sometime between 2020 and 2025, see Figure 2. Cove Rd. used to be called Brock Ave.

**Figure 2:** Inside of R-004A Overflow Chamber. Knocked over tide gate and sand visible.
