New Bedford Regulator Specification Sheet

Regulator #: R-012B

Location: E. Rodney French Blvd. and Bellevue St.

Date: 6/25/25

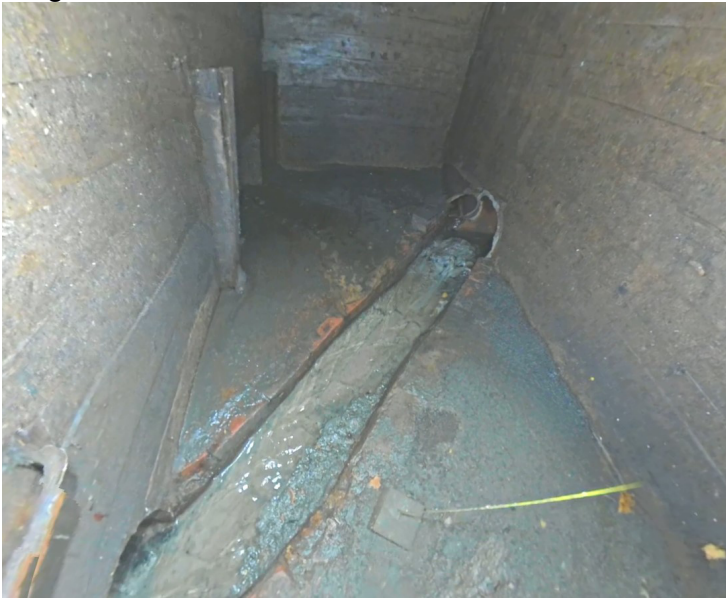
Figure 1

Figure 1: Inside of R-012B. Inlet pipes, dry weather outlet, and overflow opening are visible.

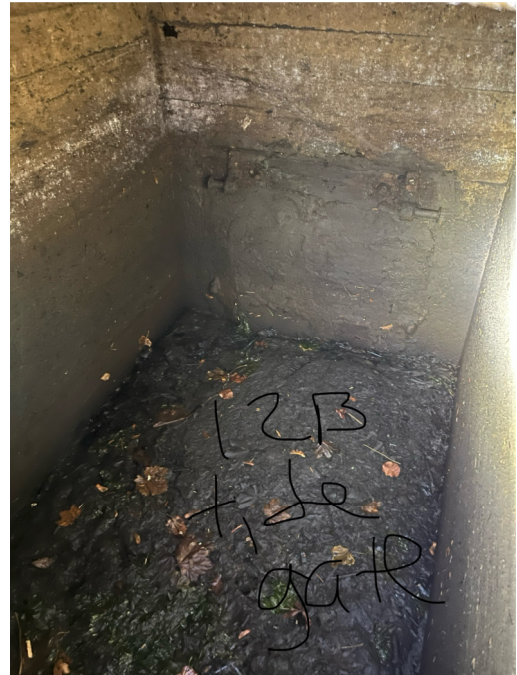
Figure 2

Tide Gate Status: Wooden flap gate sealed shut

Notes: Only the inlet chamber was scanned by Redzone in 2023. Other dimensions and elevations were estimated from record drawing- 6639A - ROD FR BLVD. Tide gate appears to be sealed shut, see Figure 2.

Figure 2: Inside of R-012B Tide Gate Chamber. Tide Gate appears to be sealed shut.
