R-030A

visited 3/21/25 at 3:15 pm

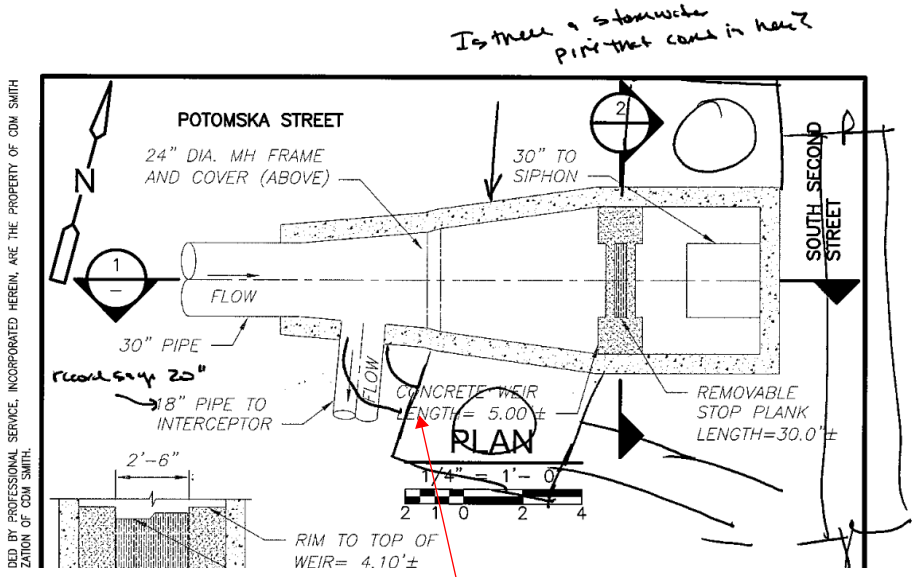
- Block missing
- meter present
- no flow gate
- 2 videos
- located the clean out chamber
- Rim to ledge: 6.05 ft
- Rim to bottom: 6.6 ft

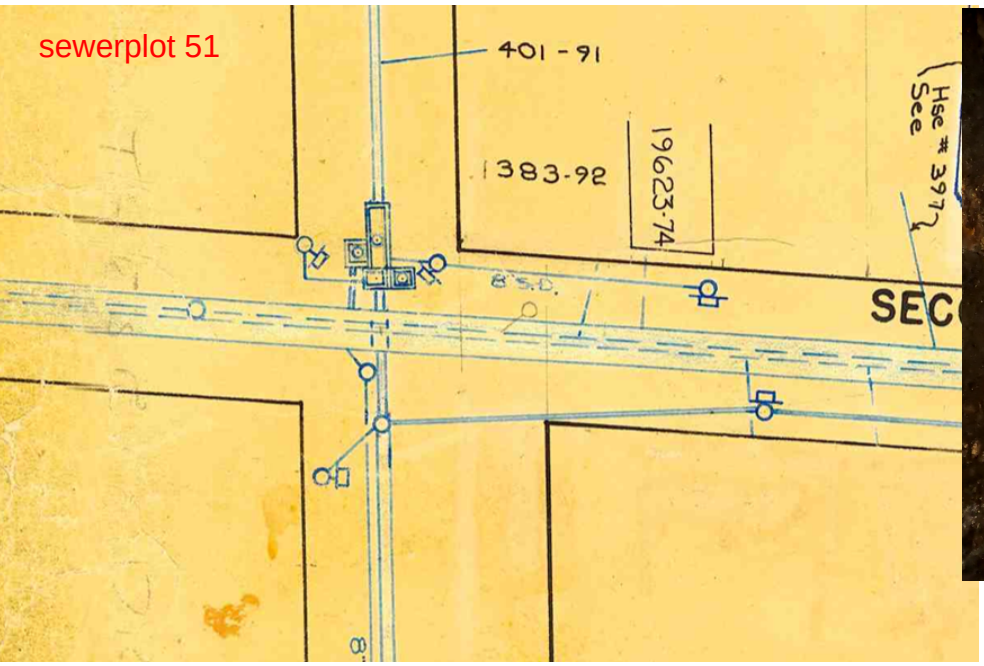
strange protrusion in 30" pipe entering R-030A

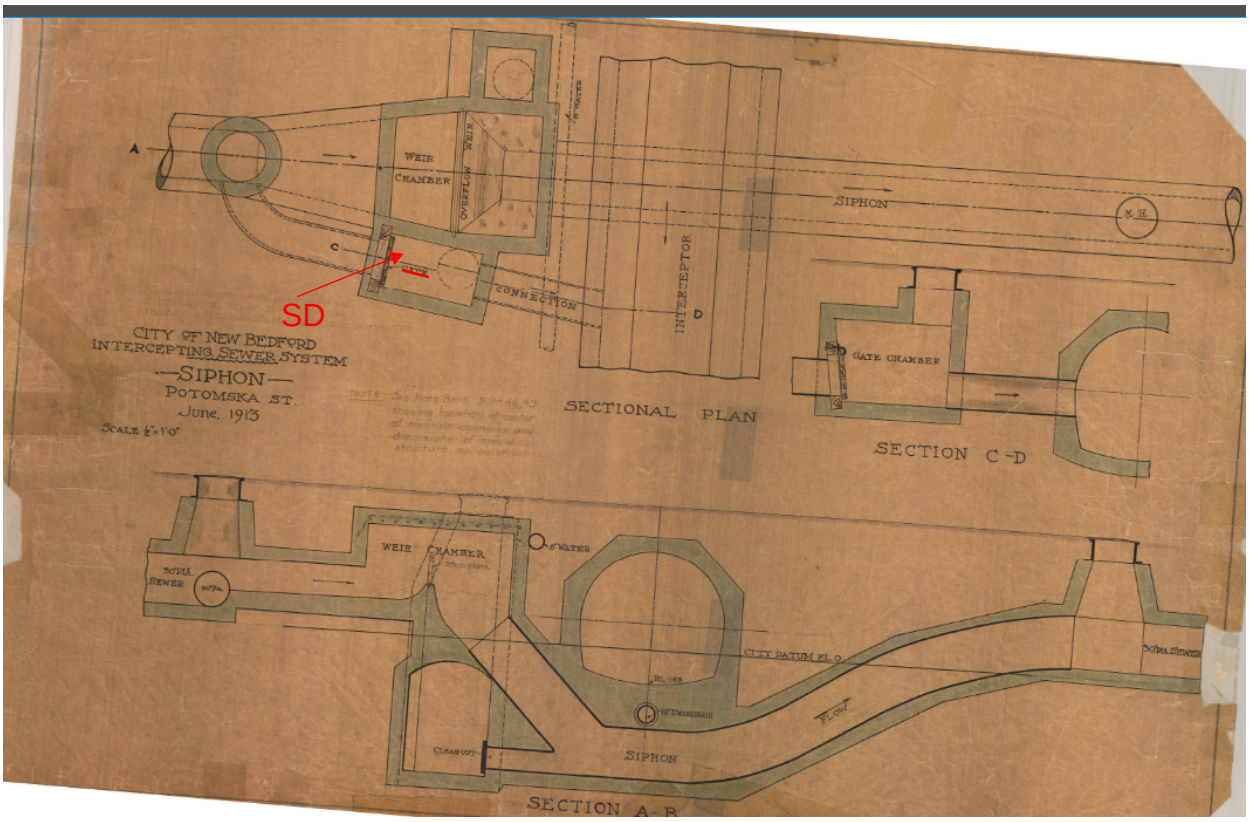
cleanout chamber mostly submerged

rim to bottom: 13.9 ft
approx 6ft of standing water
