R-030B

visited 3/21/25 at 3:31pm

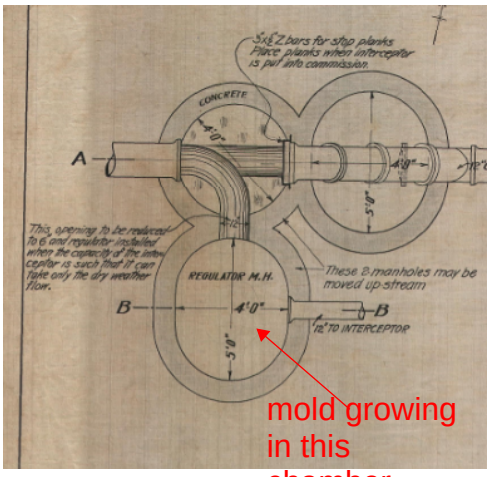
mold growing in this chamber.

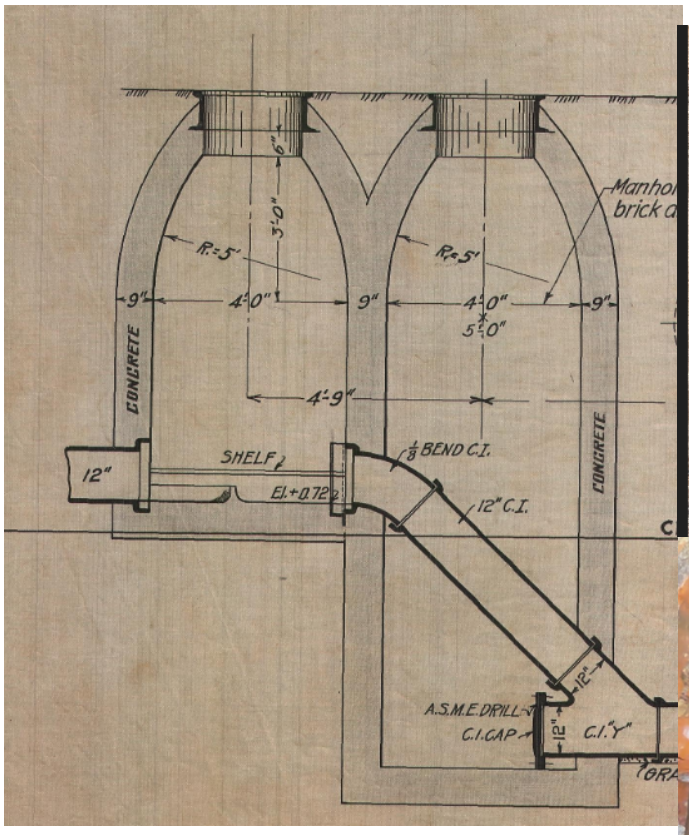
SD invert to Rim: 4.7ft

chamber bottom: 13.6 ft

rim to invert: 5.7ft

rim to invert: 8.6ft

chamber bottom: 8.6 ft
