R-004A_FLOAT

COVE RD
New Bedford

Inspection Status: Remote Inspection
Inspection Level: Level 2

Project: | New Bedford 3D Regulator Inspections

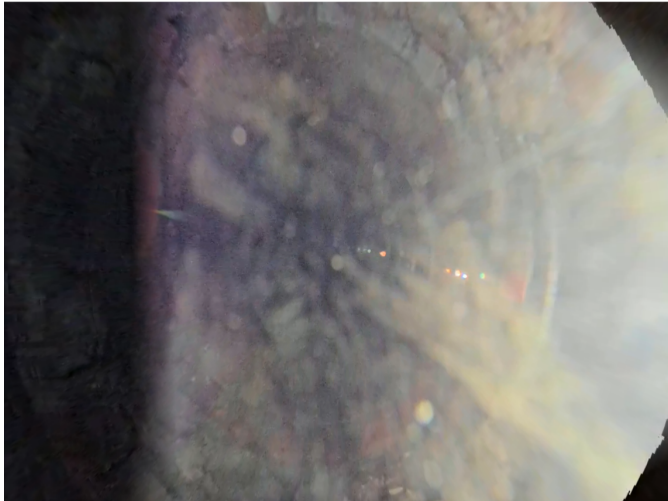
Code: **MGO**
Description: **Miscellaneous General Observation**

Distance: **0ft**
Structural Grade: **0**
O&M Grade: **0**
Clock Start/From:
Clock To:
1st Value:
2nd Value:
Value Percent:
Continuous Index:
Within Eight" of Joint: **False**
Remarks: **Start inspection**
