R-004A_TIDE

COVE RD
New Bedford

Project: | New Bedford 3D Regulator Inspections
Owner: New Bedford, MA
Customer: CDM Smith

Condition Report

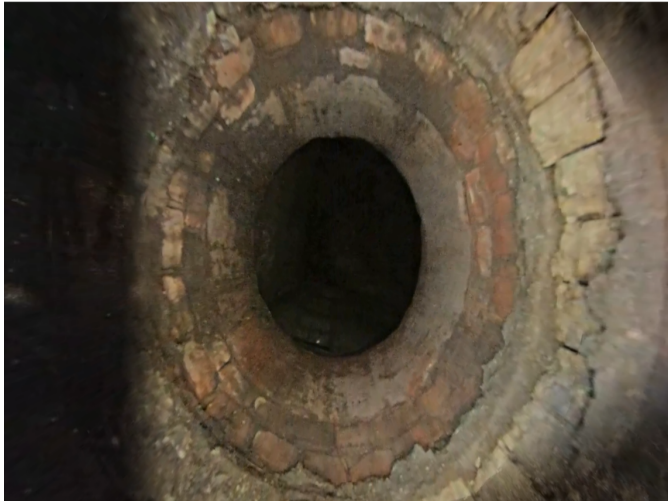
Code: **MGO**
Description: **Miscellaneous General Observation**

Distance: **0ft**
Structural Grade: **0**
O&M Grade: **0**
Clock Start/From:
Clock To:
1st Value:
2nd Value:
Value Percent:
Continuous Index:
Within Eight" of Joint: **False**
Remarks: **Start inspection**

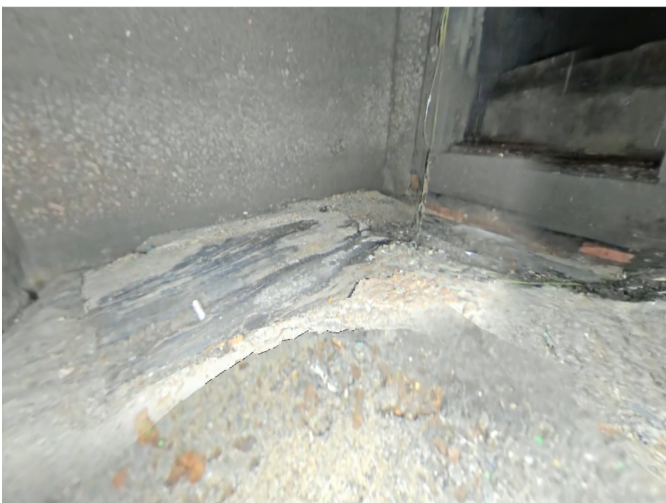
Code: **MGO**
Description: **Miscellaneous General
Observation**

Distance: **7ft**
Structural Grade: **0**
O&M Grade: **0**
Clock Start/From:
Clock To:
1st Value:
2nd Value:
Value Percent:
Continuous Index:
Within Eight" of Joint: **False**
Remarks: **End inspection**
