R-004B

COVE RD
New Bedford

Inspection Status: Remote Inspection
Inspection Level: Level 2

Project: | New Bedford 3D Regulator Inspections

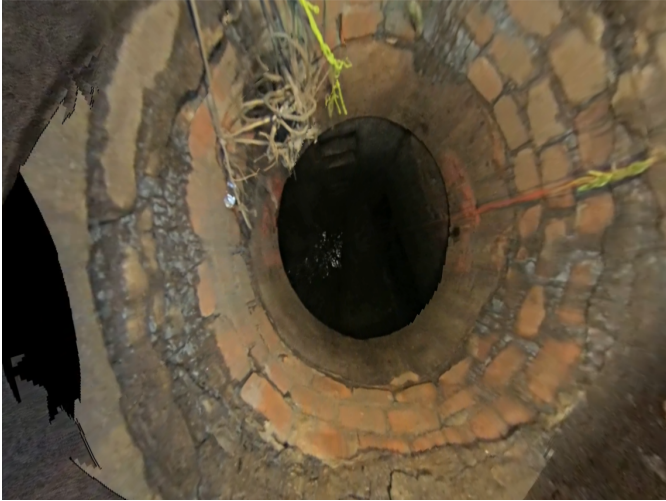
Code: **MGO**
Description: **Miscellaneous General Observation**

Distance: **0ft**
Structural Grade: **0**
O&M Grade: **0**
Clock Start/From:
Clock To:
1st Value:
2nd Value:
Value Percent:
Continuous Index:
Within Eight" of Joint: **False**
Remarks: **Start inspection**

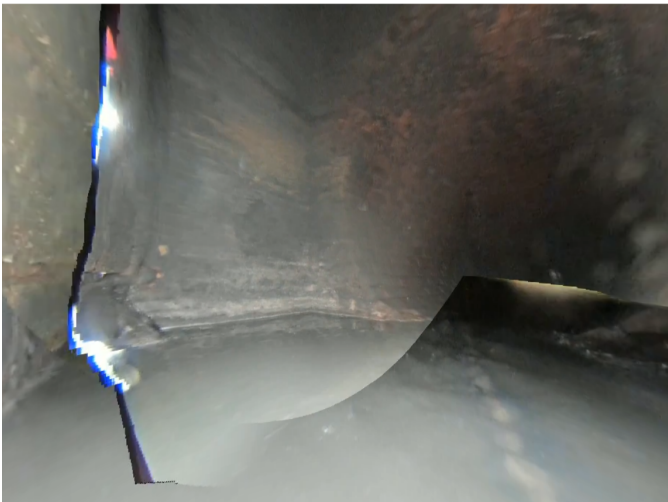
Code: **MGO**
Description: **Miscellaneous General Observation**

Distance: **9ft**
Structural Grade: **0**
O&M Grade: **0**
Clock Start/From:
Clock To:
1st Value:
2nd Value:
Value Percent:
Continuous Index:
Within Eight" of Joint: **False**
Remarks: **End inspection**
