R-004B_FLOAT

COVE RD
New Bedford

Inspection Status: Remote Inspection
Inspection Level: Level 2

Project: | New Bedford 3D Regulator Inspections

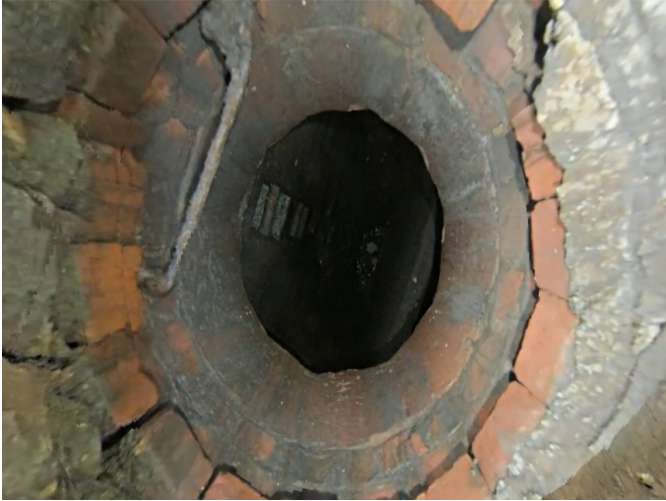
Code: **MGO**
Description: **Miscellaneous General Observation**

Distance: **0ft**
Structural Grade: **0**
O&M Grade: **0**
Clock Start/From:
Clock To:
1st Value:
2nd Value:
Value Percent:
Continuous Index:
Within Eight" of Joint: **False**
Remarks: **Start inspection**

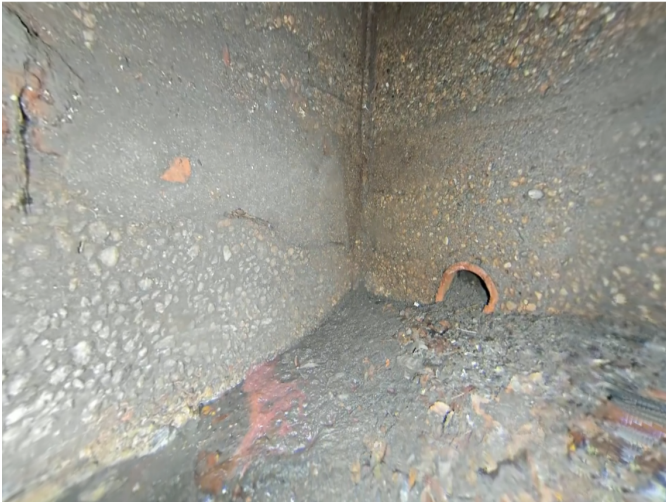
Code: **MGO**
Description: **Miscellaneous General Observation**

Distance: **9ft**
Structural Grade: **0**
O&M Grade: **0**
Clock Start/From:
Clock To:
1st Value:
2nd Value:
Value Percent:
Continuous Index:
Within Eight" of Joint: **False**
Remarks: **End inspection**
